APPENDIX 3: Photographs of test setup

Radiated Spurious Emission

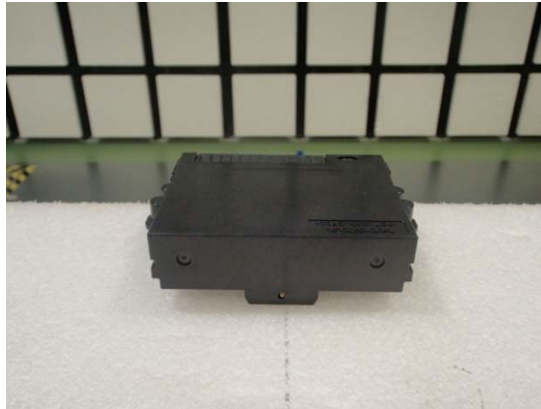
X-axis

Worst Case Position

Above 1 GHz (Horizontal: Y-axis/ Vertical: Z-axis)
Below 1 GHz (Horizontal: X-axis/ Vertical: X-axis)
