ANNEX 1 - PLOTS OF MEASUREMENTS  
TRANSIENT FREQUENCY BEHAVIOR

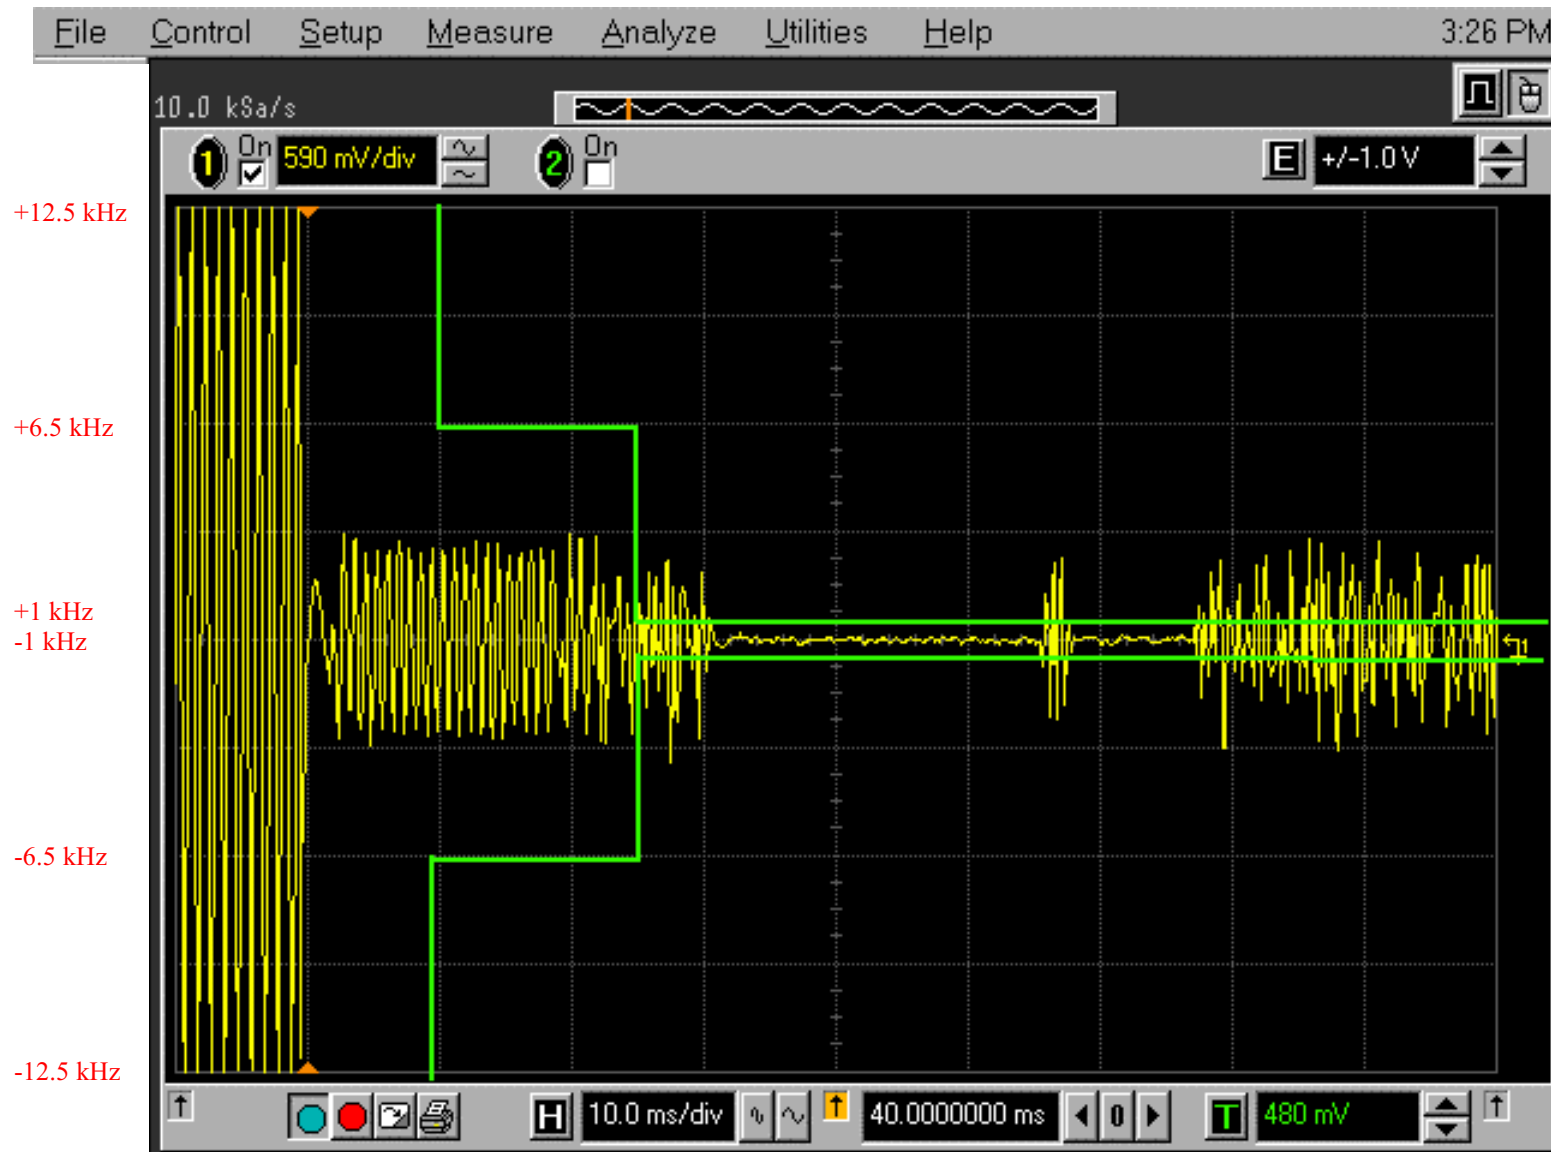
**PLOT # 32**

**12.5 kHz Channel Spacing, Transmitter was being turned ON, FM MODULATION with internal random data**

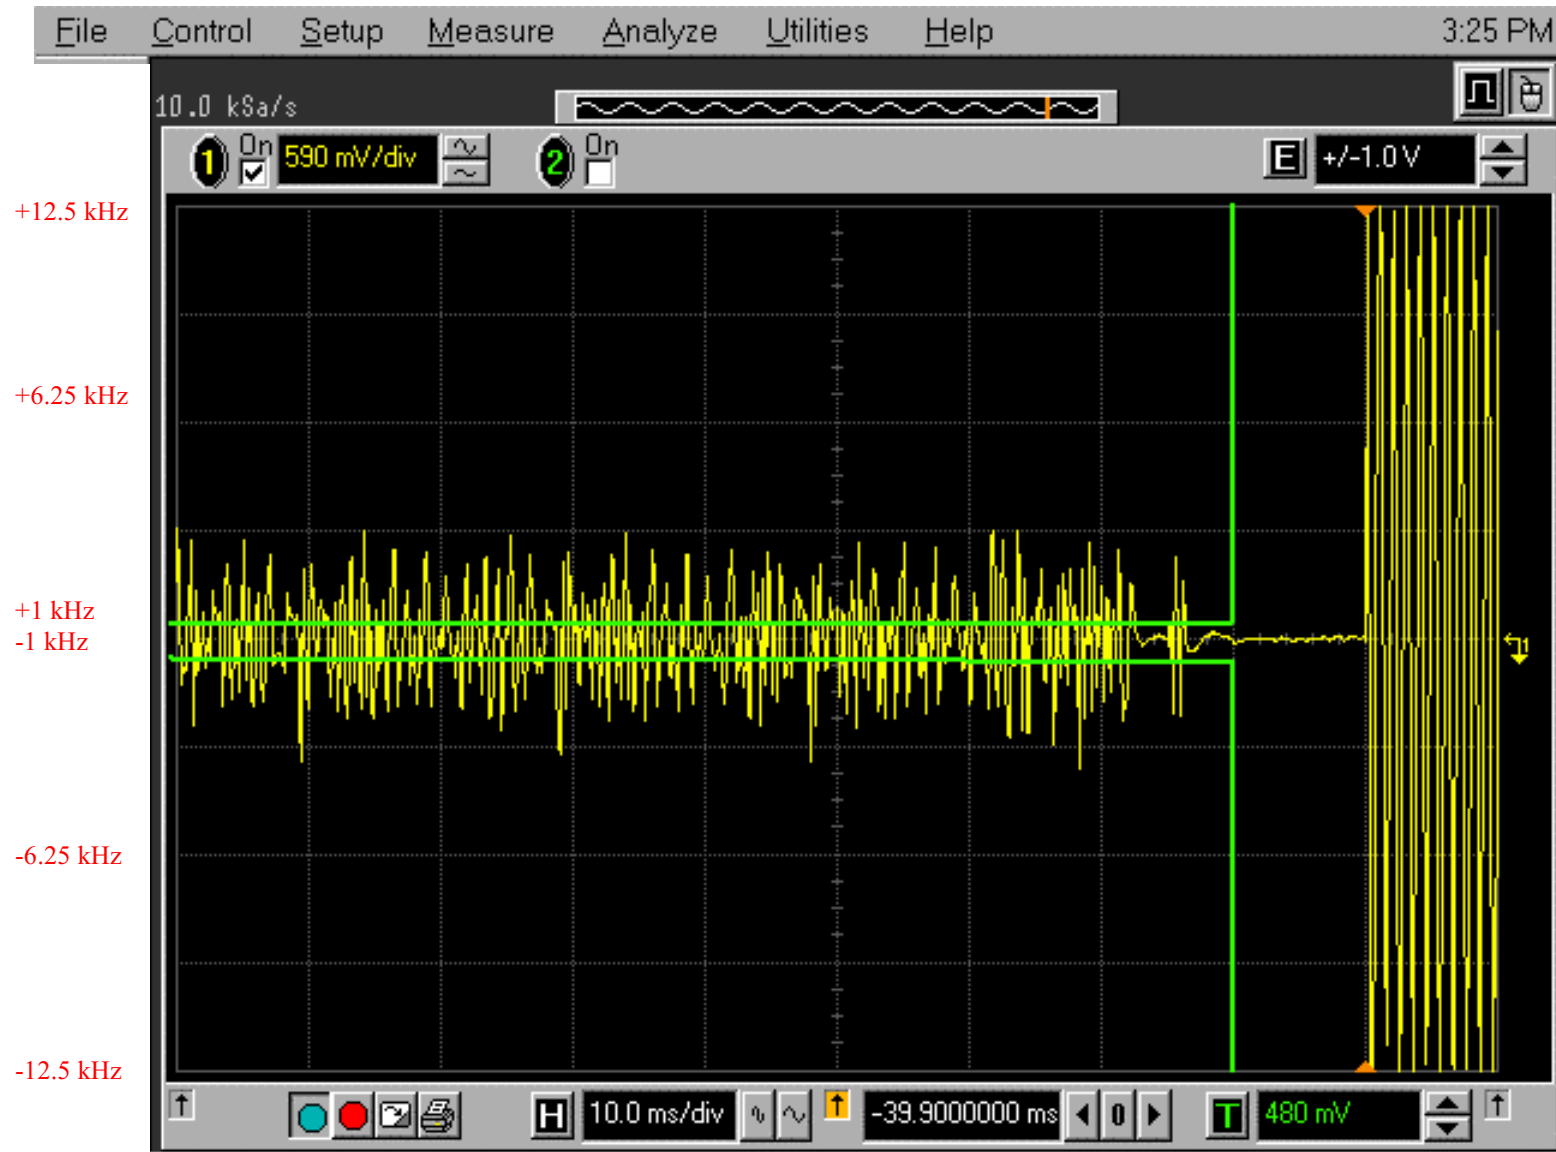
**PLOT # 33**

**12.5 kHz Channel Spacing, Transmitter was being turned OFF, FM MODULATION with internal random data**
