Environmental Testing of the McMurdo Limited 406 MHz Fastfind Plus PLB with  
internal GPS position encoded data and 121.5 MHz Radio locating device

Report No: SX608213

December 2001

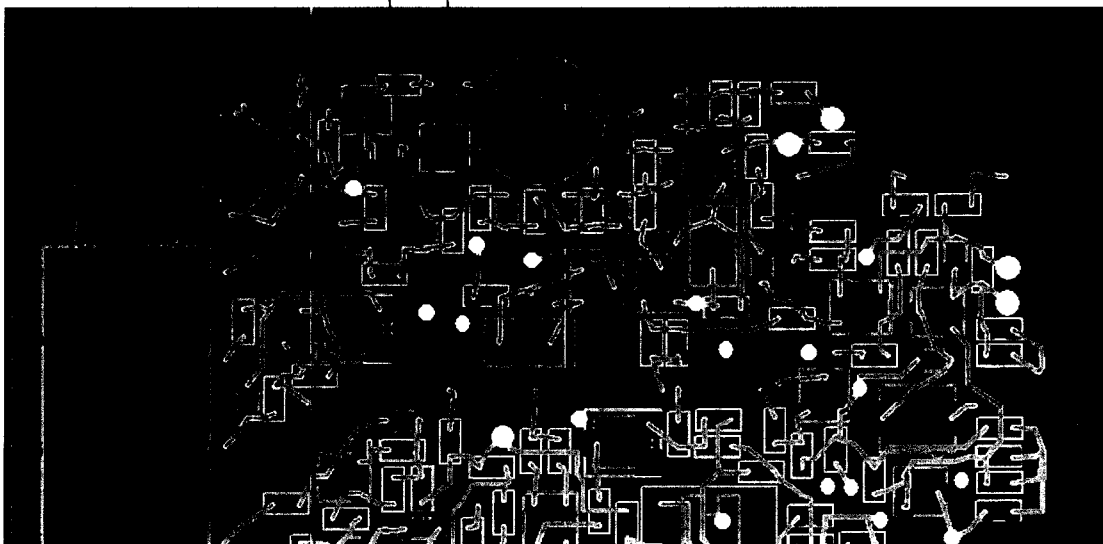
C67 L15

The production issue artwork has these components fitted to 0805/0603 component pads, so this problem will not occur in production units. A detail from the production release PCB artwork is shown below, illustrating the placement of the affected components.
