Radio Approval Testing of the
McMurdo Limited
SmartFind S5 AIS SART
In accordance with IEC 61097-14 and IEC 60945

Document 75907213 Report 02 Issue 3

May 2010

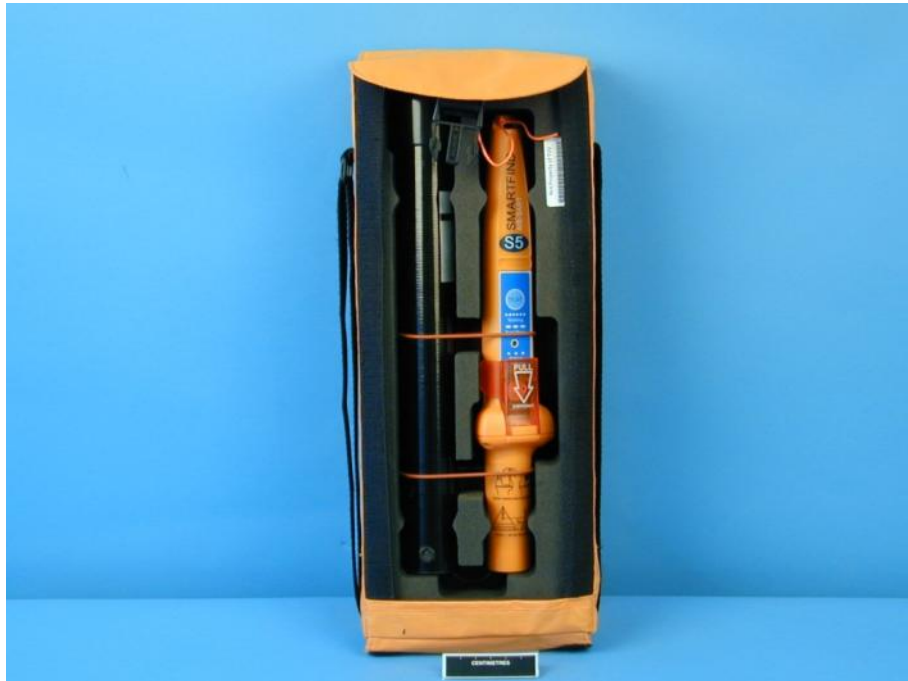
The Equipment Under Test (EUT) was a McMurdo Limited SmartFind S5 AIS SART as shown in the photograph below. A full technical description can be found in the manufacturer's documentation.

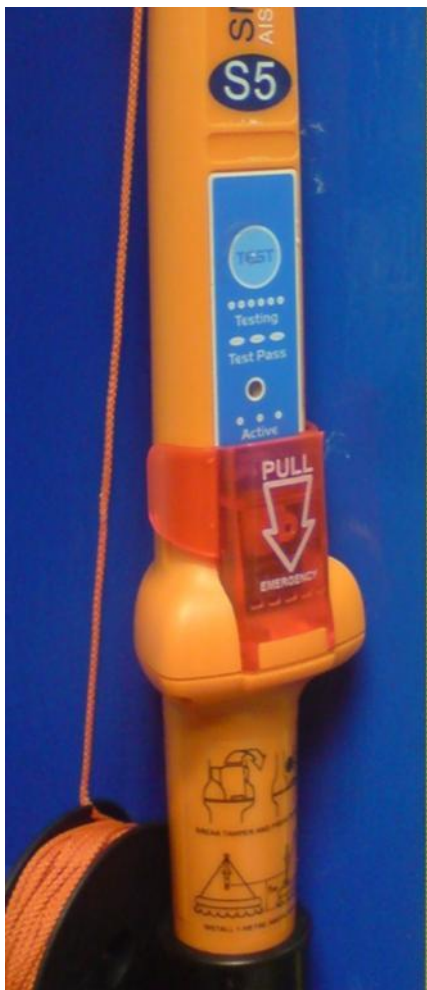
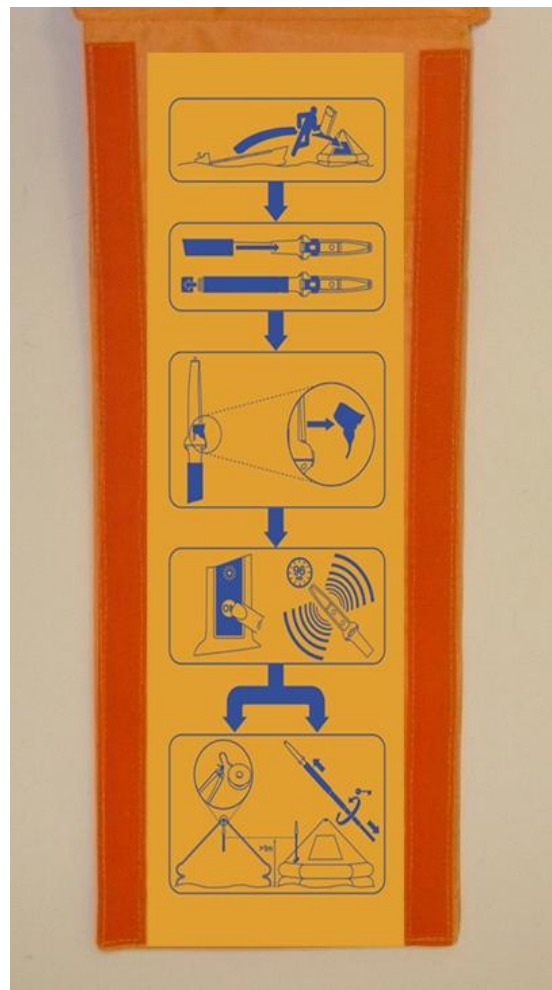
The SmartFind S5 AIS SART is equipped with a blue label which indicates the position of the ON button: this switch is set behind the tamperproof device which provides a means to prevent inadvertent activation. There are additional diagram labels which are located on the lower section of the AIS-SART which depict the removal of the tamper proof device and the pressing of the ON button. Additional diagrams are provided for the installation of the mounting pole; along with installation instructions printed on the inside of the carry bag. Additional instructions are provided in the operator's manual supplied with the product.

SmartFind S5 AIS SART labels depicting activation and installation

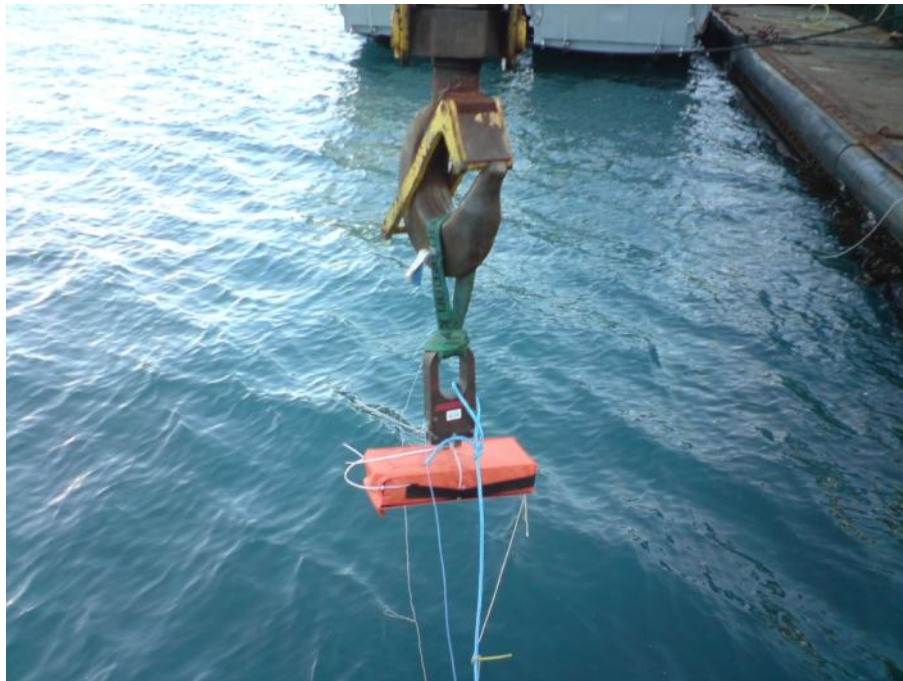
Test Set-up

The test was performed with the EUT in the following mode(s): Idle. This test was performed with the EUT enclosed in the storage bag as supplied by the manufacturer.

The EUT was subject to a mechanical inspection after the third drop: no signs of deterioration or of water ingress were noted.

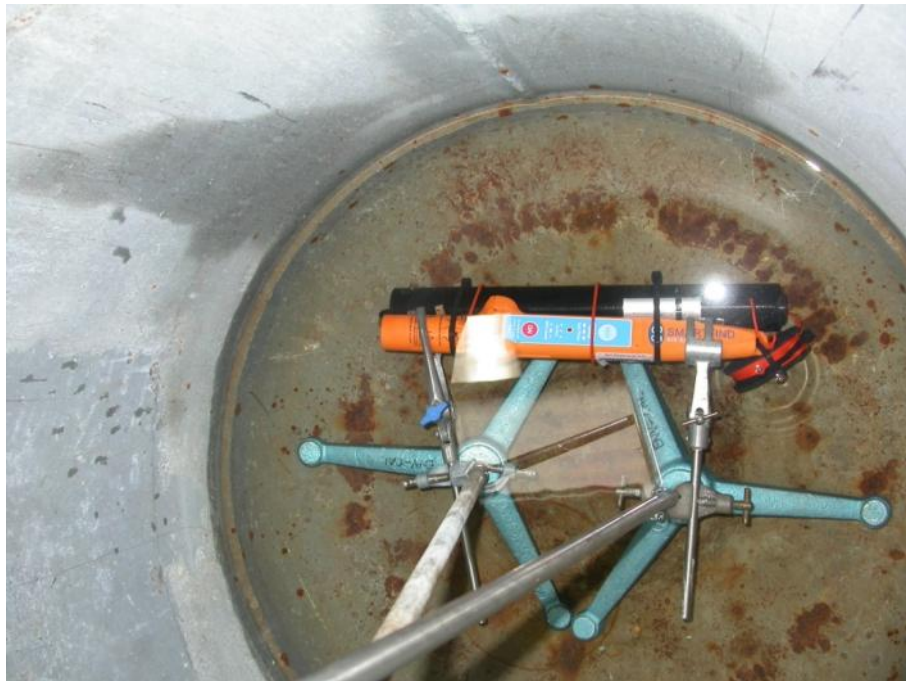
Test Set-up – Water Immersion

The test was performed with the EUT in the following mode(s): Idle. The EUT was tested stand alone i.e. not enclosed in the storage bag as supplied by the manufacturer.

With the EUT in the idle state the pressure of the vessel was raised to 1.0 bar (g); this condition was maintained for 5 minutes, after which the pressure vessel was returned to laboratory ambient.

The EUT was subject to a visual inspection: no signs of water ingress were noted.

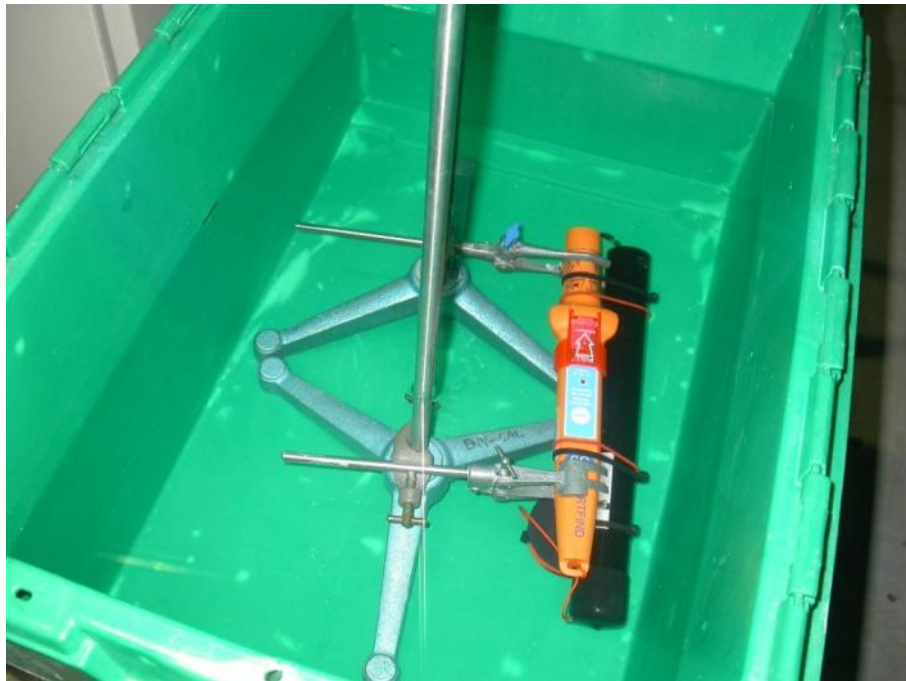
Test Set-up

The test was performed with the EUT in the following mode(s): Idle. The EUT was tested stand alone i.e. not enclosed in the storage bag as supplied by the manufacturer.

The chamber conditions were maintained for 1 hour after which time the EUT was immersed in water at 24.9°C to a depth of 100mm from the highest point of the EUT to the surface of the water.

The EUT was subject to a visual inspection: no signs of water ingress were noted.

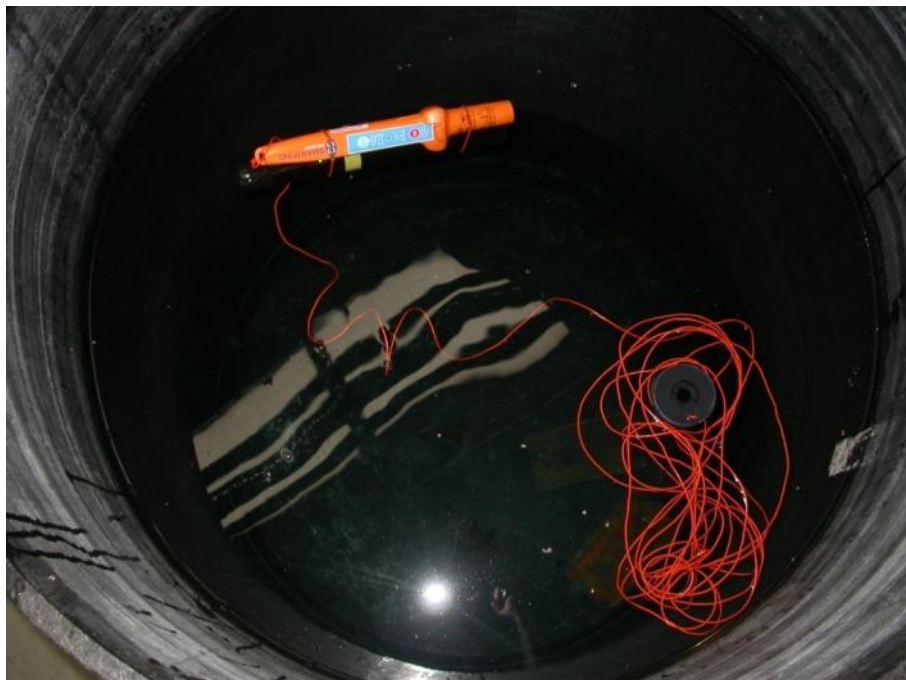
Test Set-up

The test was performed with the EUT in the following mode(s): Idle. The EUT was tested with the mounting pole attached but not installed. The EUT was not enclosed in the storage bag as supplied by the manufacturer.

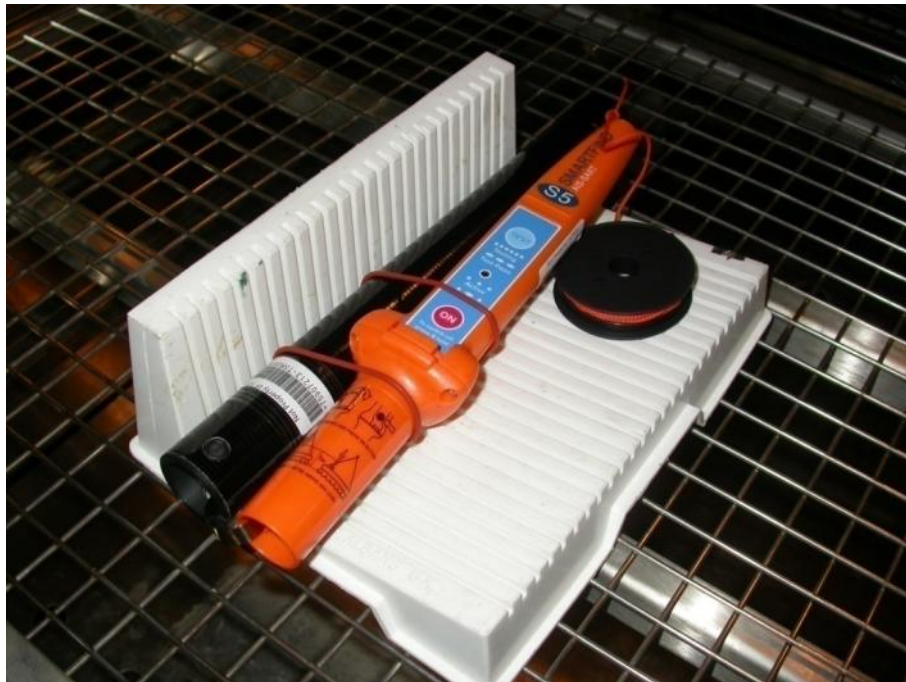
Test Set-up – Dry Heat

The test was performed with the EUT in the following mode(s): Idle. The EUT was tested stand alone i.e. not enclosed in the storage bag as supplied by the manufacturer.

The EUT was placed in the environmental chamber at laboratory ambient conditions. The temperature was then raised and maintained at +70°C for a period of approximately 13.5 hours after which time a performance check was carried out. The temperature of the chamber was then returned to laboratory ambient conditions after which time another performance check was carried out.

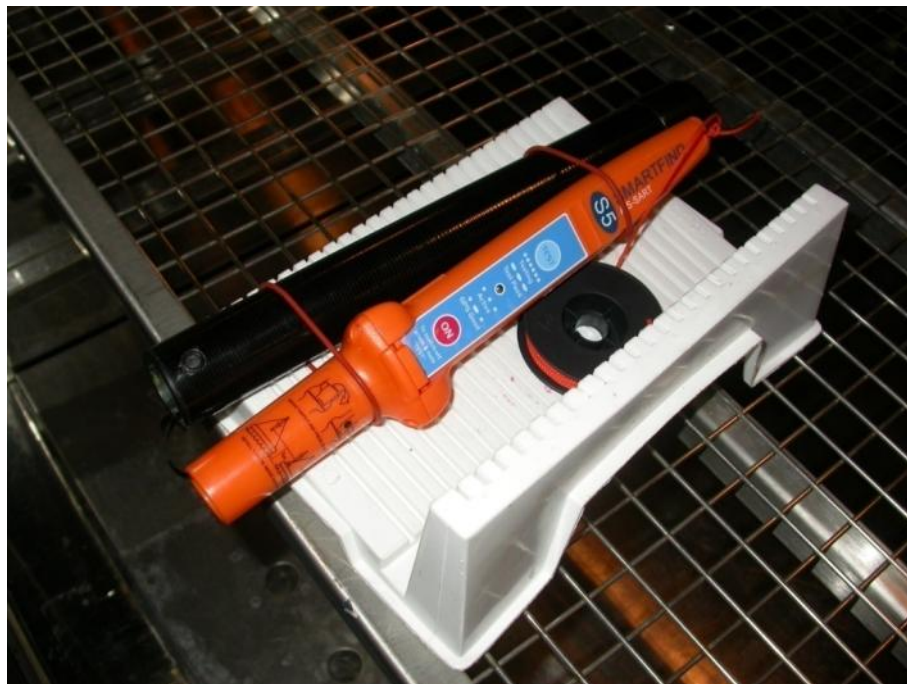
Test Set-up – Damp Heat

The test was performed with the EUT in the following mode(s): Idle. The EUT was tested stand alone i.e. not enclosed in the storage bag as supplied by the manufacturer.

The EUT was placed in the environmental chamber at laboratory ambient conditions. The temperature of the chamber was then raised to +40 °C and the relative humidity raised to 93% over a period of 3 hours. The conditions were maintained for 15 hours after which time the AIS SART was switched on and remained operational for 2 hours. During the 2 hours of operation the AIS SART was subject to a performance check. The environmental conditions of the climatic chamber were then returned to room temperature within 1 hour. A performance check was also carried out after the test.

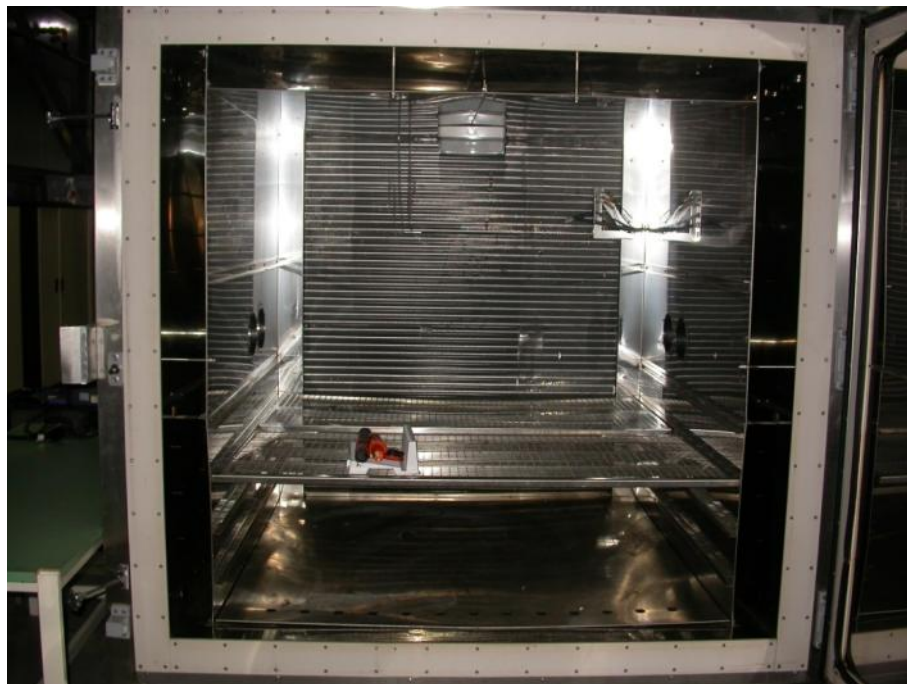
Test Set-up – Low Temperature

The test was performed with the EUT in the following mode(s): Idle. The EUT was tested stand alone i.e. not enclosed in the storage bag as supplied by the manufacturer.

The EUT was placed in the environmental chamber at laboratory ambient conditions. The temperature was then lowered to -30°C for 15.5 hours. The temperature was raised to -20°C and the AIS SART was switch on and remained operational for 2 hours; a performance test and check were carried out during this time. Once the performance test and check were complete the conditions of the environmental chamber were returned to laboratory ambient.

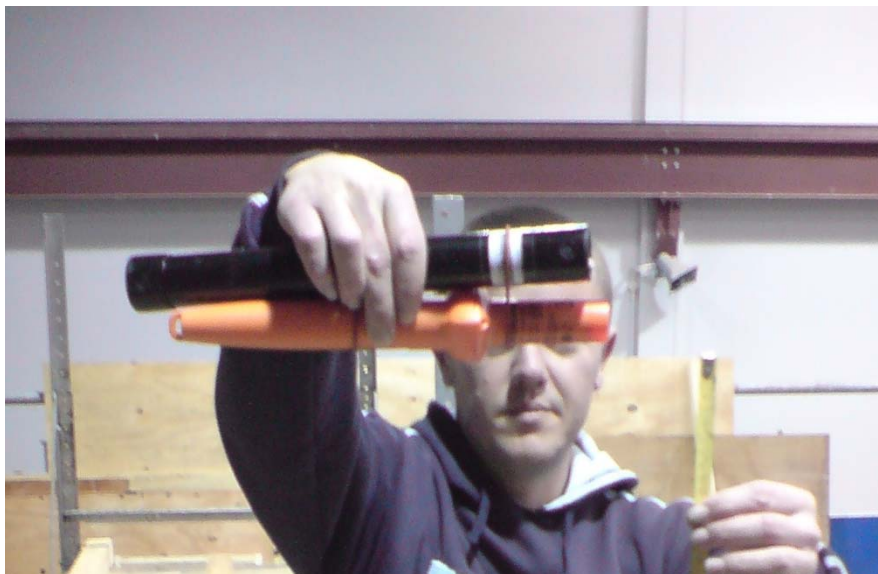
Test Set-up - Drop Test

The test was performed with the EUT in the following mode(s): Idle. The EUT was tested stand alone i.e. not enclosed in the storage bag as supplied by the manufacturer. The mounting pole was attached to the AIS SART but not installed. A bung was fitted in the end of the mounting pole and the AIS SART was held together with the mounting pole with two rubber bands as supplied by the manufacturer.

The EUT was subject to a series of 6 drops from a height of 1 metre, one on each face of the EUT. The EUT was dropped onto a piece of solid hard wood in accordance with the specification. After the 6 drops the EUT was inspected for external signs of damage and subject to the performance check.

The test was carried out twice as some damage occurred. The AIS SART was modified and the EUT retested. No further damage occurred. The modification details are recorded in section 1.6.

Following the second drop test (i.e. after the modification) there were no visible external indications of damage that could affect the functionality of the EUT.

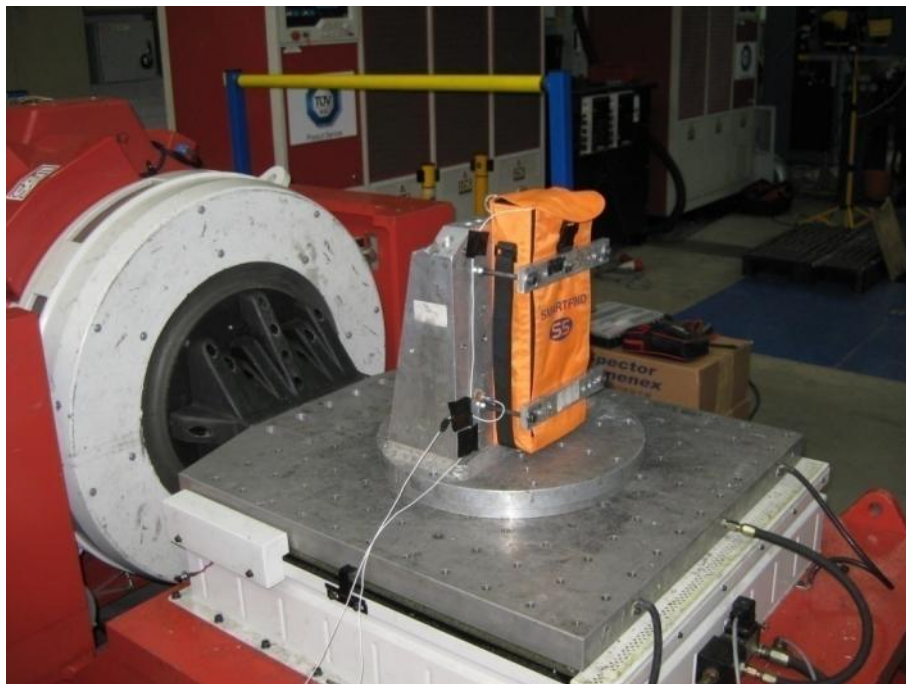
Test Set-up – Vibration

The test was performed with the EUT in the following mode(s): Idle. The EUT was tested in the storage bag as supplied by the manufacturer.

For each axis a resonance search was conducted, see Control Channel (input) and Response Channel (output/EUT response) plots. If no resonance was found the endurance run was performed at 30Hz for a period of 2 hours, see following Control Channel and Response Channel plots.

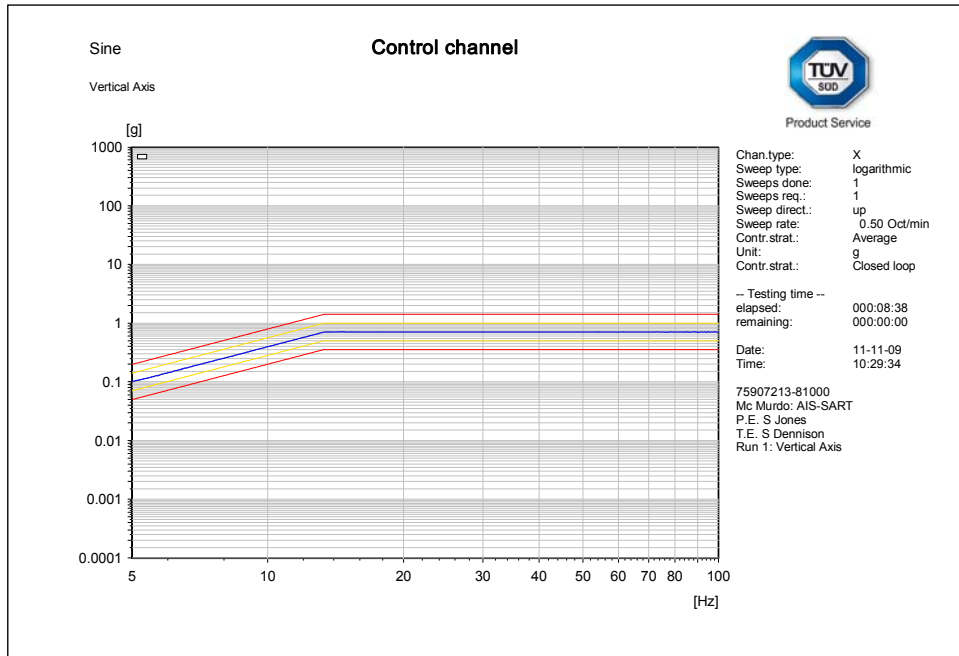
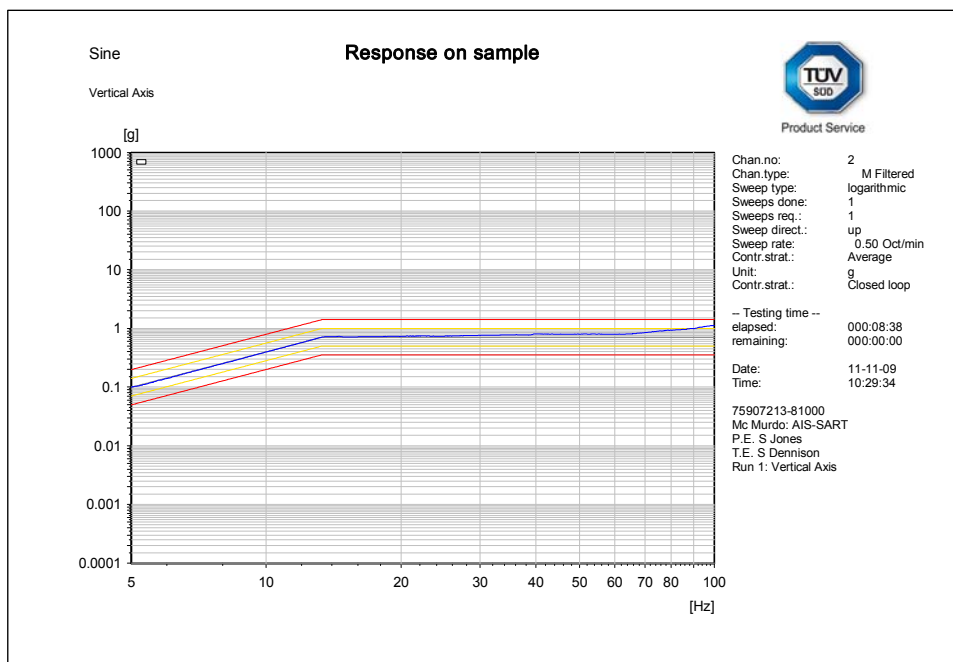
Lateral Axis – Resonance Search

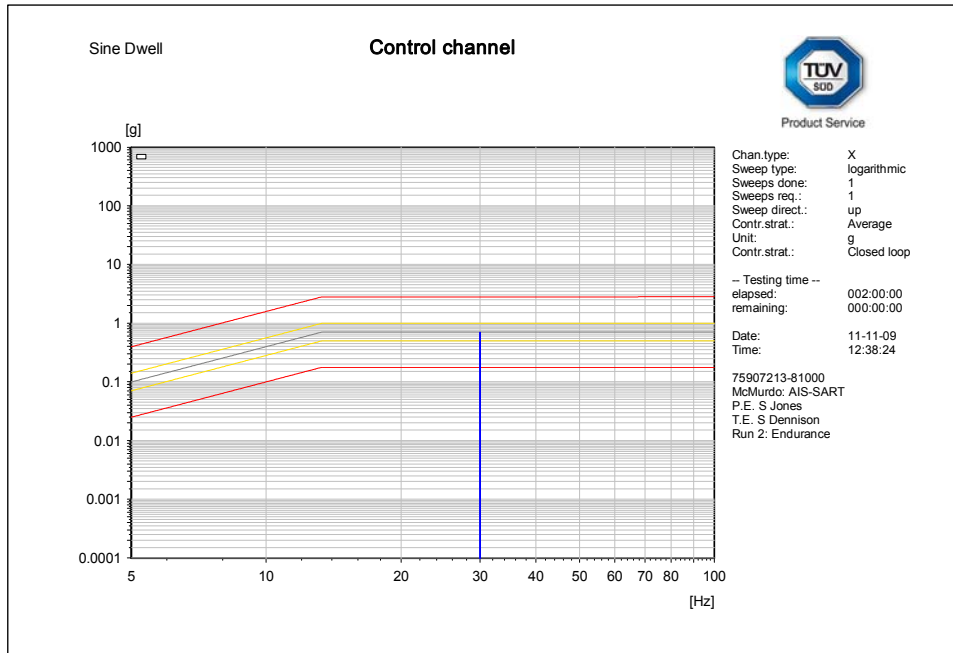
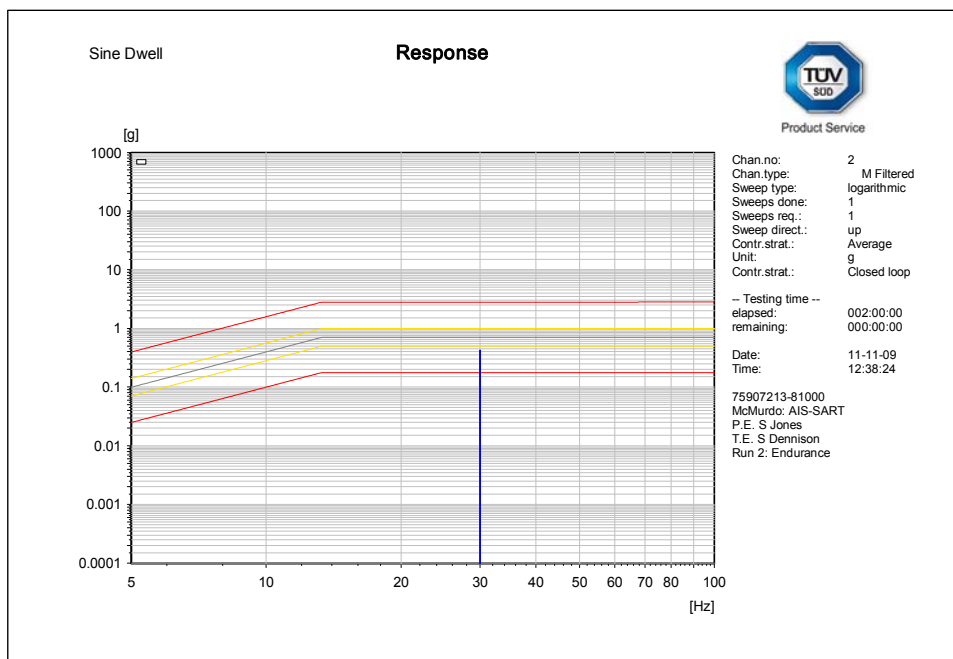
Lateral Axis – Endurance Run

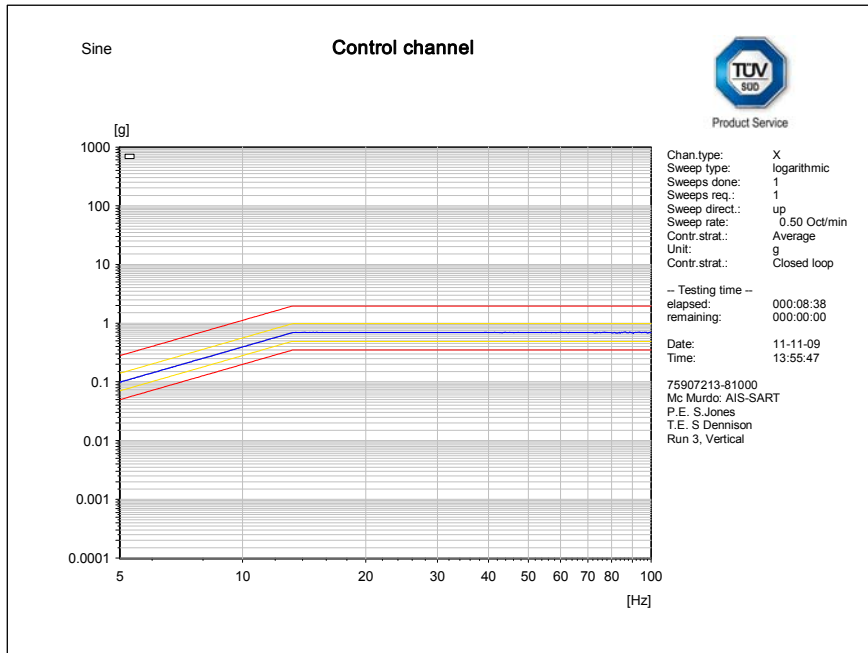
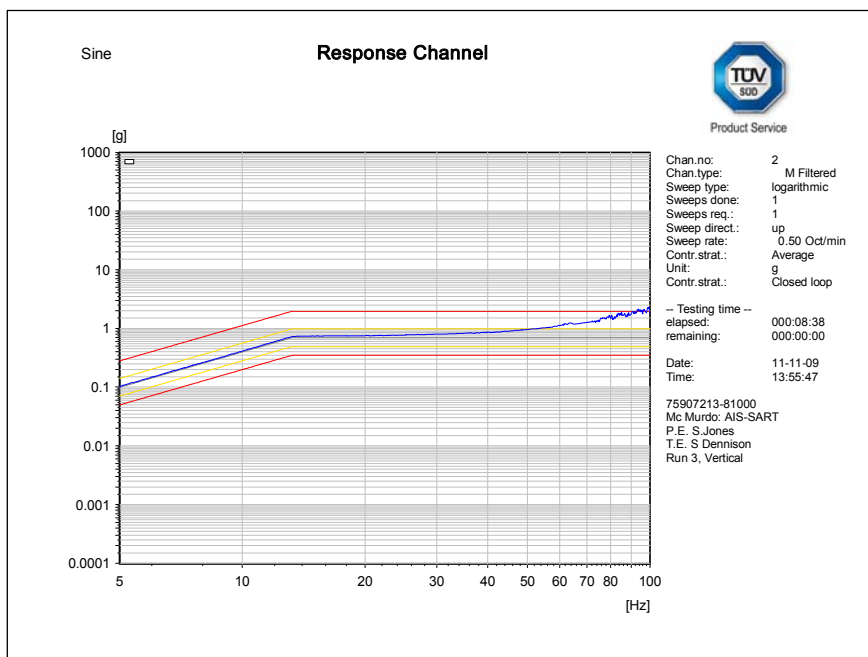
Vertical Axis – Resonance Search

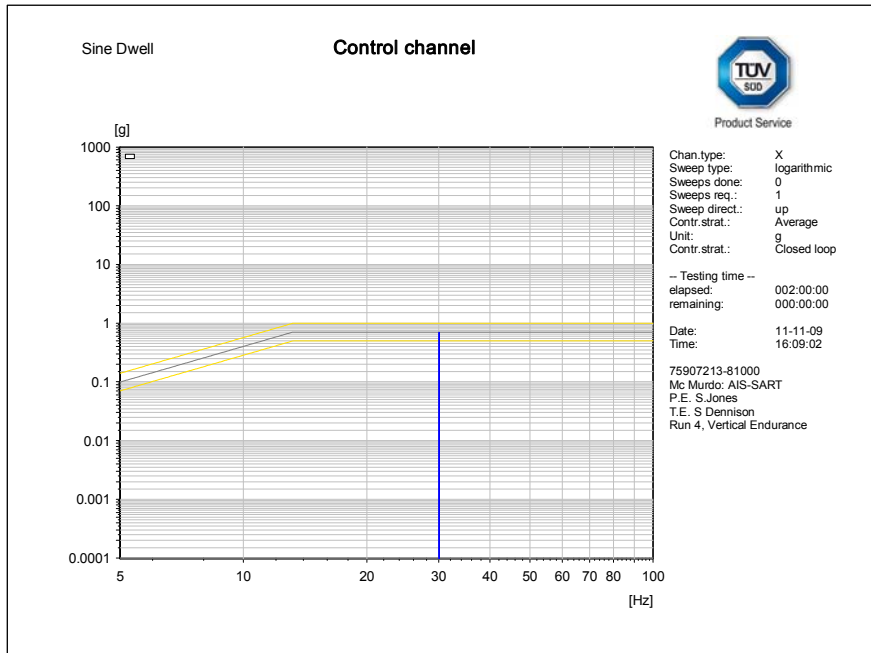
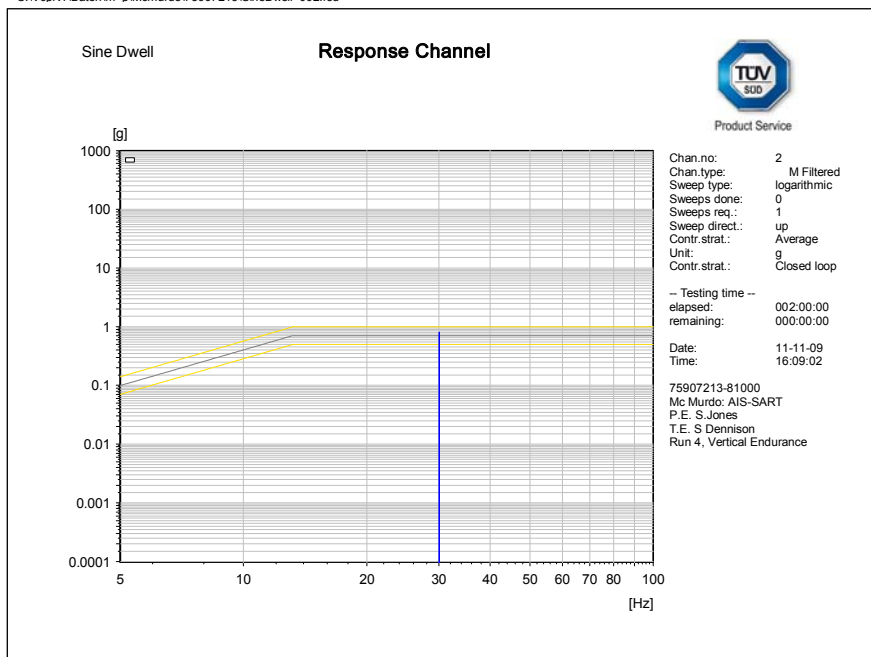
Vertical Axis – Endurance Run

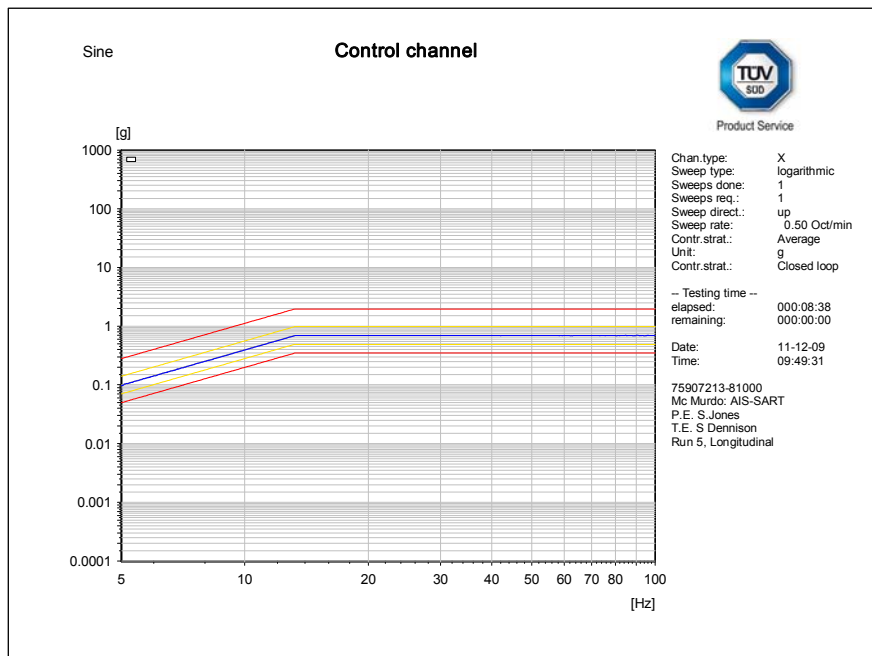
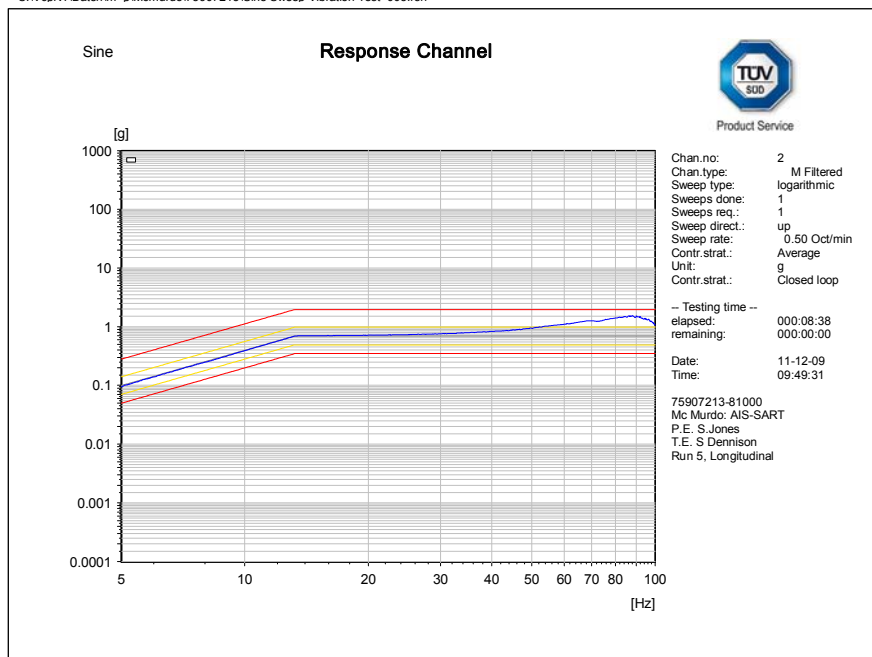
Longitudinal Axis – Resonance Search

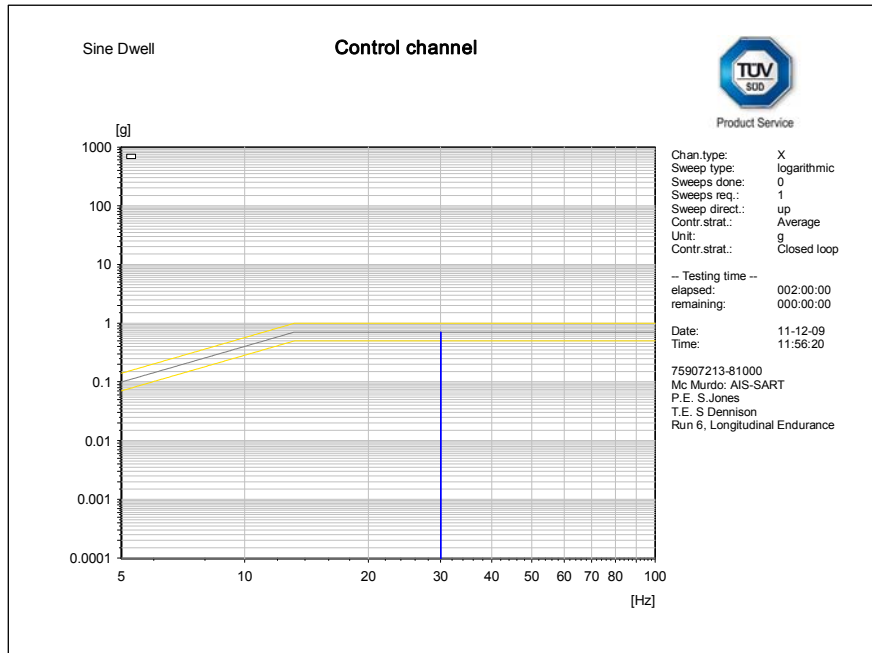
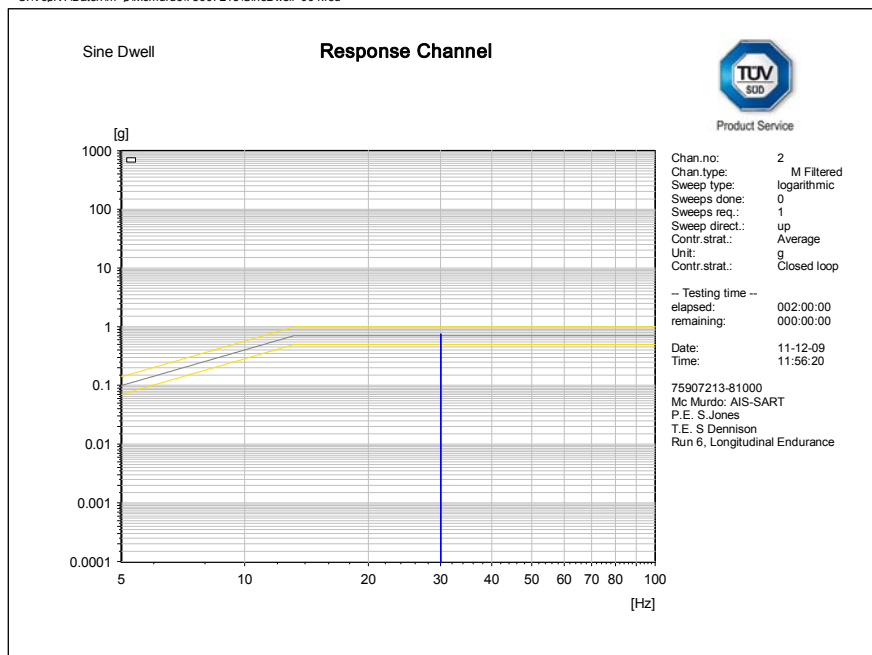
Longitudinal Axis – Endurance Run

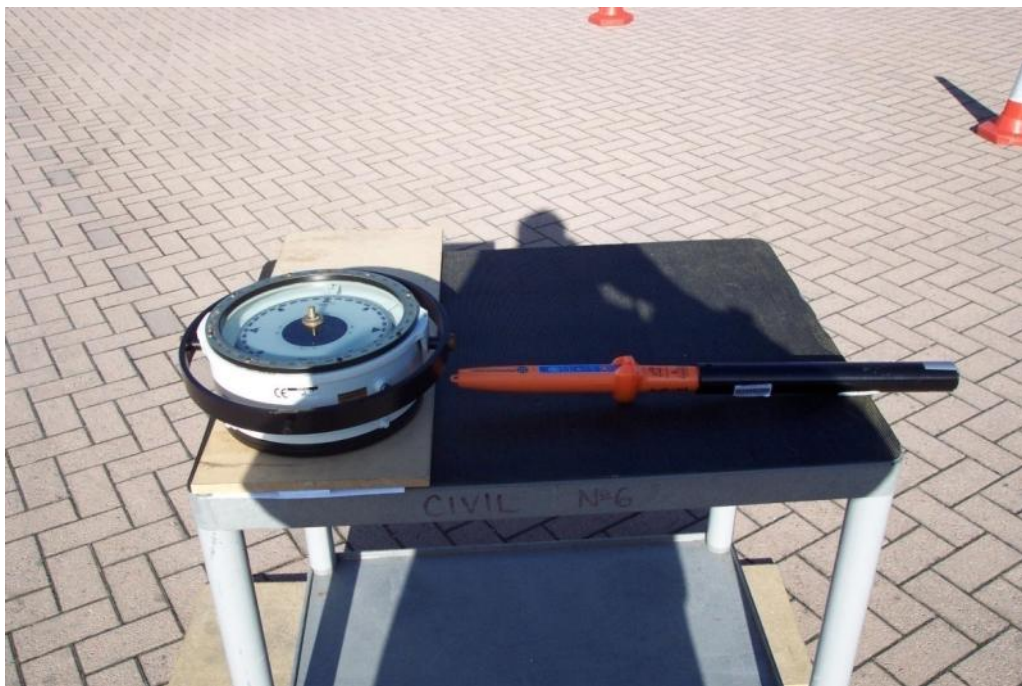
Test Set-up – Compass Safe Distance

The test was performed with the EUT in the following mode(s): Idle.

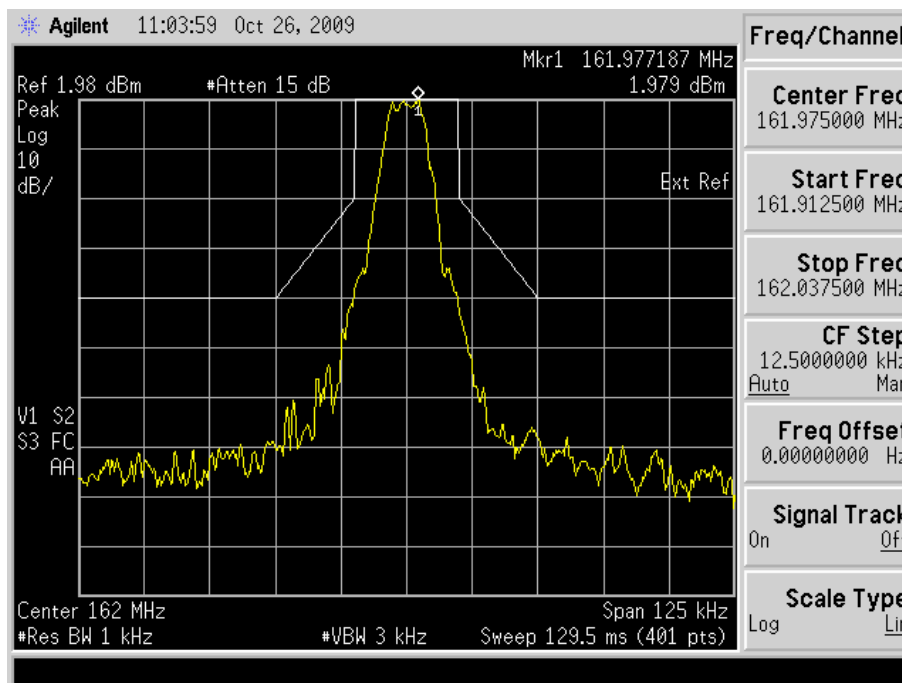
AIS 1 Bottom Channel

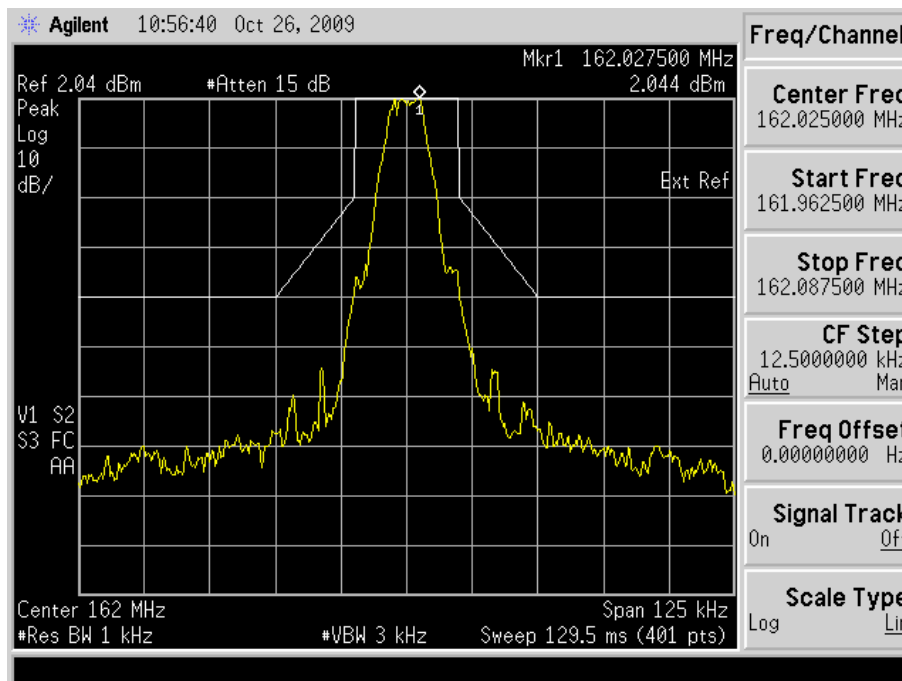
AIS 2 Top Channel

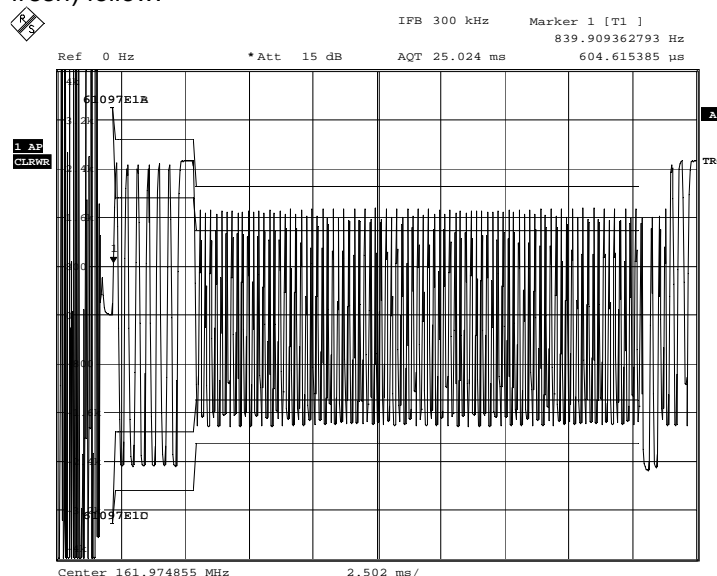
AIS1, Signal 1 – High Temperature and Fresh Battery

Plots for AIS 1 and AIS 2, for both signals 1 and 2 follow at varying temperatures and battery states (old or fresh) follow.

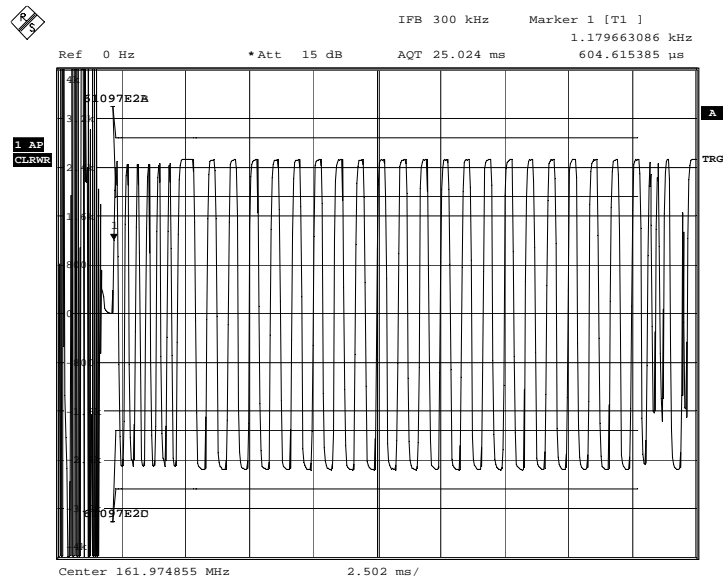
AIS1, Signal 2 – High Temperature and Fresh Battery

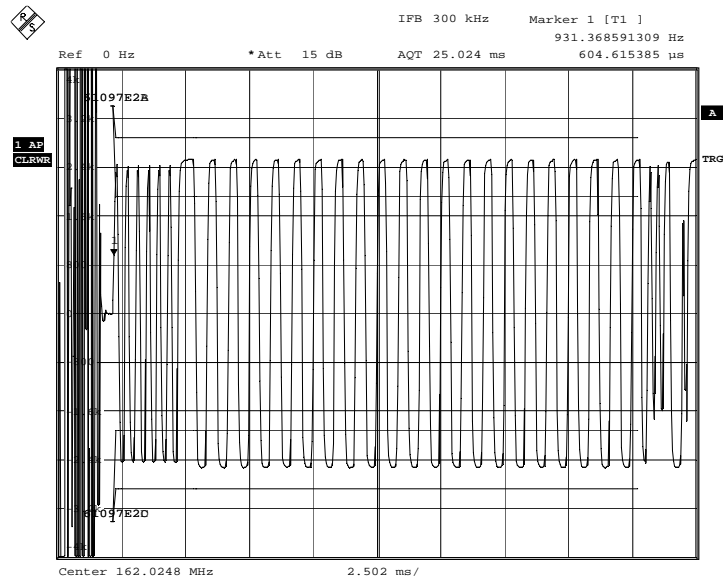
AIS2, Signal 1 – High Temperature and Fresh Battery

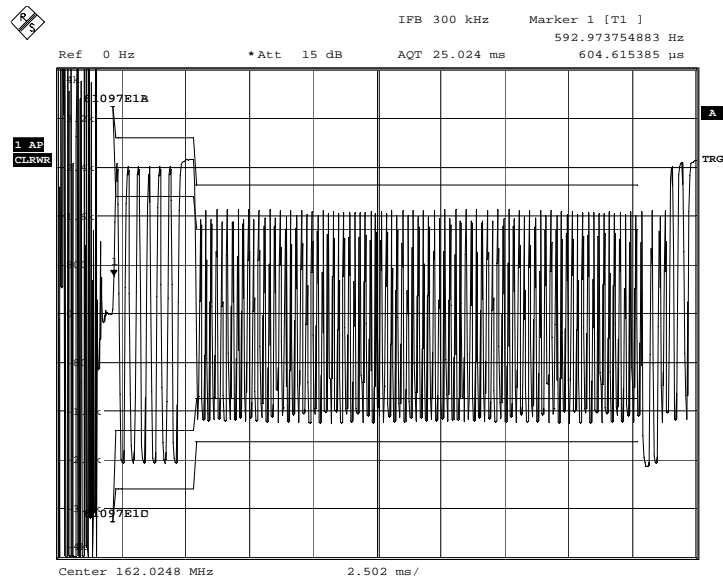
AIS2, Signal 2 – High Temperature and Fresh Battery

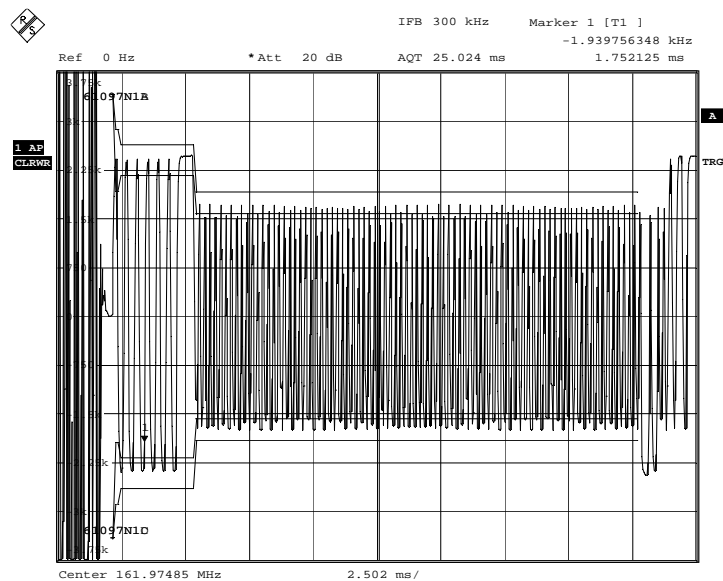
AIS1, Signal 1 – Normal Test Conditions

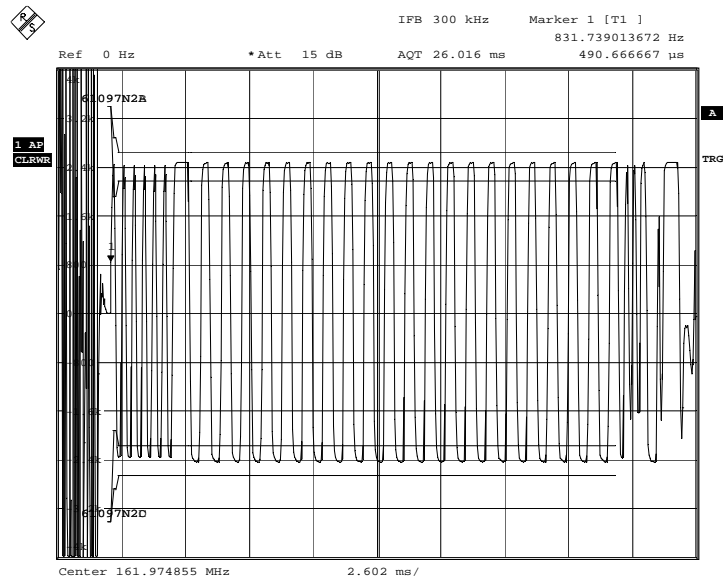
AIS1, Signal 2 – Normal Test Conditions

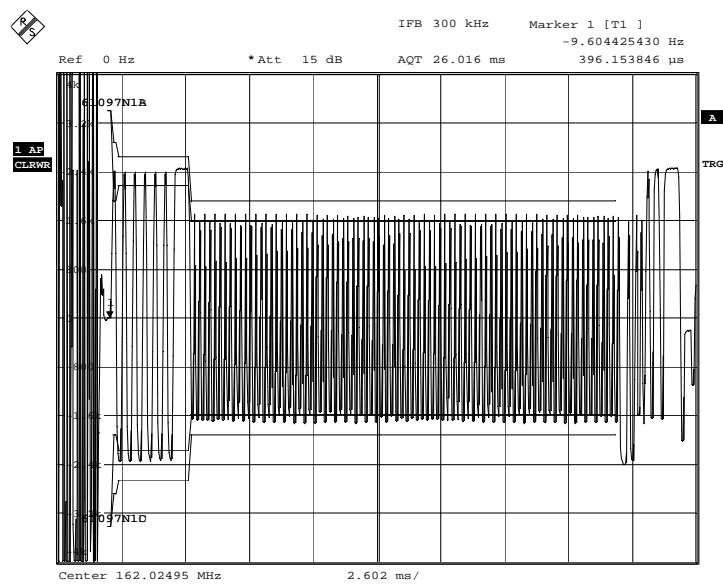
AIS2, Signal 1 – Normal Test Conditions

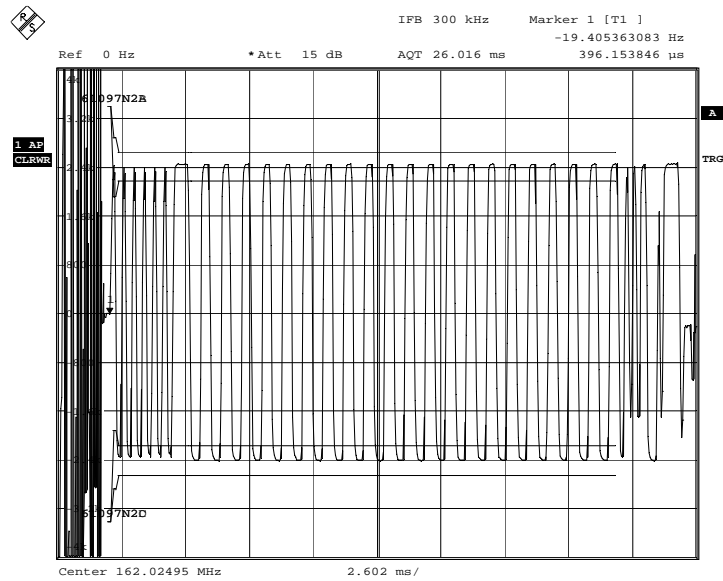
AIS2, Signal 2 – Normal Test Conditions

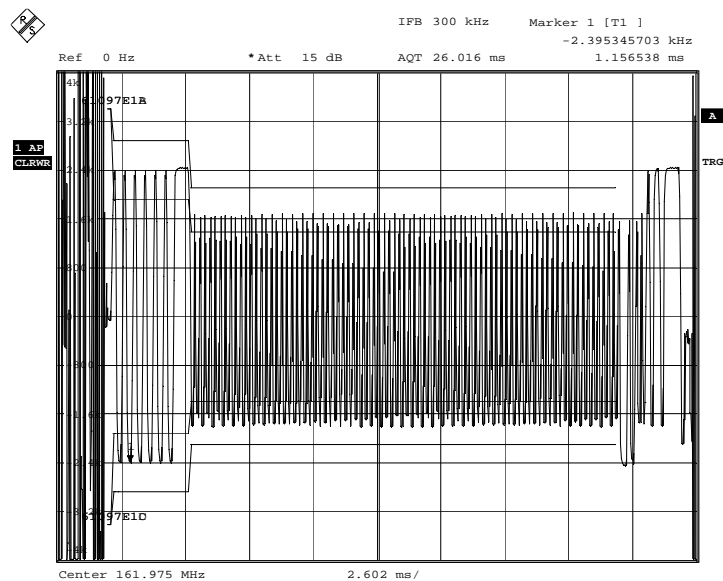
AIS1, Signal 1 – Low Temperature and Old Battery

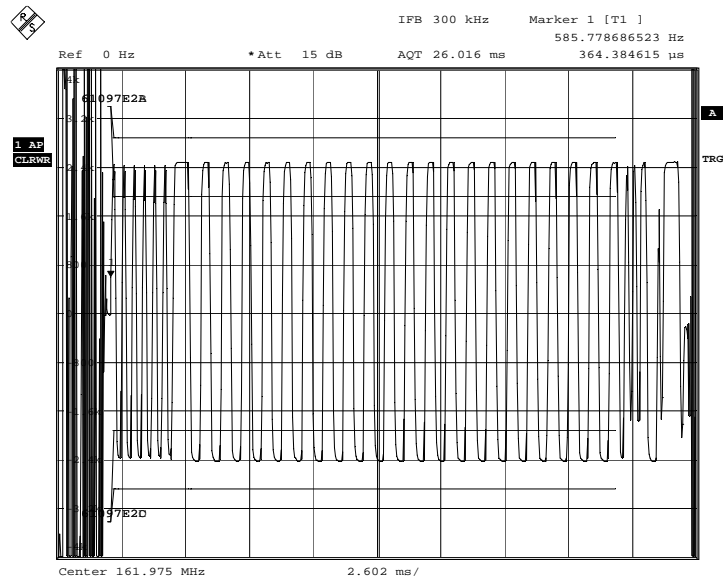
AIS1, Signal 2 – Low Temperature and Old Battery

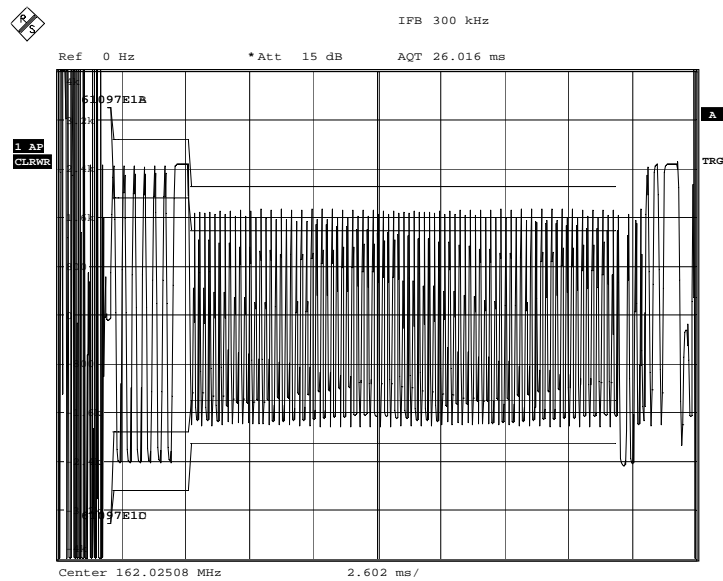
AIS2, Signal 1 – Low Temperature and Old Battery

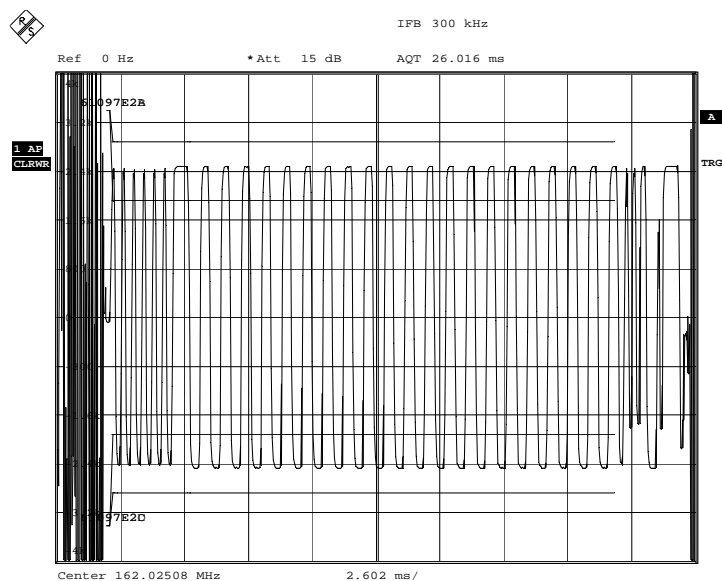
AIS2, Signal 2 – Low Temperature and Old Battery
