Radio Approval Testing of the
McMurdo Limited
SmartFind S5 AIS SART
In accordance with IEC 61097-14 and IEC 60945

Document 75907213 Report 02 Issue 3

May 2010

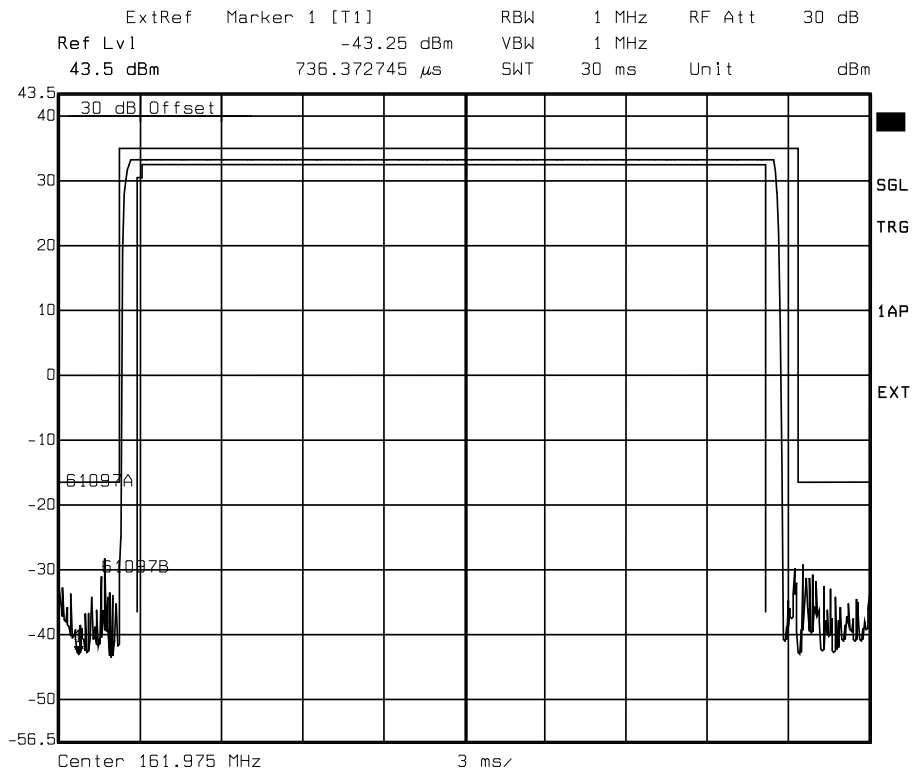
Power verses time function mask: AIS 1

Test Conditions	Output Power versus Time Function (ms)					
	AIS 1					
	T ₀	T _A	T _{B1}	T _{B2}	T _{B2} to T _E	T _F
Normal Test Conditions	0	0.005	0.1725	0.270	24.225	24.225
Measurement uncertainty	± 4.6%

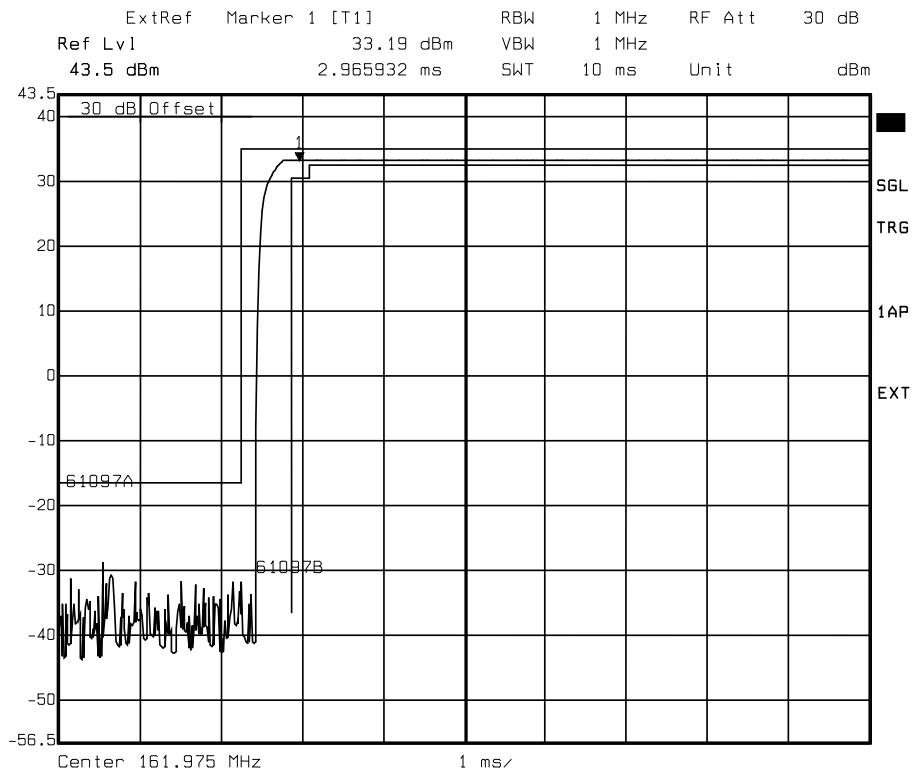
Power verses time function mask: AIS 1 – expanded plot

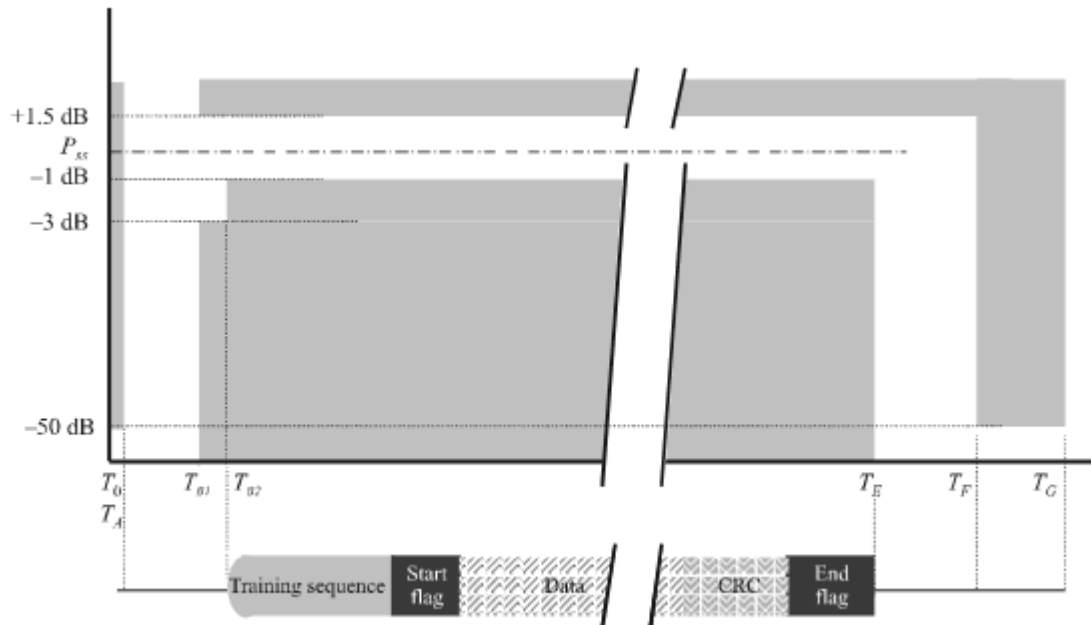
1371-02

Power versus time mask

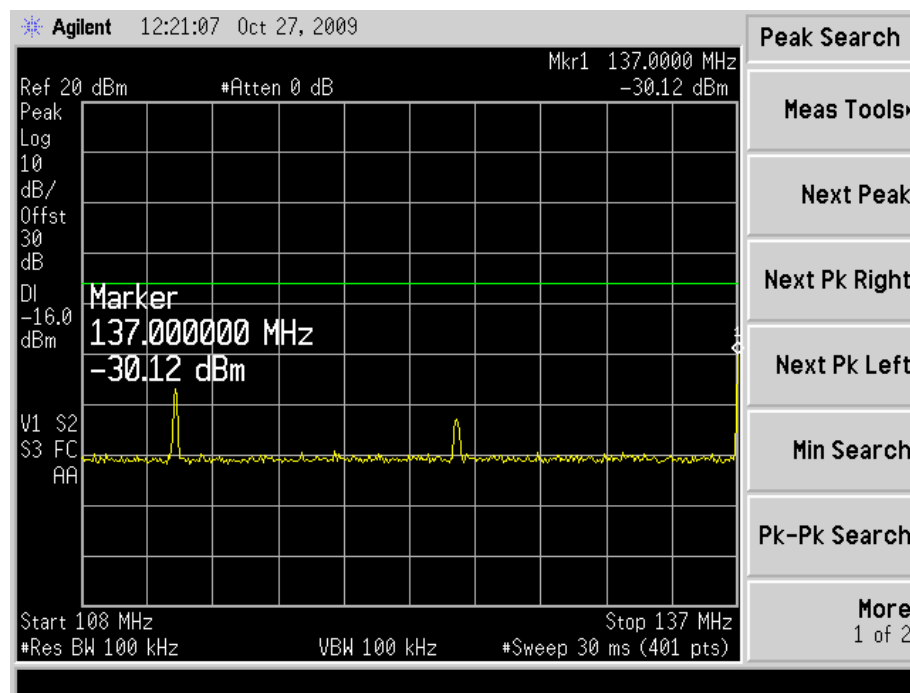
108.0 MHz to 137.0 MHz

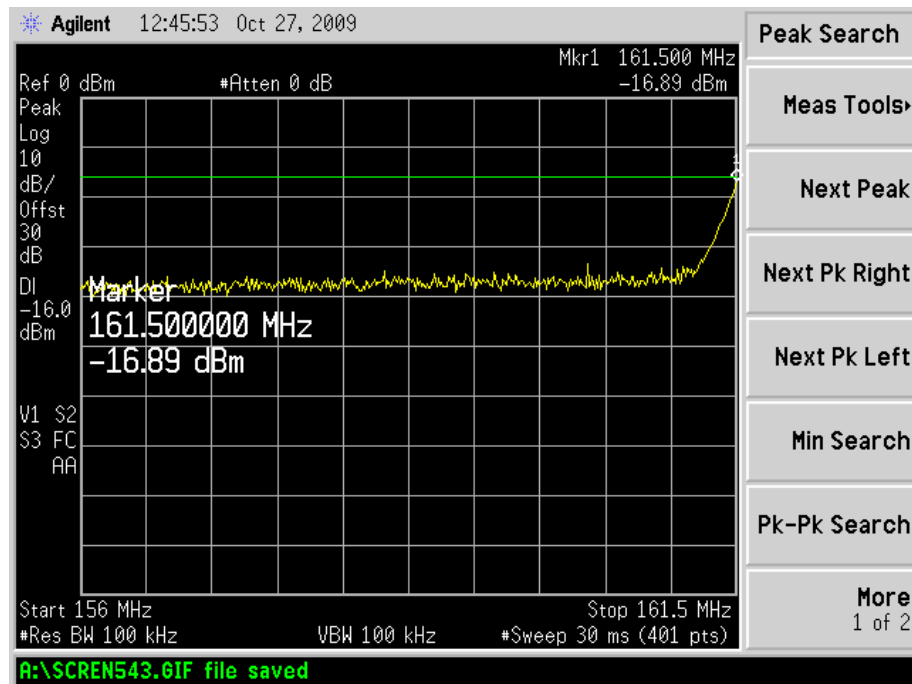
156.0 MHz to 161.5 MHz

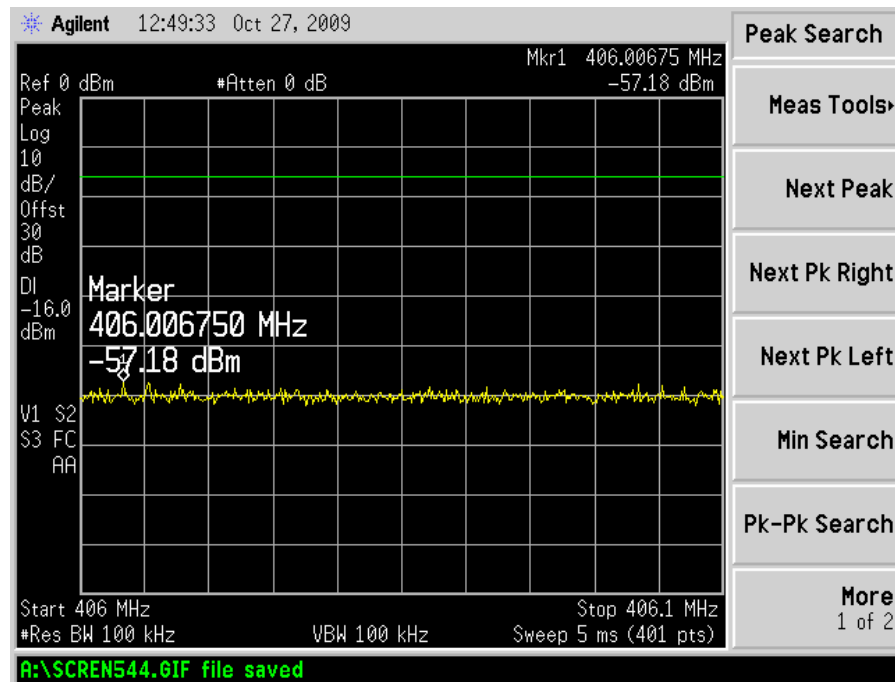
406.0 MHz to 406.1 MHz

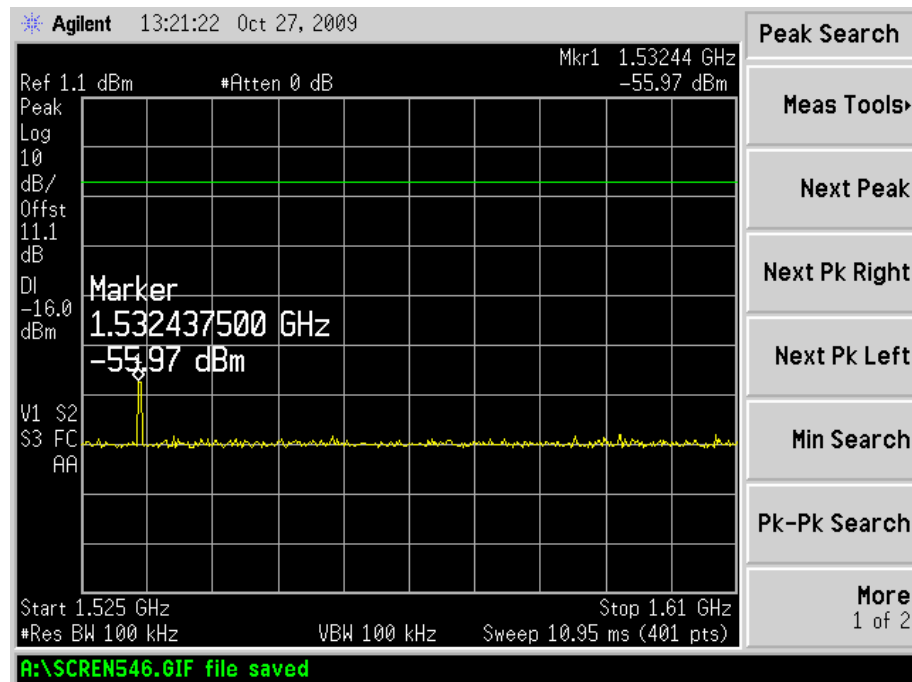
1525.0 MHz to 1610.0 MHz

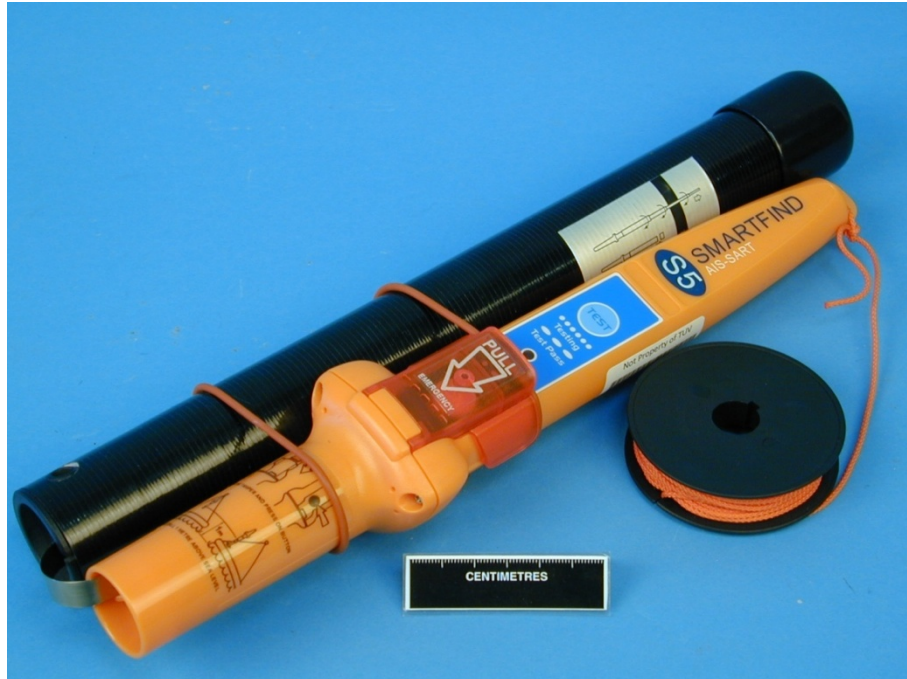
SmartFind S5 AIS SART

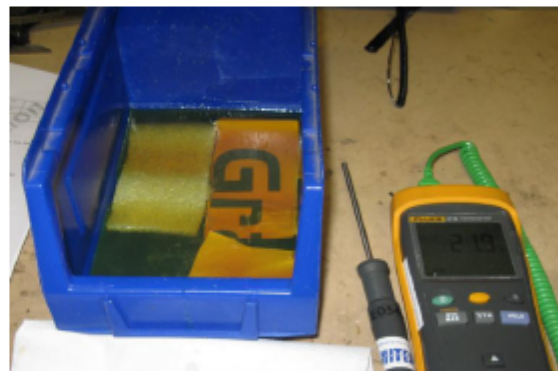
This was left submerged in oil for 24 hours at a temperature of $19^{\circ}\text{C} \pm 5^{\circ}\text{C}$.

After 24 hours in the oil, no detrimental effects were noticed on any of the materials tested, and the stitching did not appear to be weakened in any way.

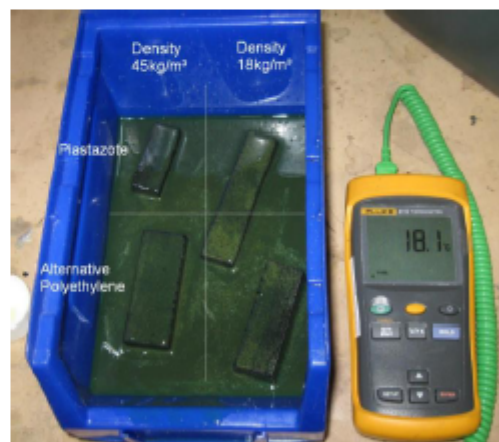
The foams regularly worked their way to the surface of the oil. These were frequently pushed back under the surface.

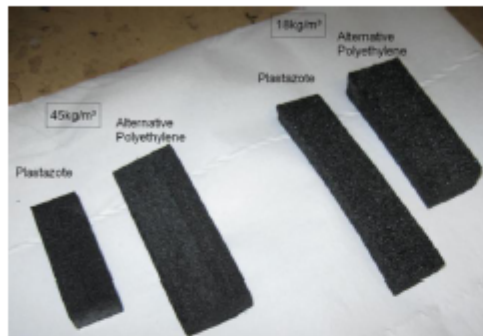
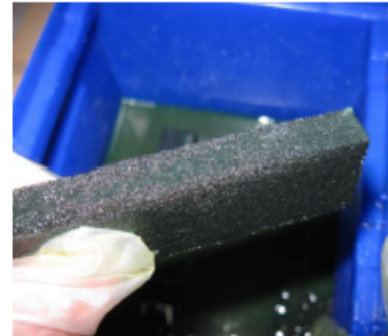
After 3 hours, the foams were removed from the oil and inspected. All samples showed no signs of degradation, and still floated above the oil.

The results of the test show that Nylon 420D, the Polyethylene foam and the Velcro are not unduly affected by the specified oil, and so meet with the requirements of IEC-60945. Therefore, these materials can be implemented in the production of the AIS SART Storage Bag – 92-206-XXXD.
