Environmental Testing of the
Orolia Limited
1001802 Battery Pack

Document 75942209 Report 06 Issue 1

The information contained in this report is intended to show verification of the Orolia Limited 1001802 Battery Pack to the requirements of UN ST/SG/AC.10/11REV6/ Section 38.3 dated 2015.

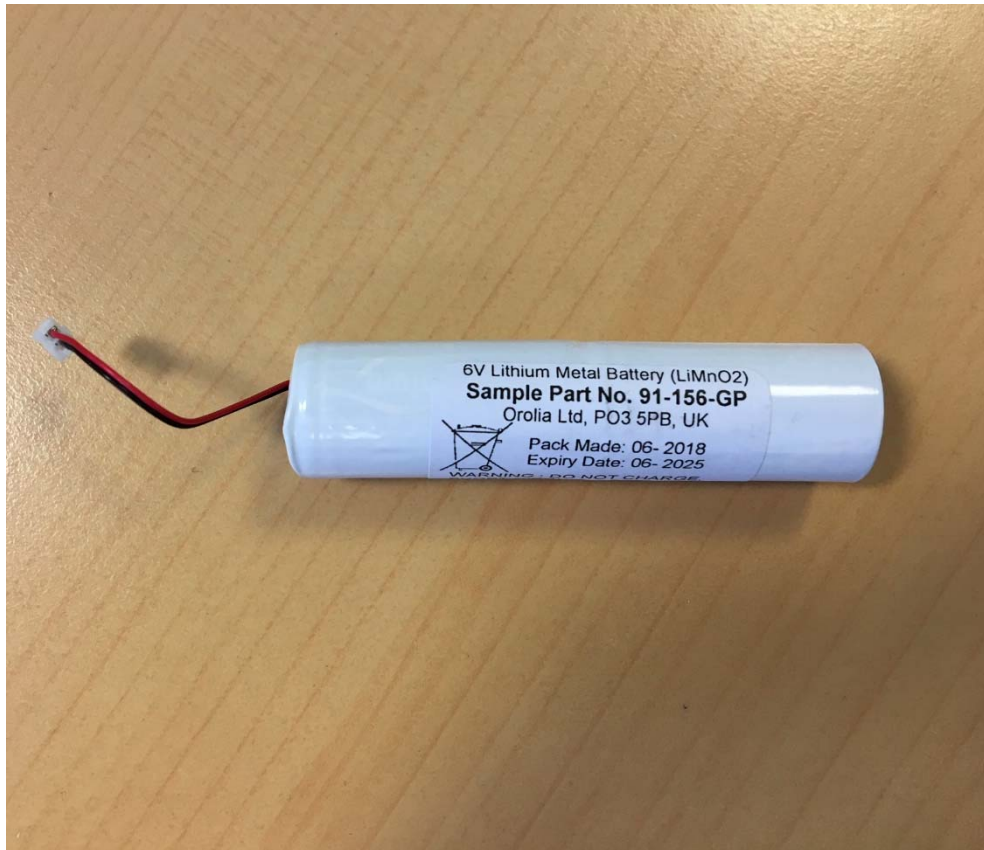
The Equipment Under Test (EUT) was a battery pack consisting of two CR123 GP lithium manganese dioxide cells (6V) as shown in the photographs below.

Figure 1.3.1 Equipment Under Test – Battery Pack

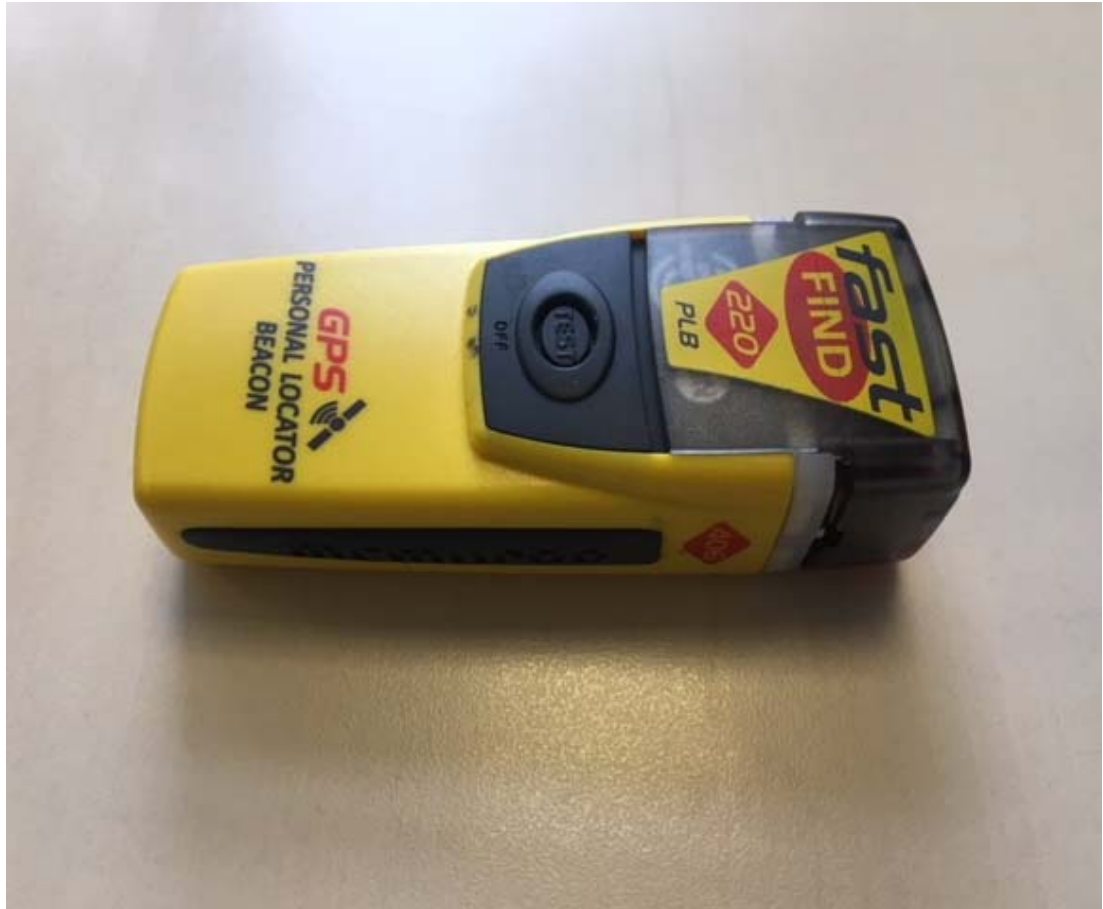
Figure 1.3.2 Equipment Under Test – Inside PLB

A further two further battery packs were installed within a PLB and were subject to the vibration and shock tests.

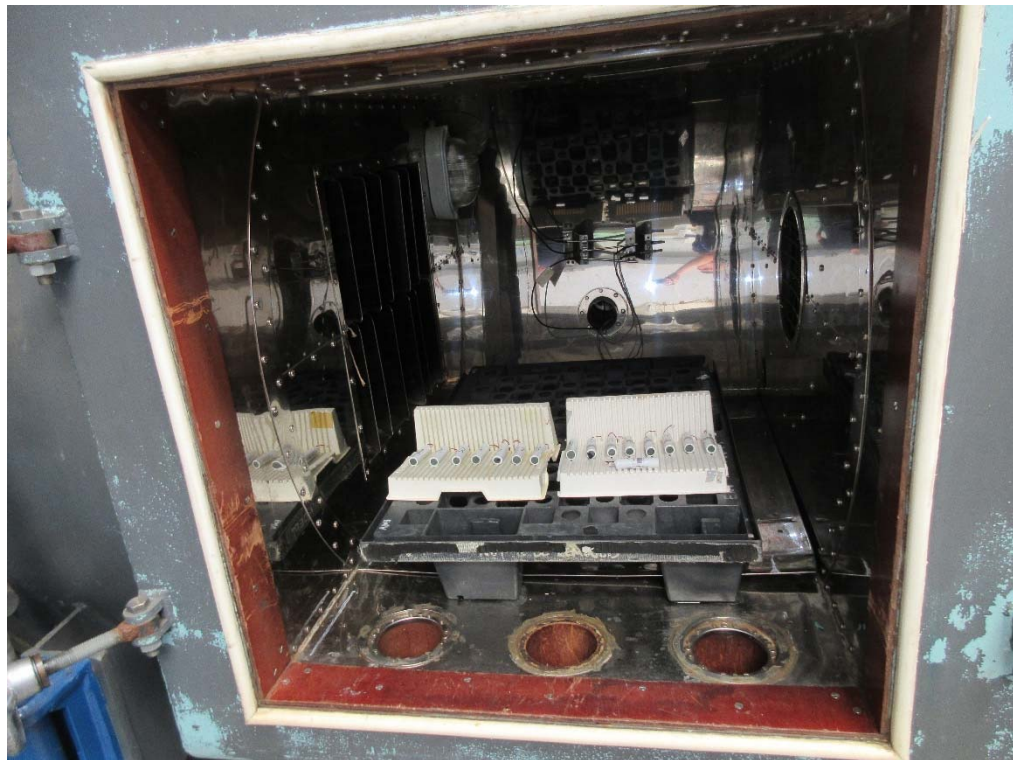
The units were installed in an environmental chamber at ambient conditions. The units were then subjected to the altitude test as shown below.

Pressure:	Minimum of 11.6 kPa (116 mbar)
Ramp period:	30 minutes
Duration of test:	Minimum of 6 Hours @ Minimum of 11.6 kPa (116 mbar)
Temperature:	20°C ±5°C

Figure 2.1.1 Chamber Test Set-up

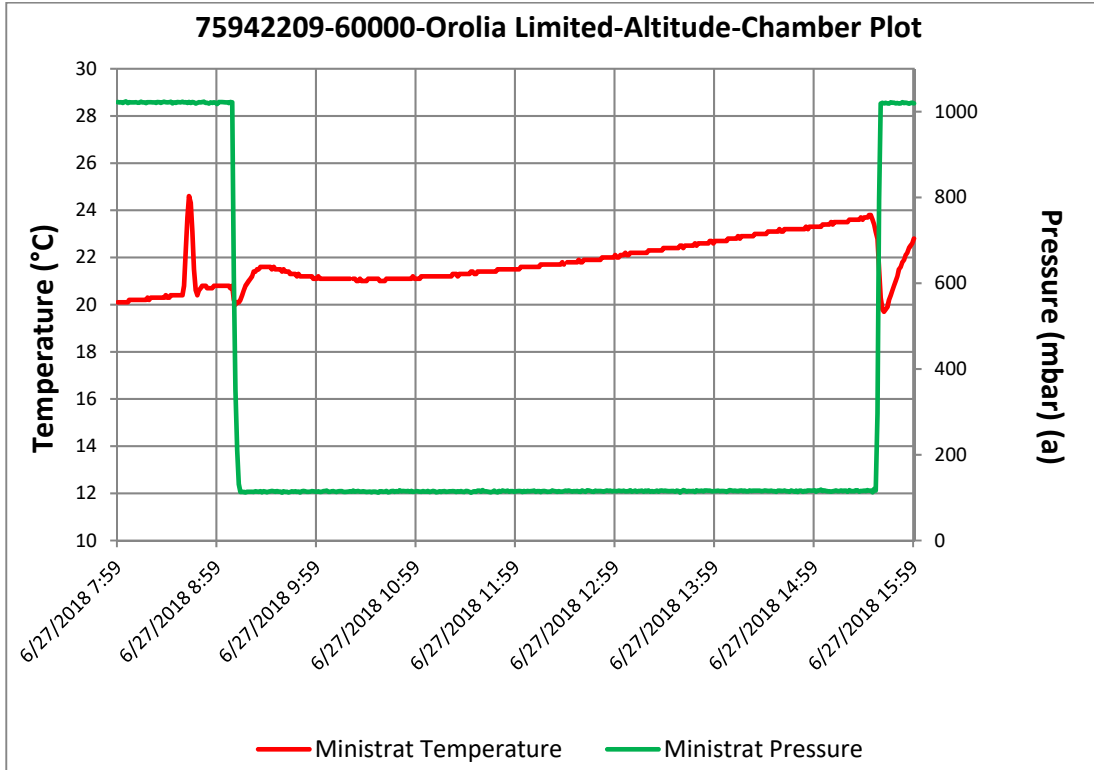
Figure 2.1.3 Temperature and Altitude Test Profile

The temperature and altitude profile is shown at Figure 2.1.3.

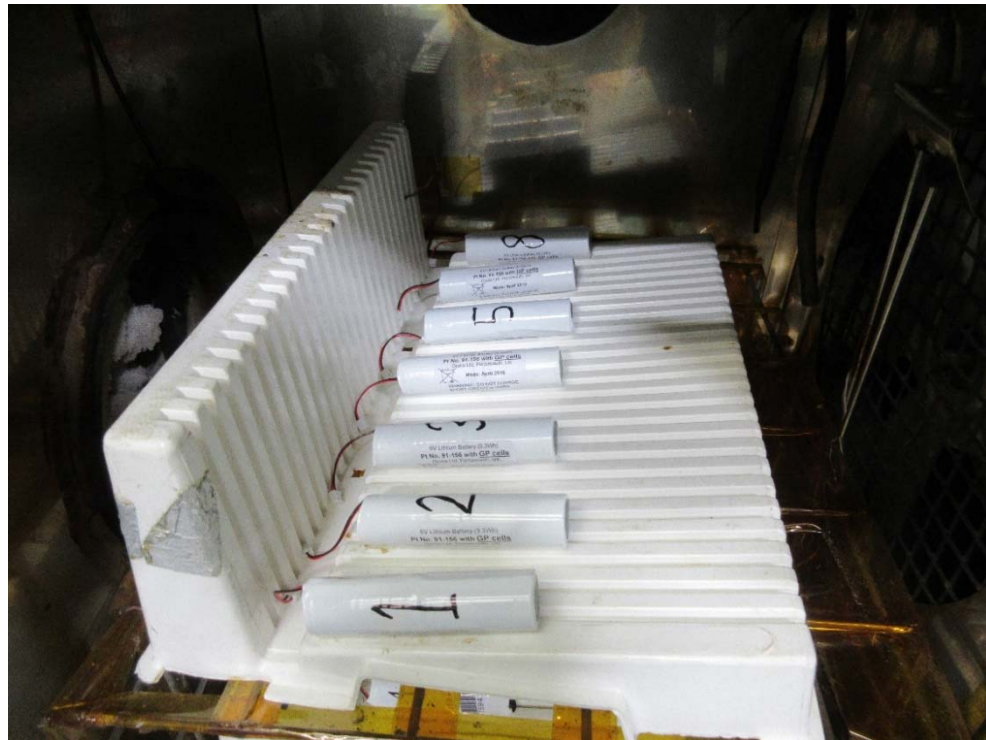
The units were installed in an environmental chamber at ambient conditions. The units were then subjected to the temperature cycle as shown below.

Temperature: 72°C ±2°C for 6 hours then -40°C ±2°C for 6 hours

Figure 2.2.1 Chamber Test Set-up

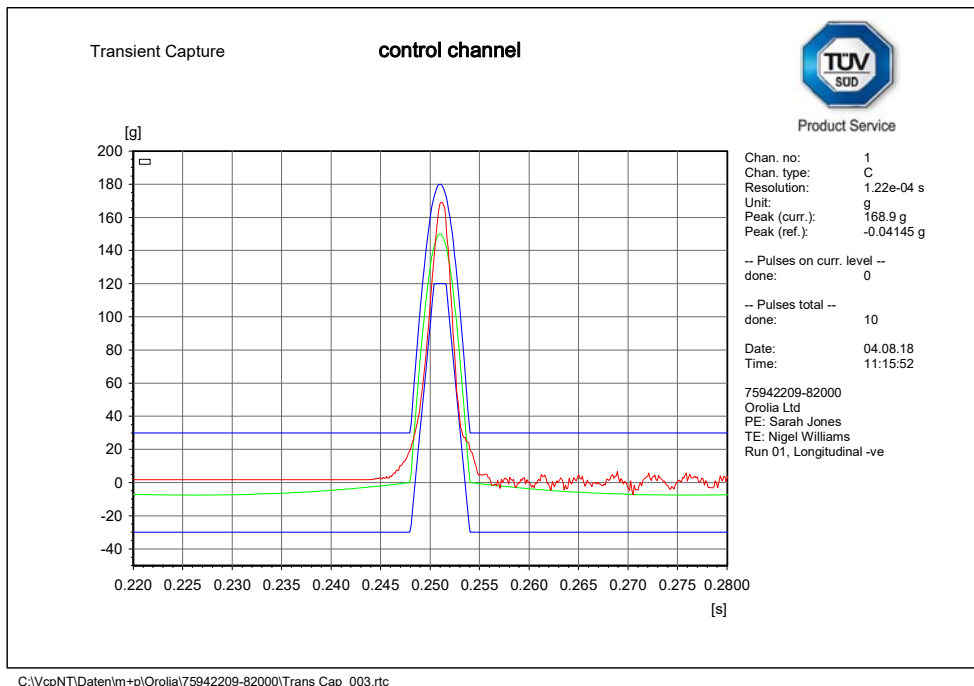
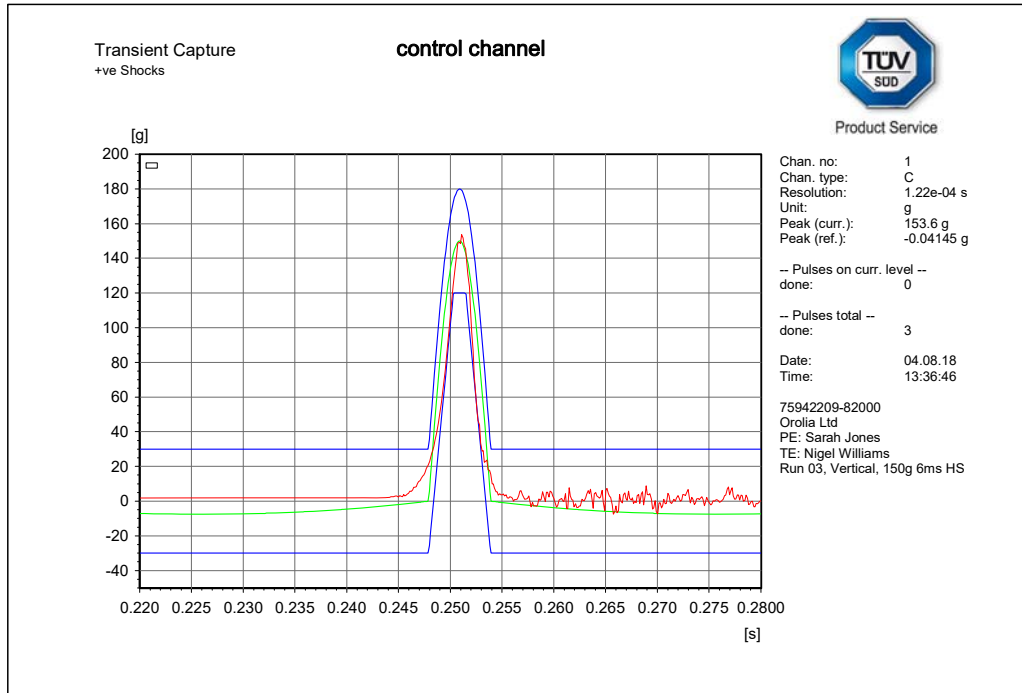
Figure 2.5.5 Shock X Axis – Control (Positive)

Figure 2.5.6 Shock X Axis – Control (Negative)

Figure 2.5.7 Shock Y Axis – Control (Positive)

Figure 2.5.8 Shock Y Axis – Control (Negative)

Figure 2.5.9 Shock Z Axis – Control (Positive)

Figure 2.5.10 Shock Z Axis – Control (Negative)

The shock test profiles are shown at Figures 2.5.5 to 2.5.10.

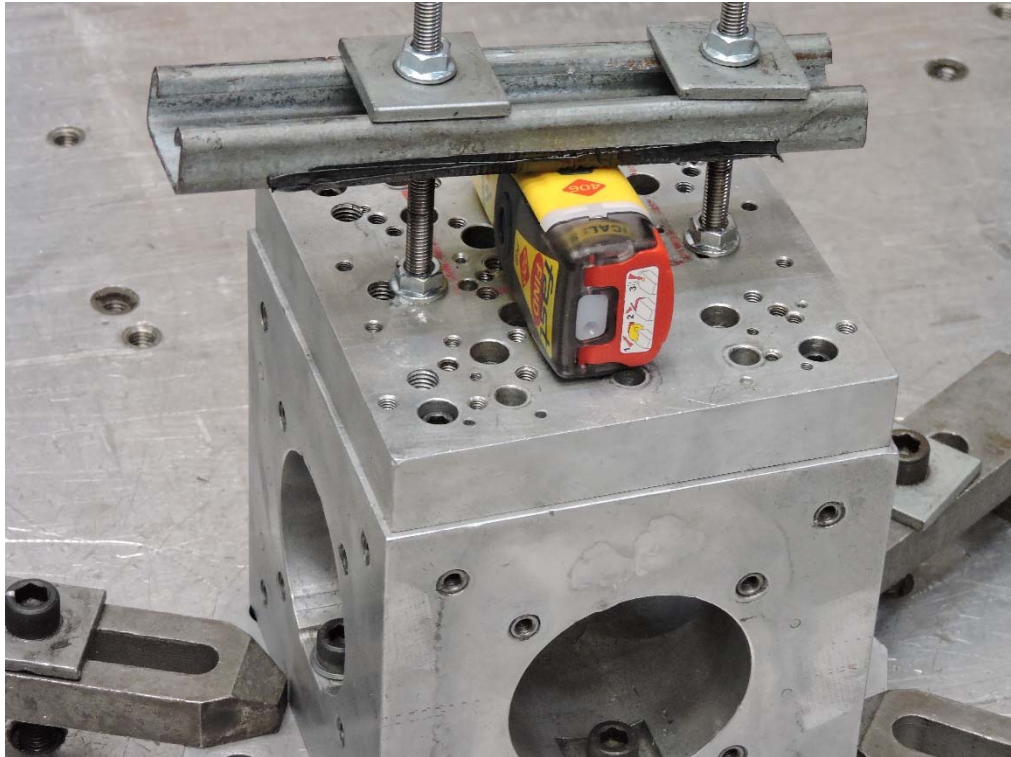
The PLB with the battery packs installed in the device were secured to the vibration machine and then subjected to the following shock test.

Test Level:	150g
Pulse Duration:	6ms
Pulse Shape:	Half Sine
No of Shocks:	Three shocks in each sense of each axis (18 Total)

Figure 2.6.1 Shock Test Set-up – X Axis (Positive)

Figure 2.6.2 Shock Test Set-up – Y Axis (Negative)

Figure 2.6.3 Shock Test Set-up – Z Axis (Positive)

Figure 2.6.4 Shock Test Set-up – Z Axis (Negative)

Figure 2.6.5 Shock Test Set-up – Z Axis (Positive)

Figure 2.6.6 Shock Test Set-up – Z Axis (Negative)

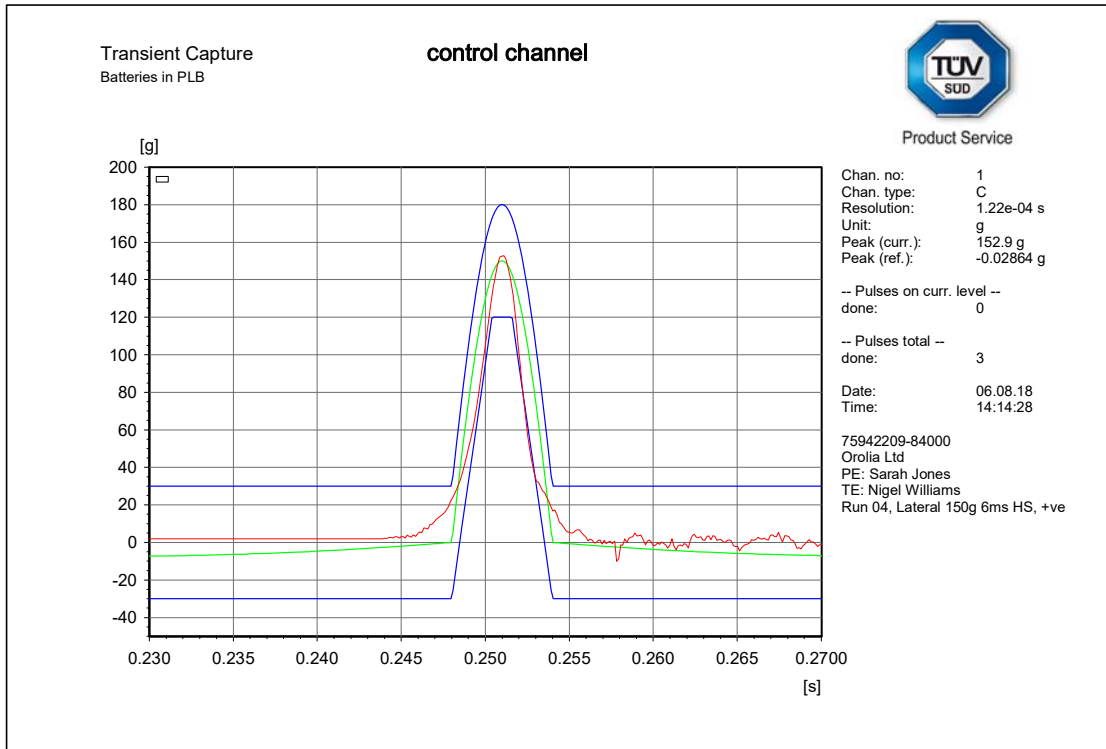
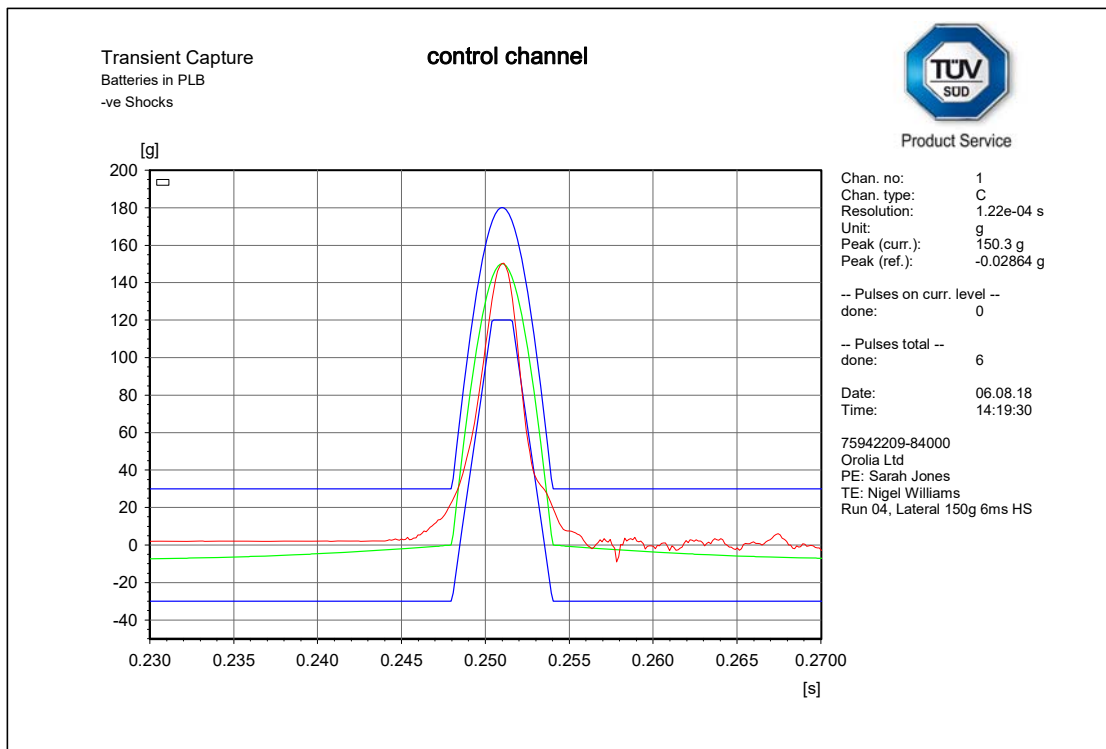
Figure 2.6.8 Shock X Axis – Control (Positive)

Figure 2.6.9 Shock X Axis – Control (Negative)

Figure 2.6.10 Shock Y Axis – Control (Positive)

Figure 2.6.11 Shock Y Axis – Control (Negative)

Figure 2.6.12 Shock Z Axis – Control (Positive)

Figure 2.6.13 Shock Z Axis – Control (Negative)

The shock test profiles are shown at Figures 2.6.8 to 2.6.13.

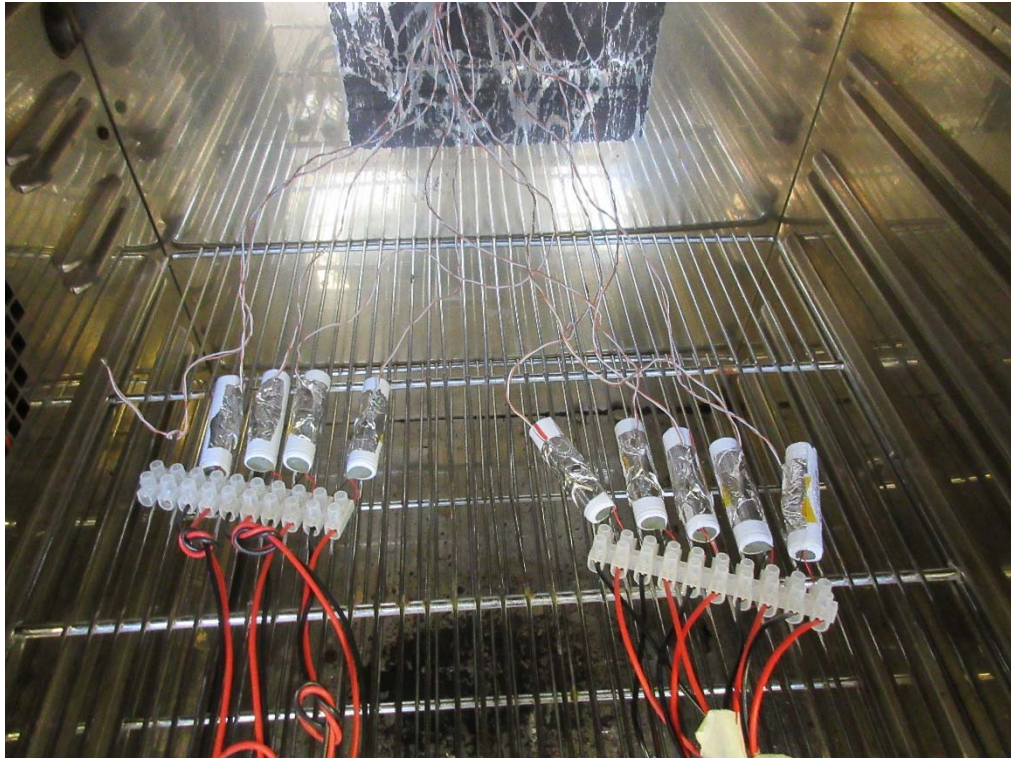
The batteries were instrumented to measure surface temperature.

The battery to be tested was temperature stabilized so that its external case temperature reached $57 \pm 4^\circ\text{C}$ and then the battery was subjected to a short circuit condition with a total external resistance of less than 0.1 ohm at $57 \pm 4^\circ\text{C}$. This short circuit condition was continued for at least one hour after the battery external case temperature had returned to $57 \pm 4^\circ\text{C}$.

Figure 2.7.1 Test Set-up

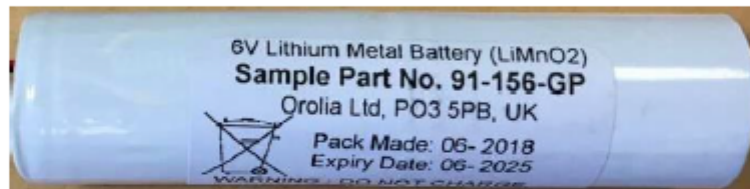
By this statement, Orolia declares that the battery pack sample Part No 91-156-GP used for the UN38.3 tests is identical to the battery pack P/N 1001802.

Sample Part 91-156-GP used for the UN38-3 tests :
