Report No.: 98075261

FCC ID: KT5HP228

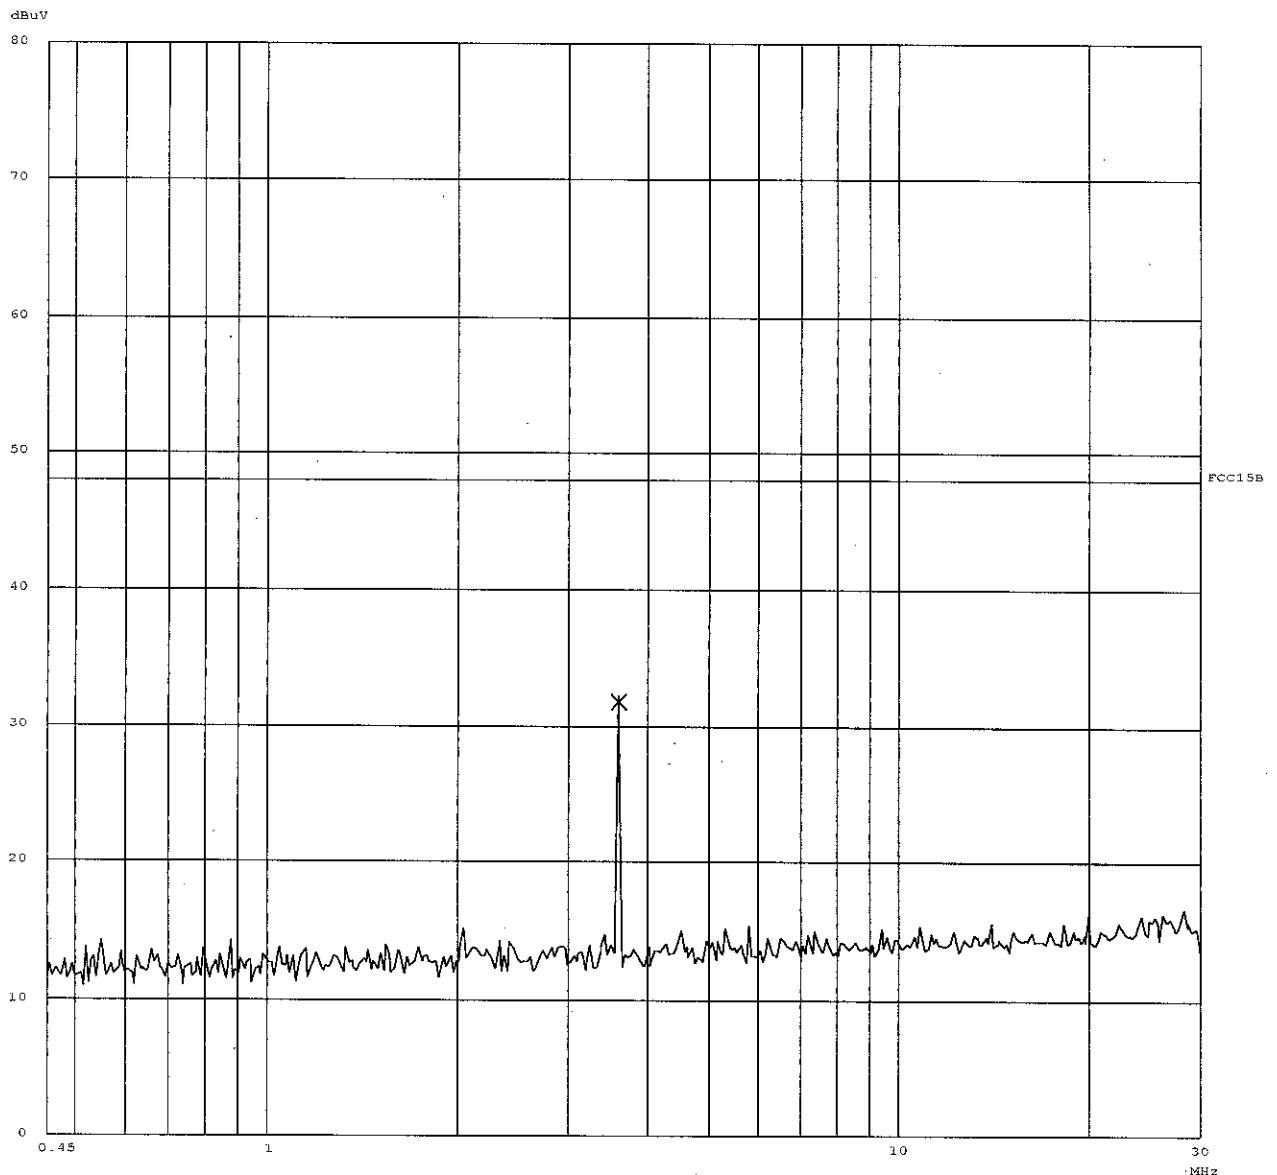
Mode : Charging

Scan Settings (1 Range)

| Start | Stop | Step | IF BW | Detector | M-Time | Atten | Praamp | OpRge |
|---|---|---|---|---|---|---|---|---|
| 450k | 30M | 5k | 10k | PK | 20ms | AUTO | LN OFF | 60dB |

Final Measurement: x QF

Acc Margin: 20dB

Final Measurement Results:

| Frequency<br>MHz | QP Level<br>dBuV | QP Limit<br>dBuV |
| 3.59500 | 31.7 | 48.0 |

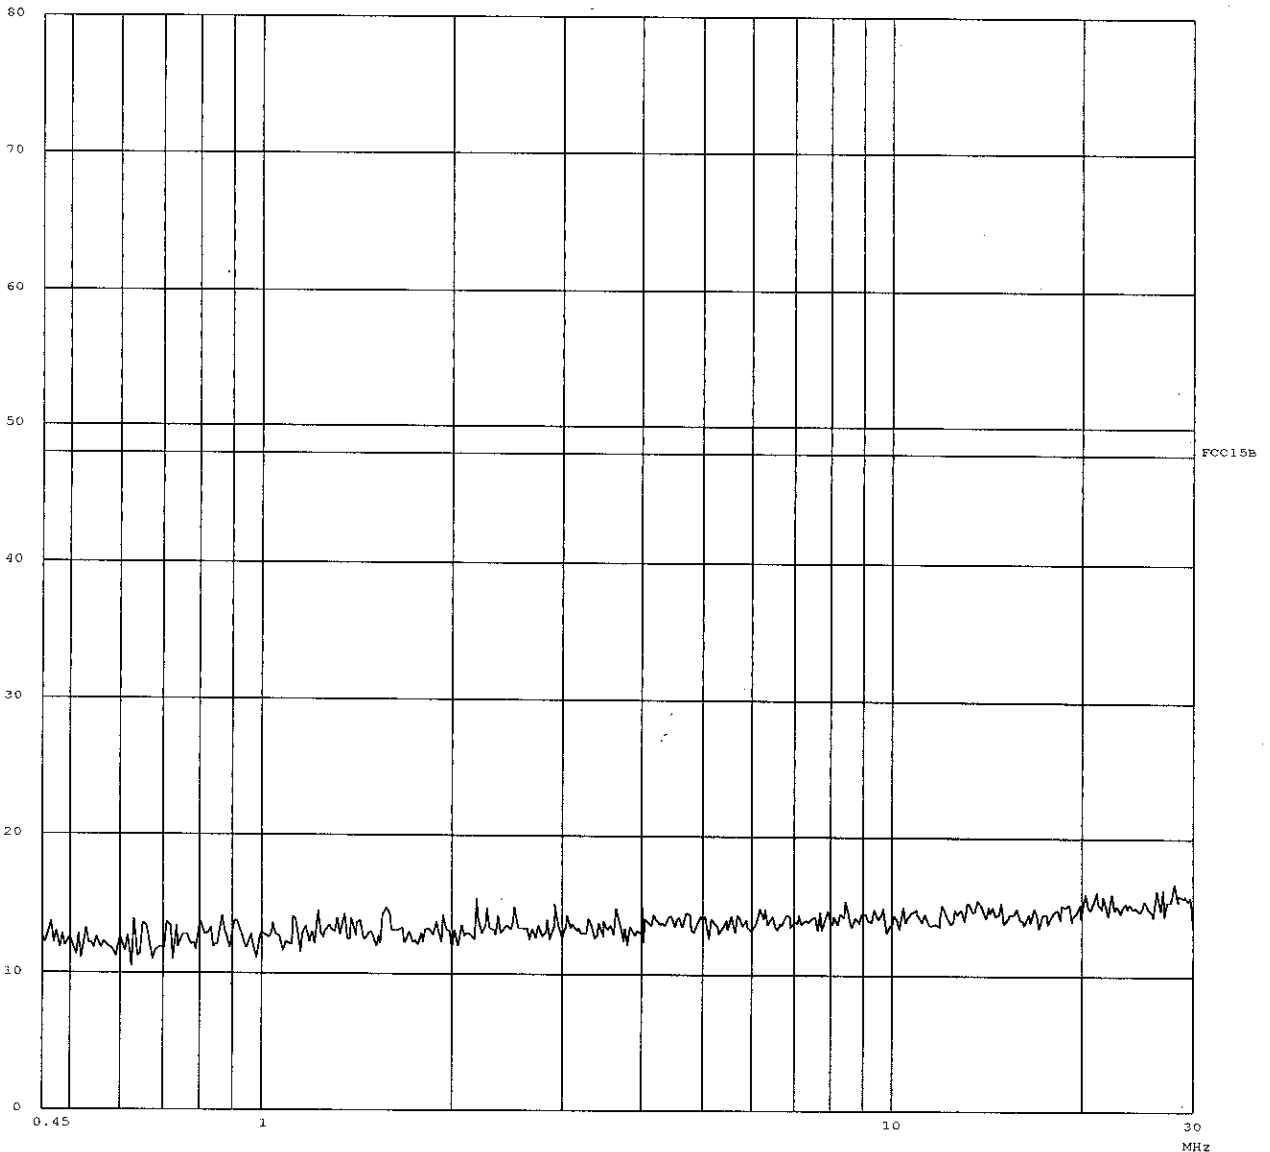
Mode: STAND BY

Scan Settings (1 Range)

| Start | Stop | Step | IF BW | Detector | M-Time | Atten | Preamp | OpRge |
|---|---|---|---|---|---|---|---|---|
| 450k | 30M | 5k | 10k | PK | 20ms | AUTO | LN OFF | 60dB |

Final Measurement: X QF

Meas Time: 1 s  
Subranges: 16  
Acc Margin: 20dB

Final Measurement Results:

no Results

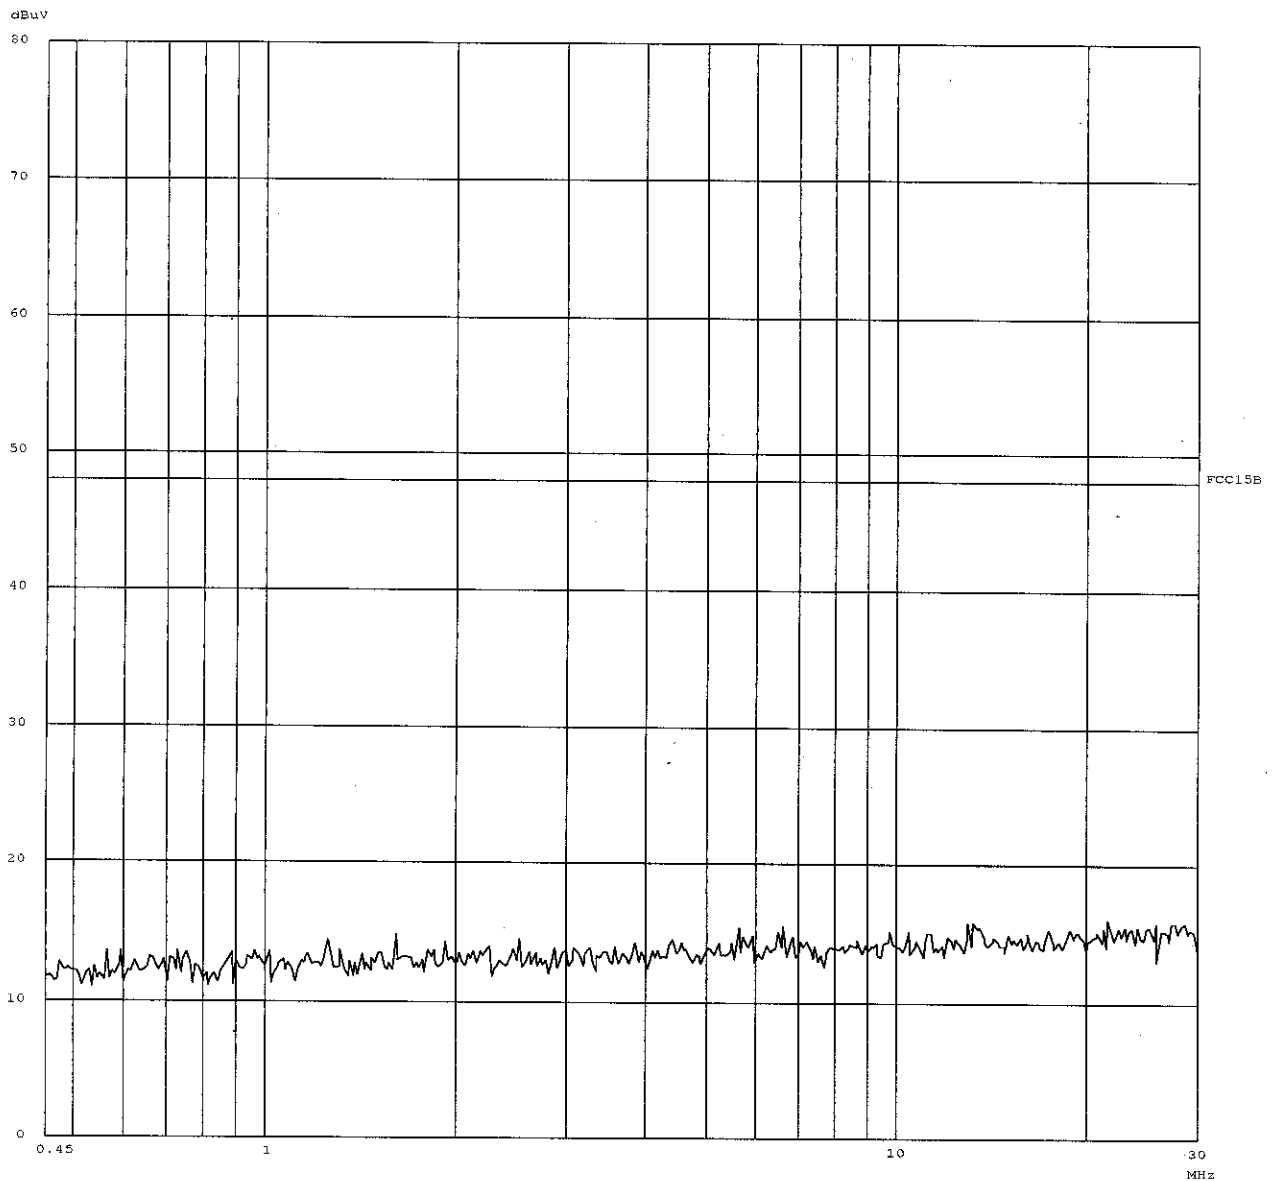
Mode: TX

Scan Settings (1 Range)

| Frequencies | | | Receiver Settings | | | | | | |
|---|---|---|---|---|---|---|---|---|--|
| 450k | 30M | 5k | 10k | PK | 20ms | AUTO | LN | OFF | |

Final Measurement: X QP

Meas Time: 1 s  
Subranges: 16  
Acc Margin: 20dB

Final Measurement Results:

no Results
