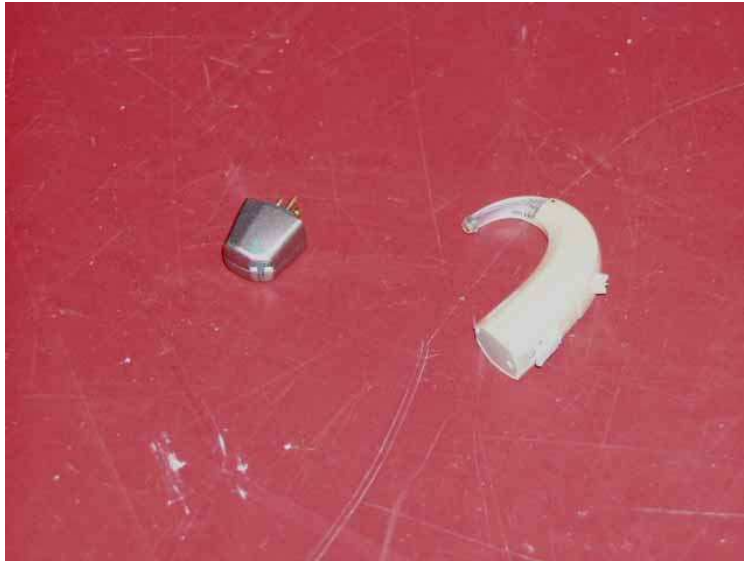
Photo 1

Equipment under test

right: Transmitter CROS CTX

left: Receiver CROS CRX

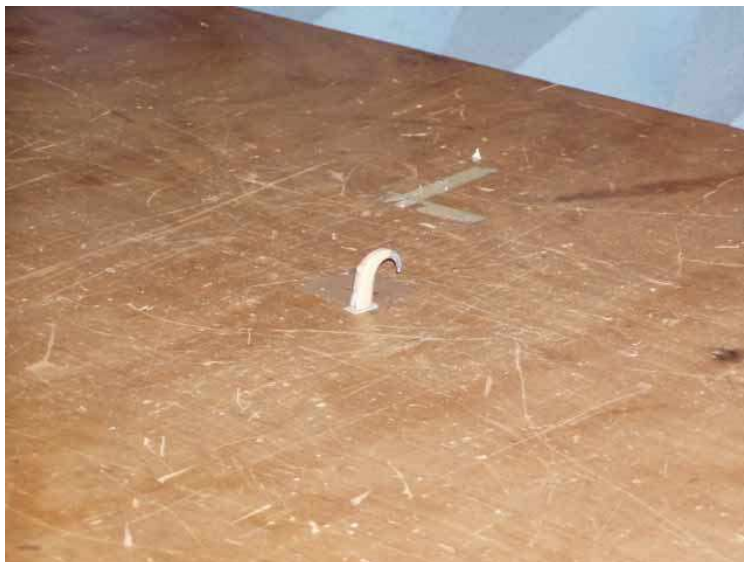
Photo 2

Measurement of carrier and spurious emissions on CTX ( $f < 30\text{MHz}$ )

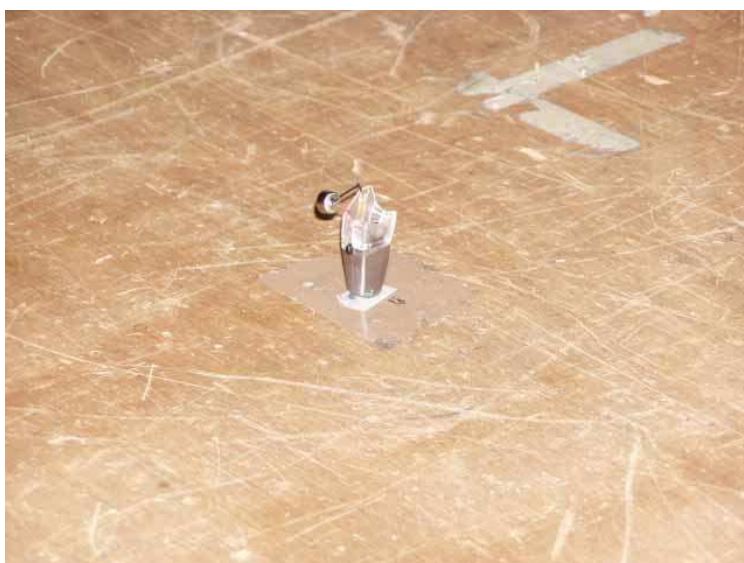
Photo 3

Measurement of spurious emissions on CRX ( $f < 30\text{MHz}$ )

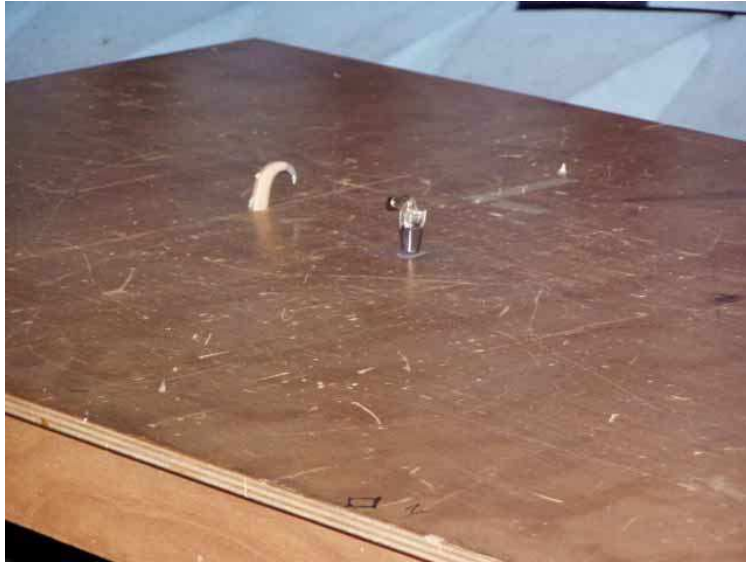
Photo 4

Measurement of spurious emissions  
( $f > 30$  MHz)
