**APPENDIX 3: Photographs of test setup**

**Radiated Spurious Emission**

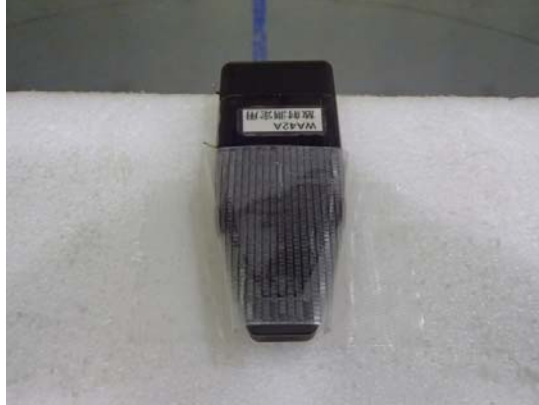
**X-axis**

**Worst Case Position**

**Below 1GHz (Horizontal: X-axis/ Vertical:Z-axis)**

**Above 1GHz (Horizontal: X-axis/ Vertical:Y-axis)**
