## TEST REPORT

REPORT NO: **SATEL-TR-0021-HMM**

DEVICE UNDER TEST: **SATELLINE-3AS**

- Transient Frequency Behaviour of the transmitter
  - #1: at 12.5 kHz channel spacing
  - (pages 2 to 10, figures 1-18)
  - on various temperatures
  - (-30, -20, -10,  $\pm 0$ , +10, +20, +30, +40, +50 °C)

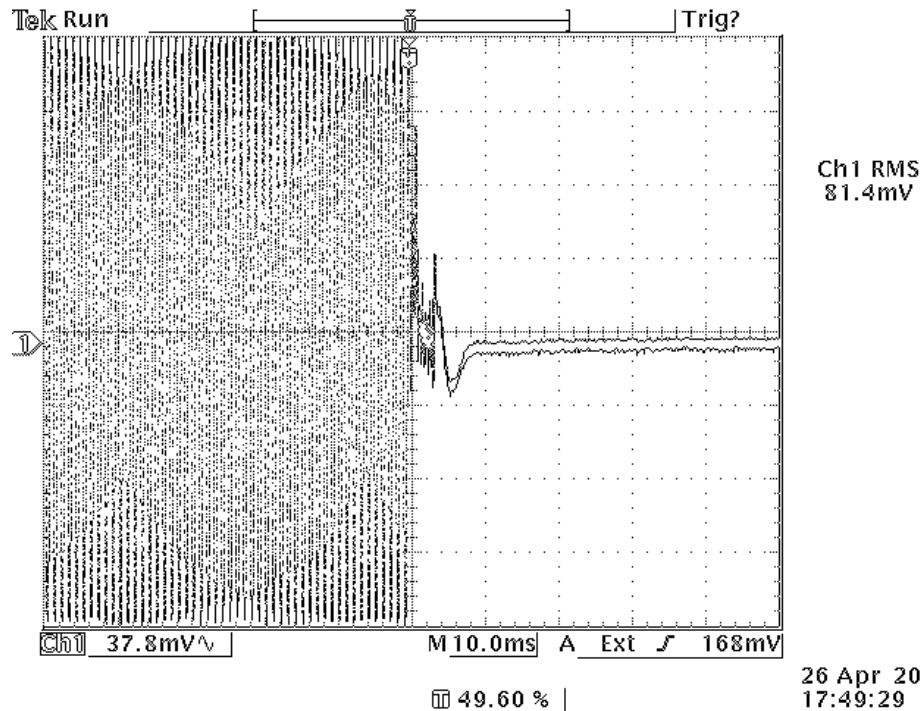
Fig. 1. Transmitter switched ON at -30 °C. (12.5 kHz ch. sp.)

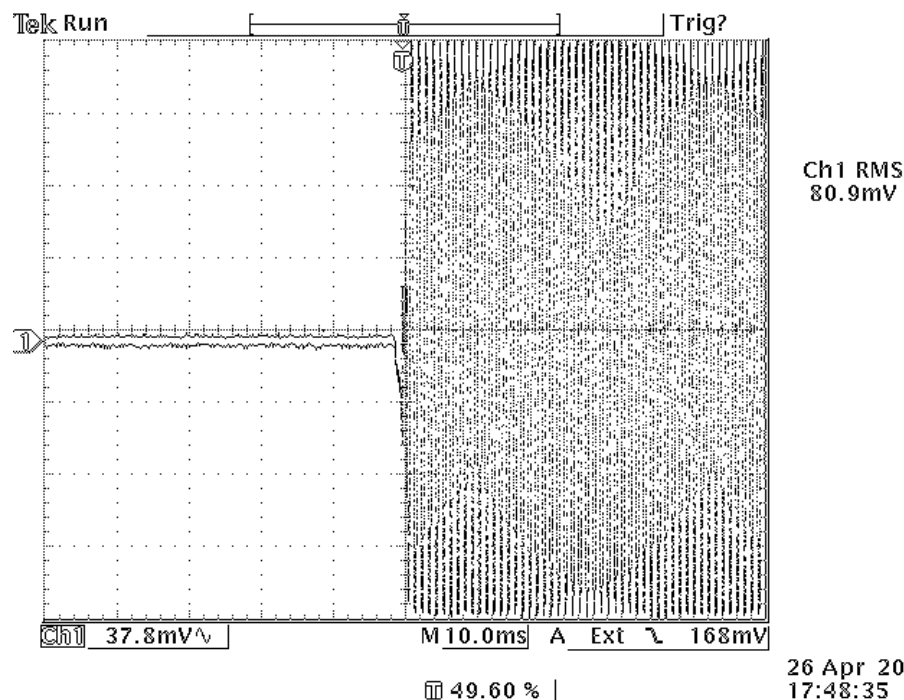
Fig. 2. Transmitter switched OFF at -30 °C. (12.5 kHz ch. sp.)

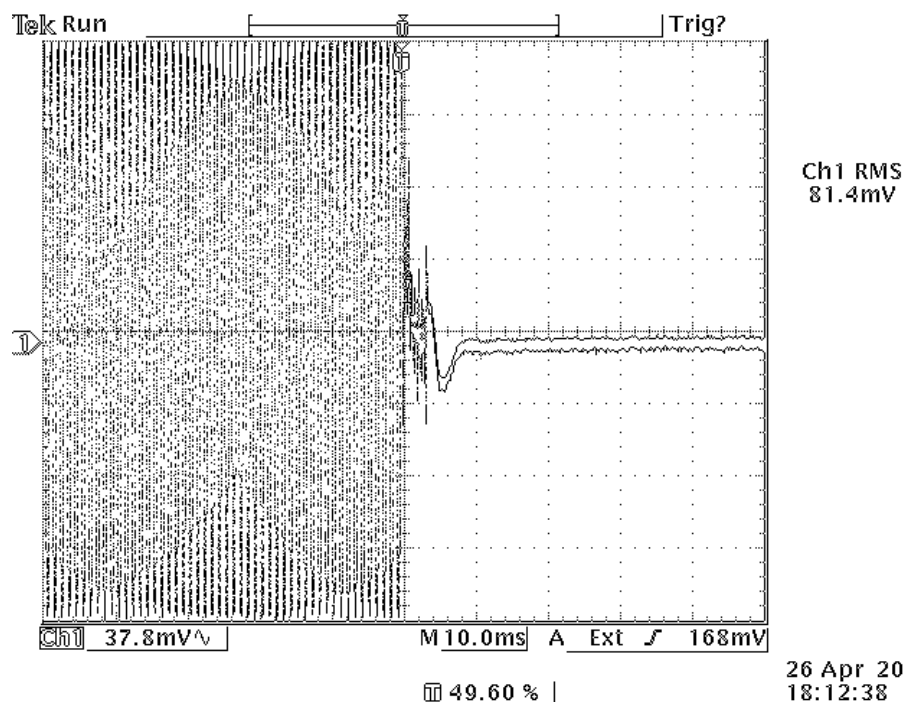
Fig. 3. Transmitter switched ON at  $-20^{\circ}\text{C}$ . (12.5 kHz ch. sp.)

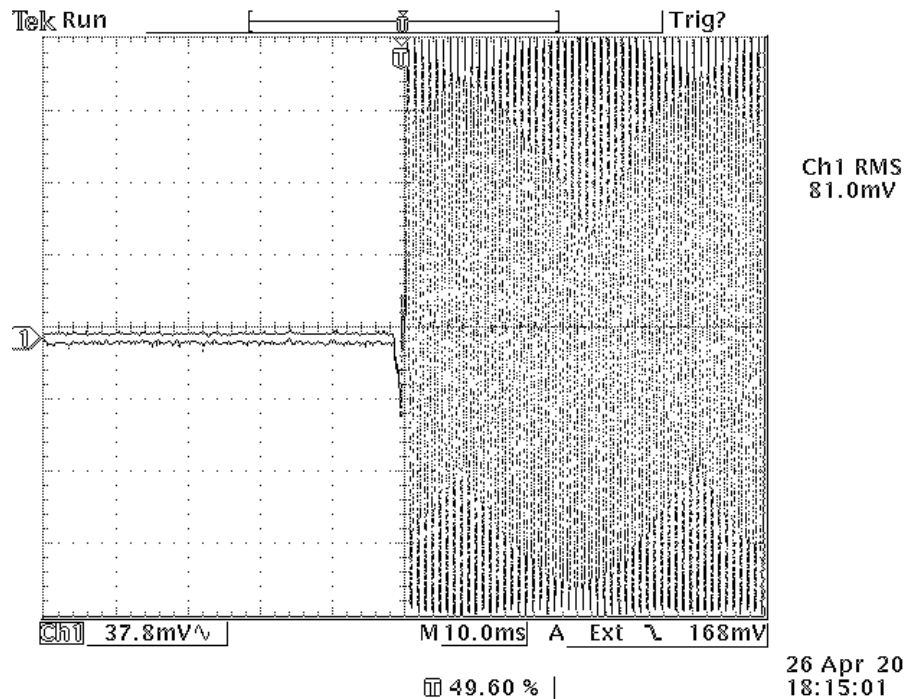
Fig. 4. Transmitter switched OFF at  $-20^{\circ}\text{C}$ . (12.5 kHz ch. sp.)

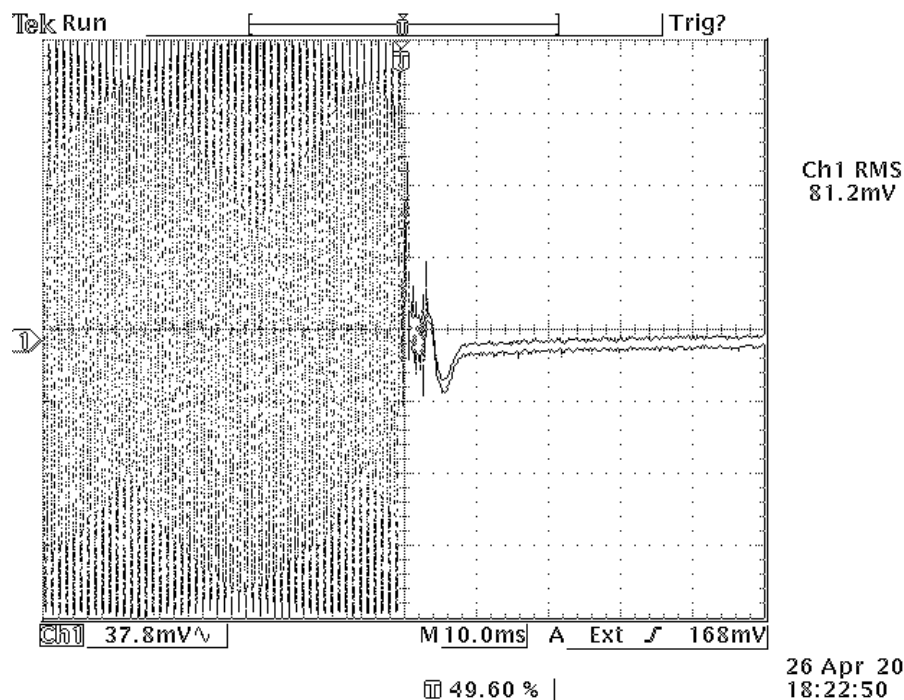
Fig. 5. Transmitter switched ON at  $-10^{\circ}\text{C}$ . (12.5 kHz ch. sp.)

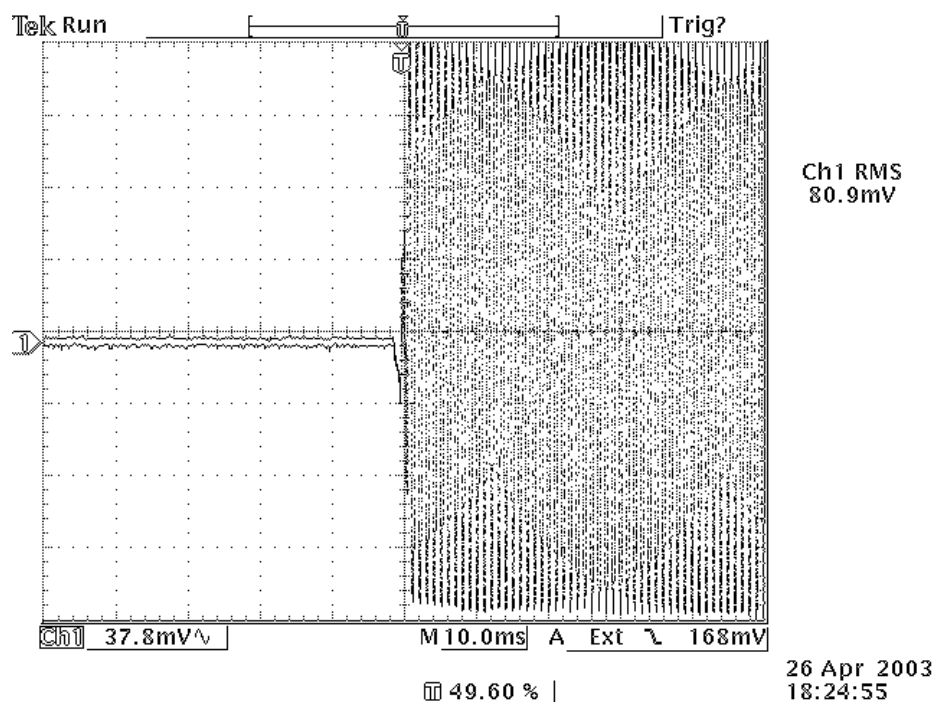
Fig. 6. Transmitter switched OFF at  $-10^{\circ}\text{C}$ . (12.5 kHz ch. sp.)

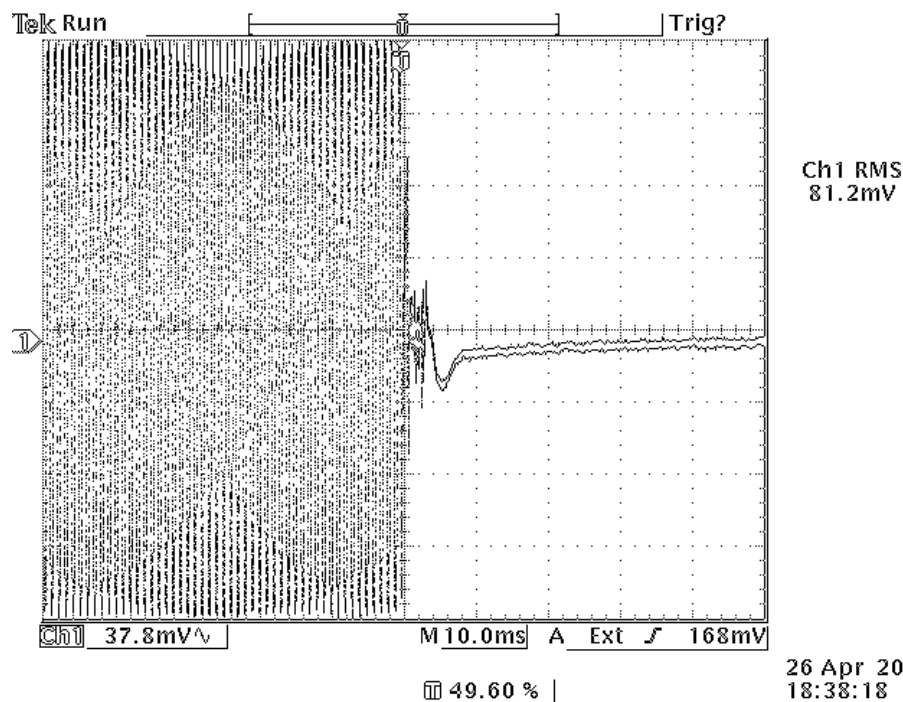
Fig. 7. Transmitter switched ON at 0 °C. (12.5 kHz ch. sp.)

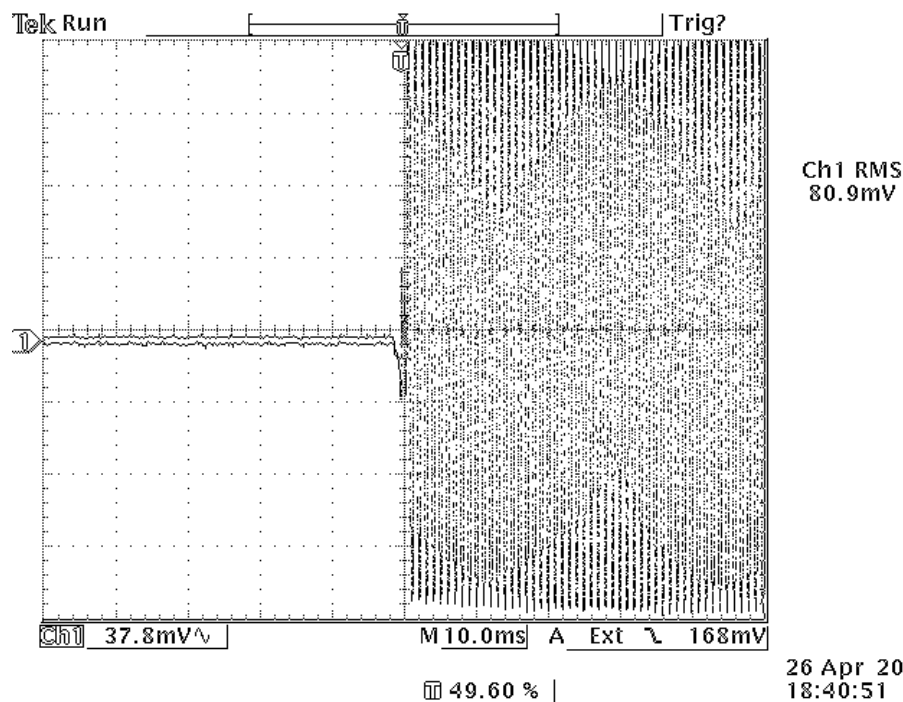
Fig. 8. Transmitter switched OFF at 0 °C. (12.5 kHz ch. sp.)

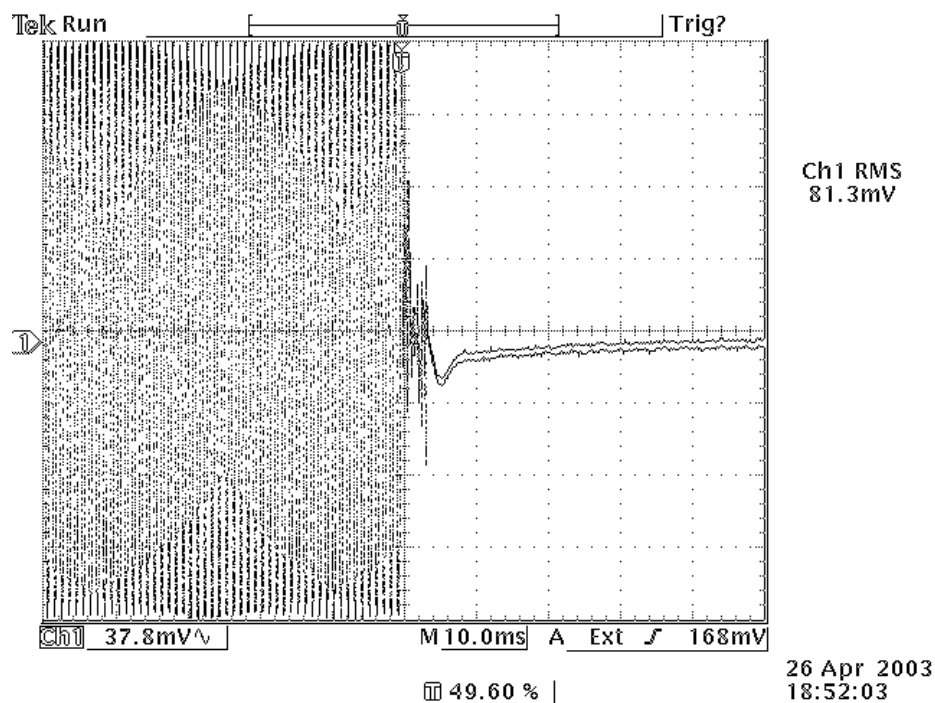
Fig. 9. Transmitter switched ON at +10 °C. (12.5 kHz ch. sp.)

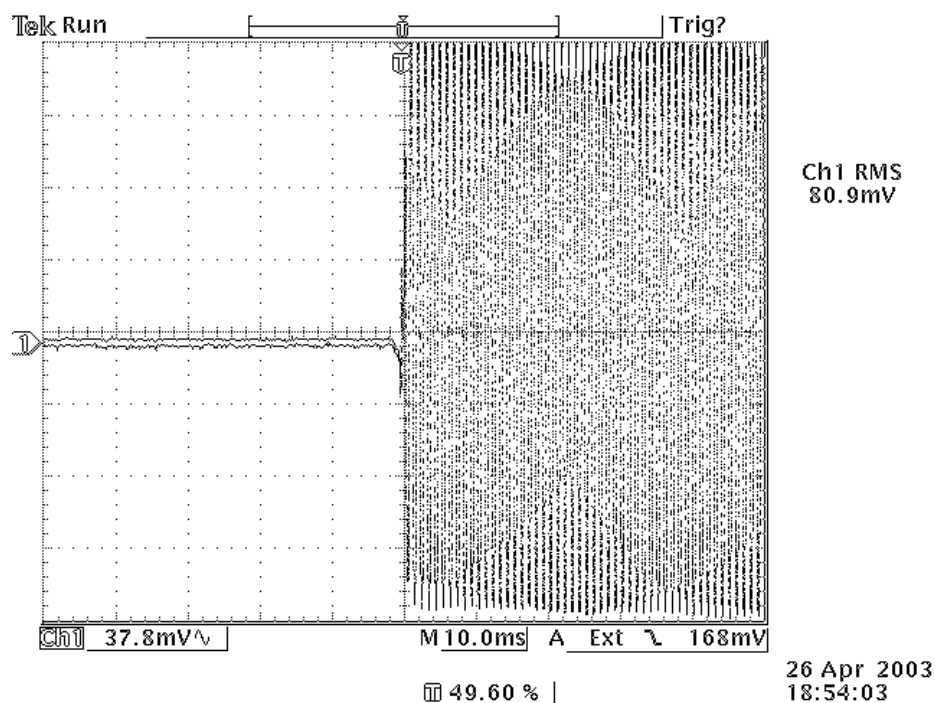
Fig. 10. Transmitter switched OFF at +10 °C. (12.5 kHz ch. sp.)

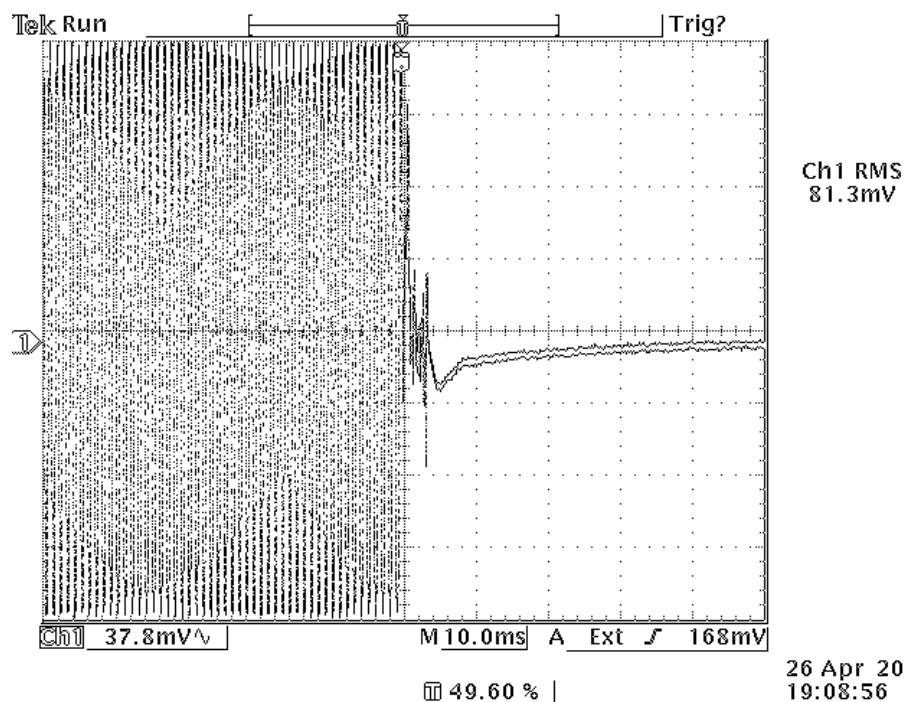
Fig. 11. Transmitter switched ON at +20 °C. (12.5 kHz ch. sp.)

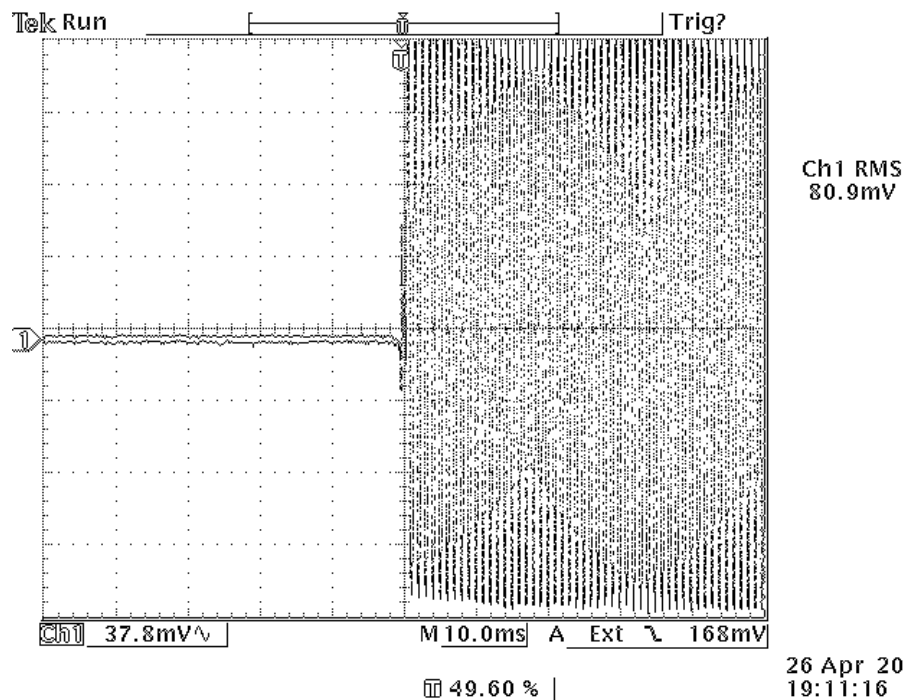
Fig. 12. Transmitter switched OFF at +20 °C. (12.5 kHz ch. sp.)

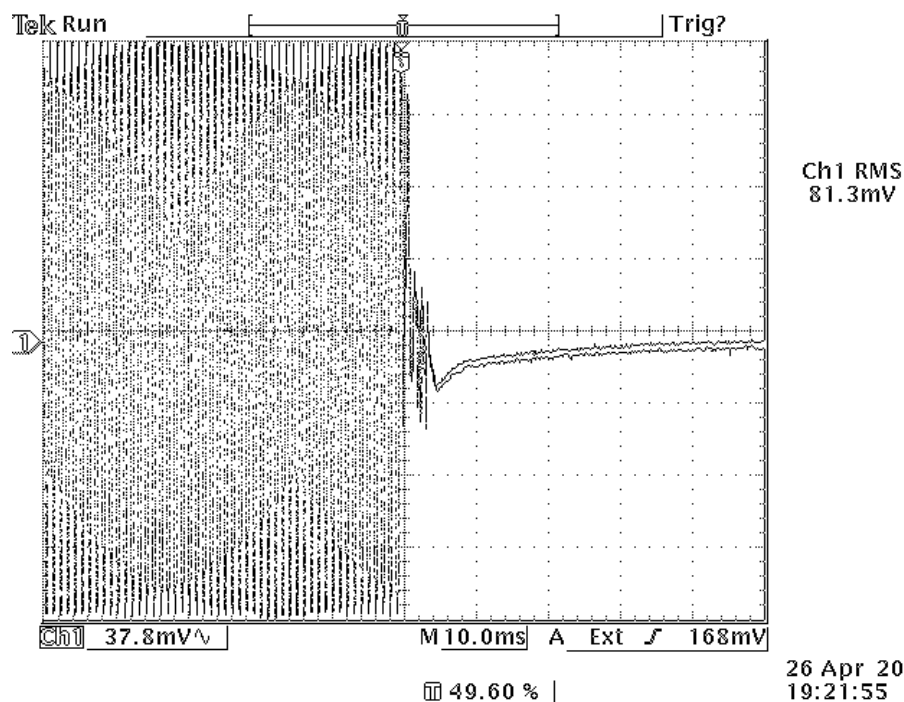
Fig. 13. Transmitter switched ON at +30 °C. (12.5 kHz ch. sp.)

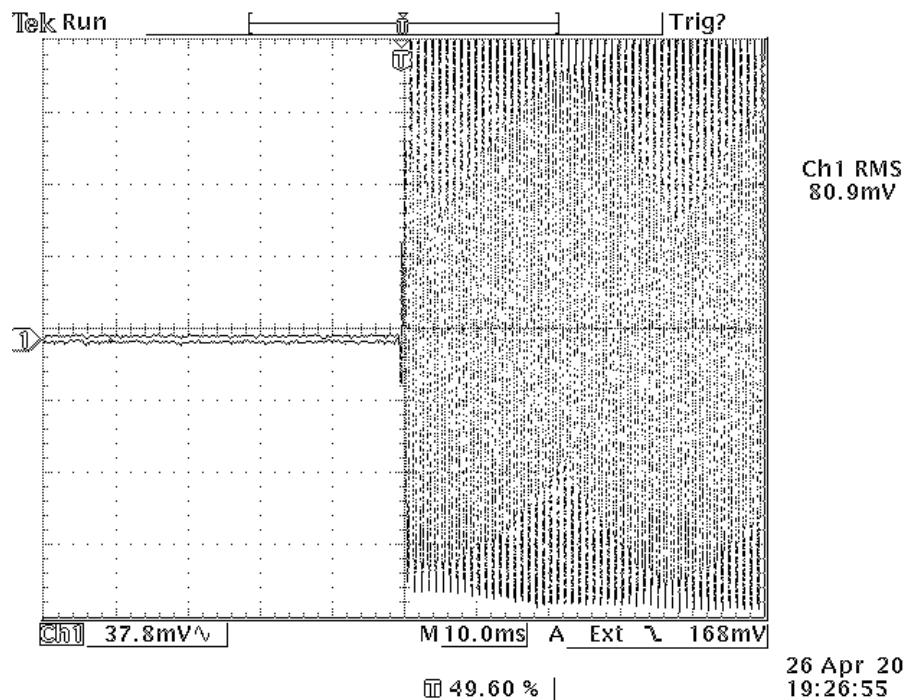
Fig. 14. Transmitter switched OFF at +30 °C. (12.5 kHz ch. sp.)

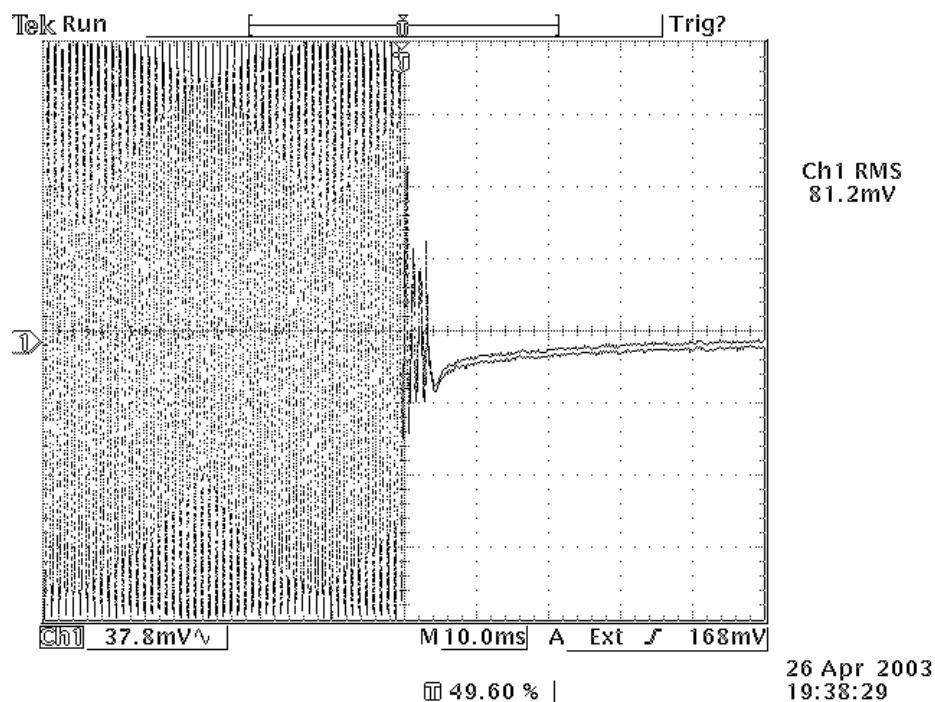
Fig. 15. Transmitter switched ON at +40 °C. (12.5 kHz ch. sp.)

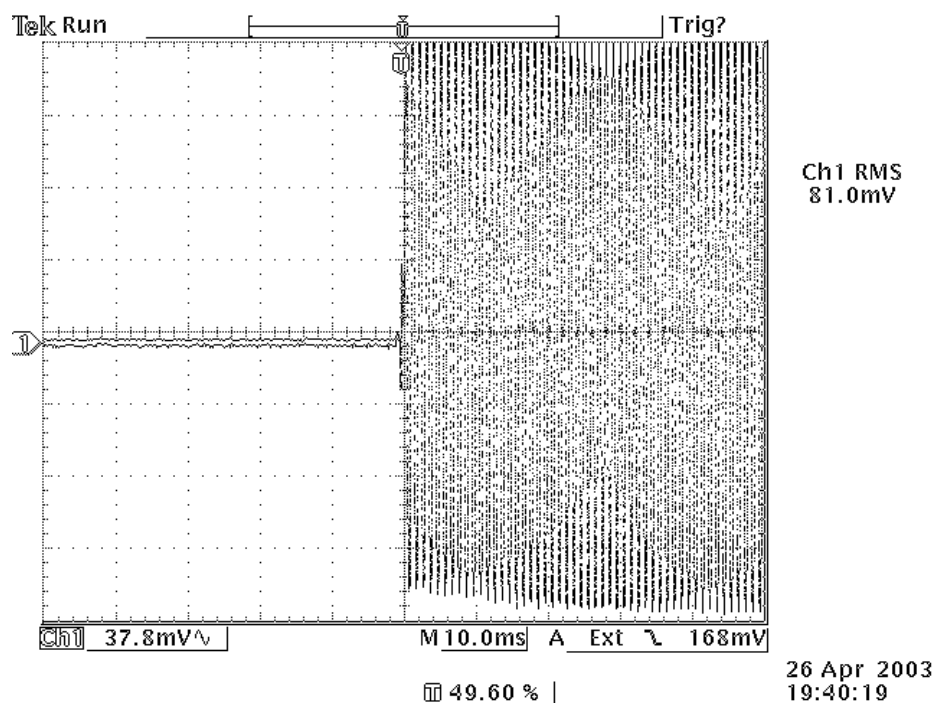
Fig. 16. Transmitter switched OFF at +40 °C. (12.5 kHz ch. sp.)

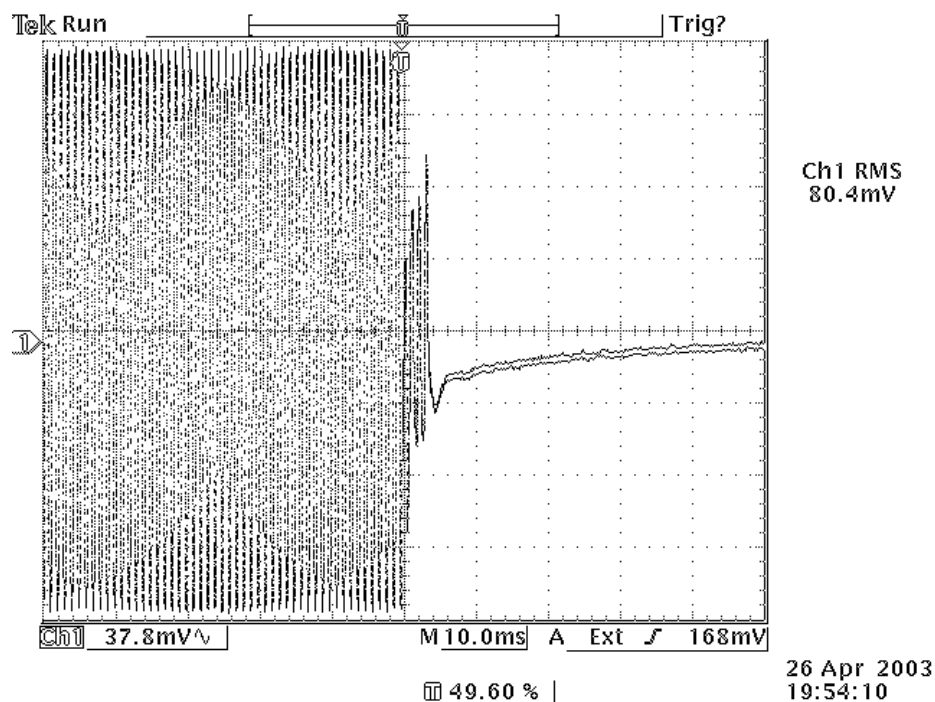
Fig. 17. Transmitter switched ON at +50 °C. (12.5 kHz ch. sp.)

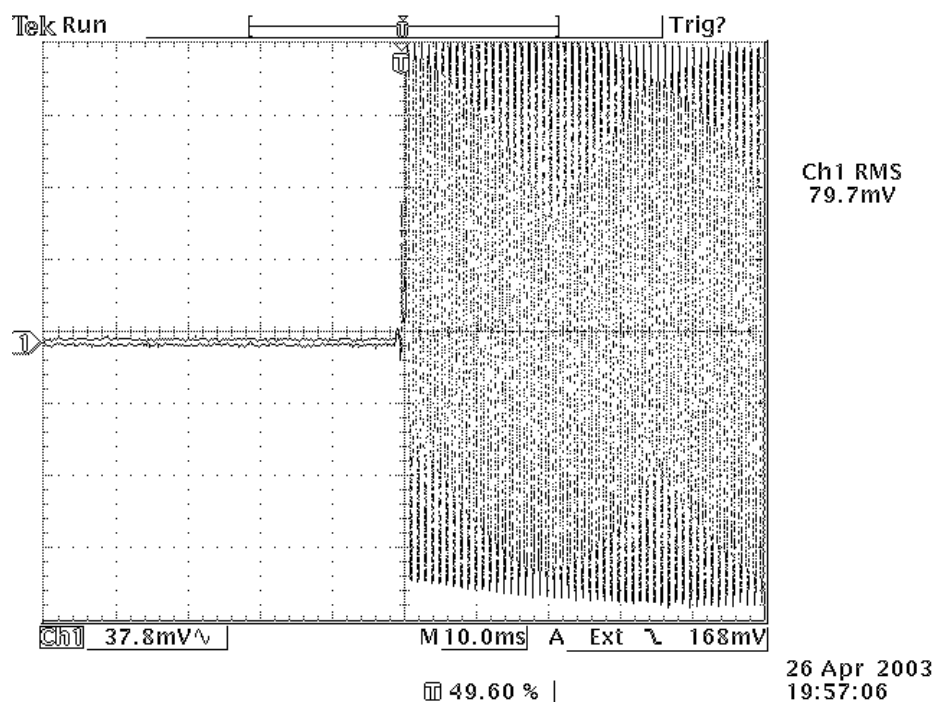
Fig. 18. Transmitter switched OFF at +50 °C. (12.5 kHz ch. sp.)
