APPENDIX 3: Photographs of test setup

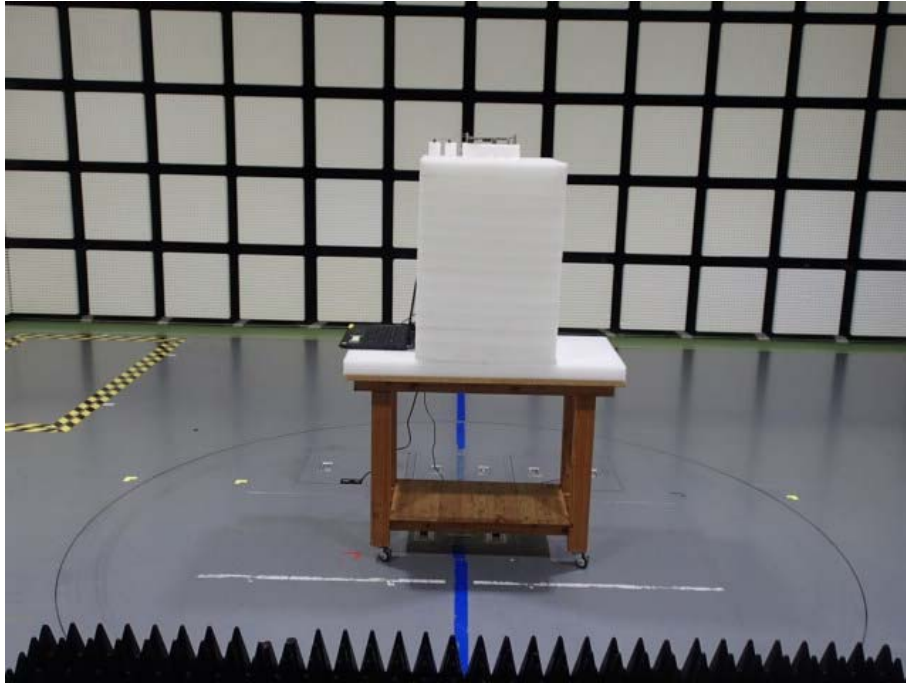
Photo 1

Radiated Spurious Emission

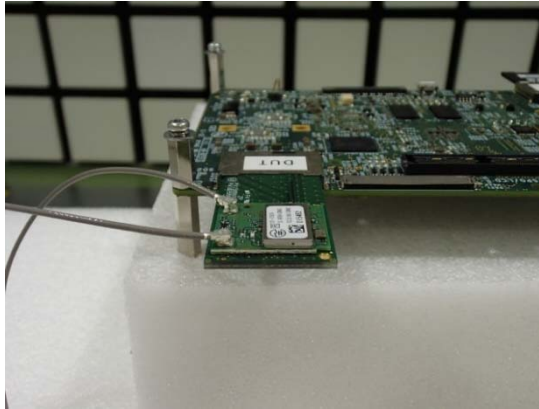
X-axis

Worst Case Position
(Module)

Below 1 GHz (Horizontal: X-axis/ Vertical:X-axis)
Above 1 GHz (Horizontal: X-axis/ Vertical:X-axis)

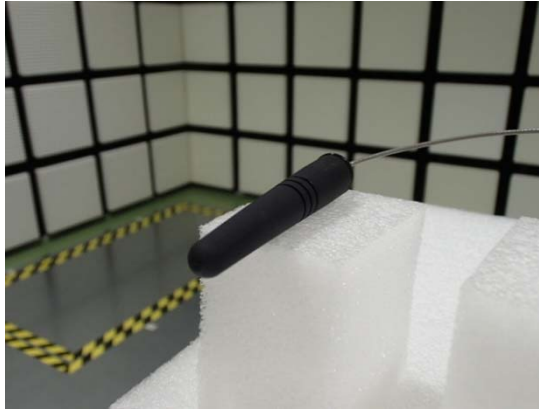
X-axis

Worst Case Position
(Antenna)

Below 1 GHz (Horizontal: X-axis/ Vertical:Y-axis)
Above 1 GHz (Horizontal: X-axis/ Vertical:Y-axis)
