**APPENDIX 3: Photographs of test setup**

**Radiated Spurious Emission**

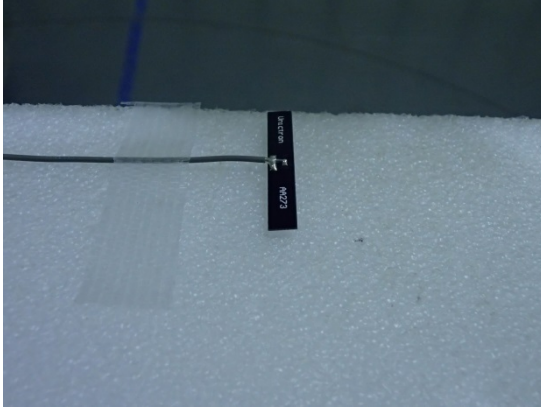
**X-axis**

**Antenna**

Below 1GHz (Hori: Antenna X, Module X / Vert: Antenna X, Module X)

Above 1GHz (Hori: Antenna X, Module X / Vert: Antenna Y, Module X)

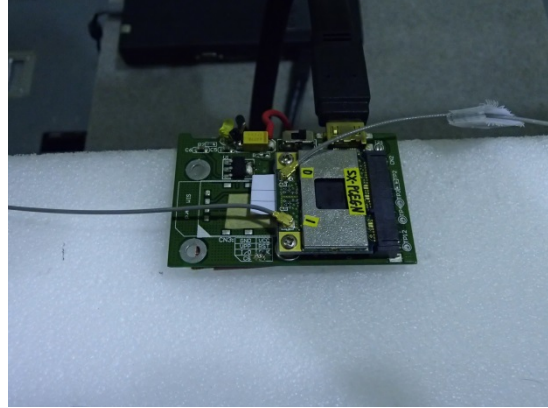
**X-axis**

**Module**
