APPENDIX 3: Photographs of test setup

Radiated Spurious Emission

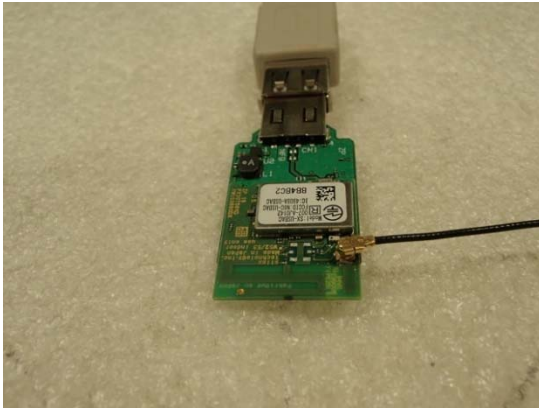
**Module
X-axis**

Module	Antenna
Below 1 GHz	Horizontal	X	X
	Vertical	X	X
Above 1 GHz	Horizontal	Z	Z
	Vertical	Y	Y

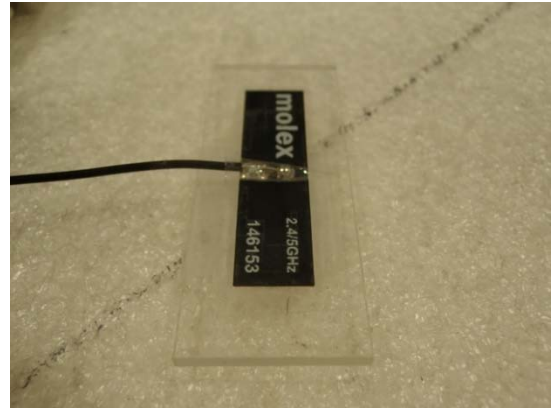
**Antenna
X-axis**

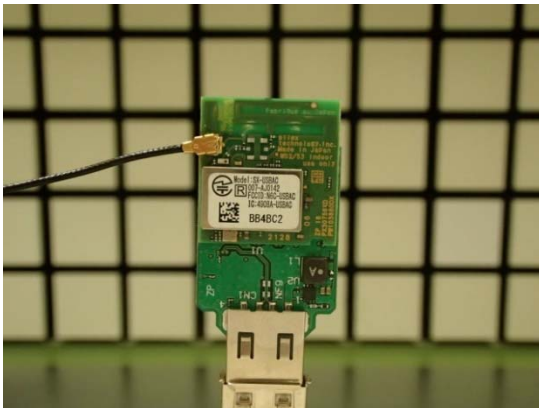
Y-axis

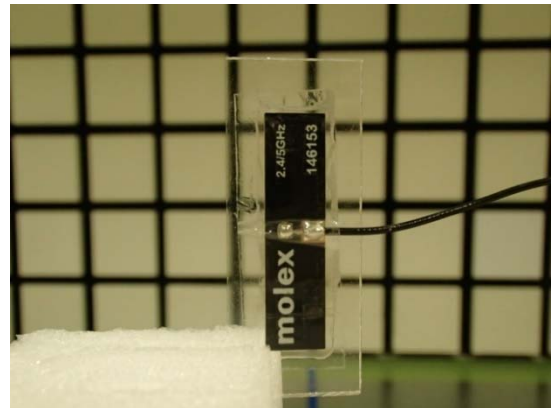
Y-axis

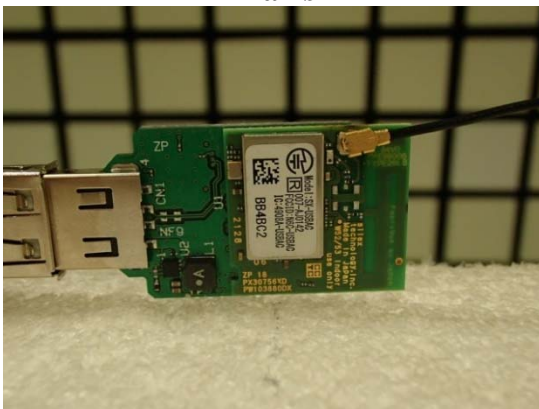
Z-axis

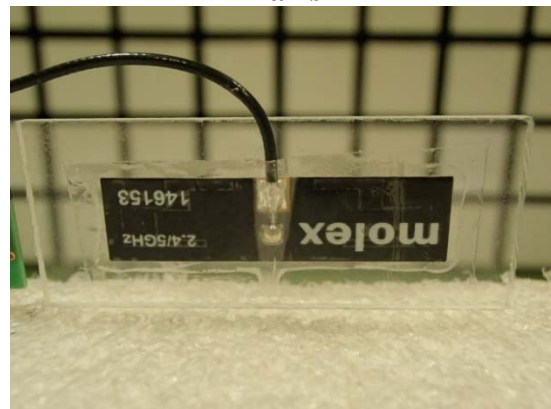
Z-axis
