Test 2, Item A - Test Set-Up Photo:

Radiated Disturbance Emissions - 30 to 1000 MHz Electric Field

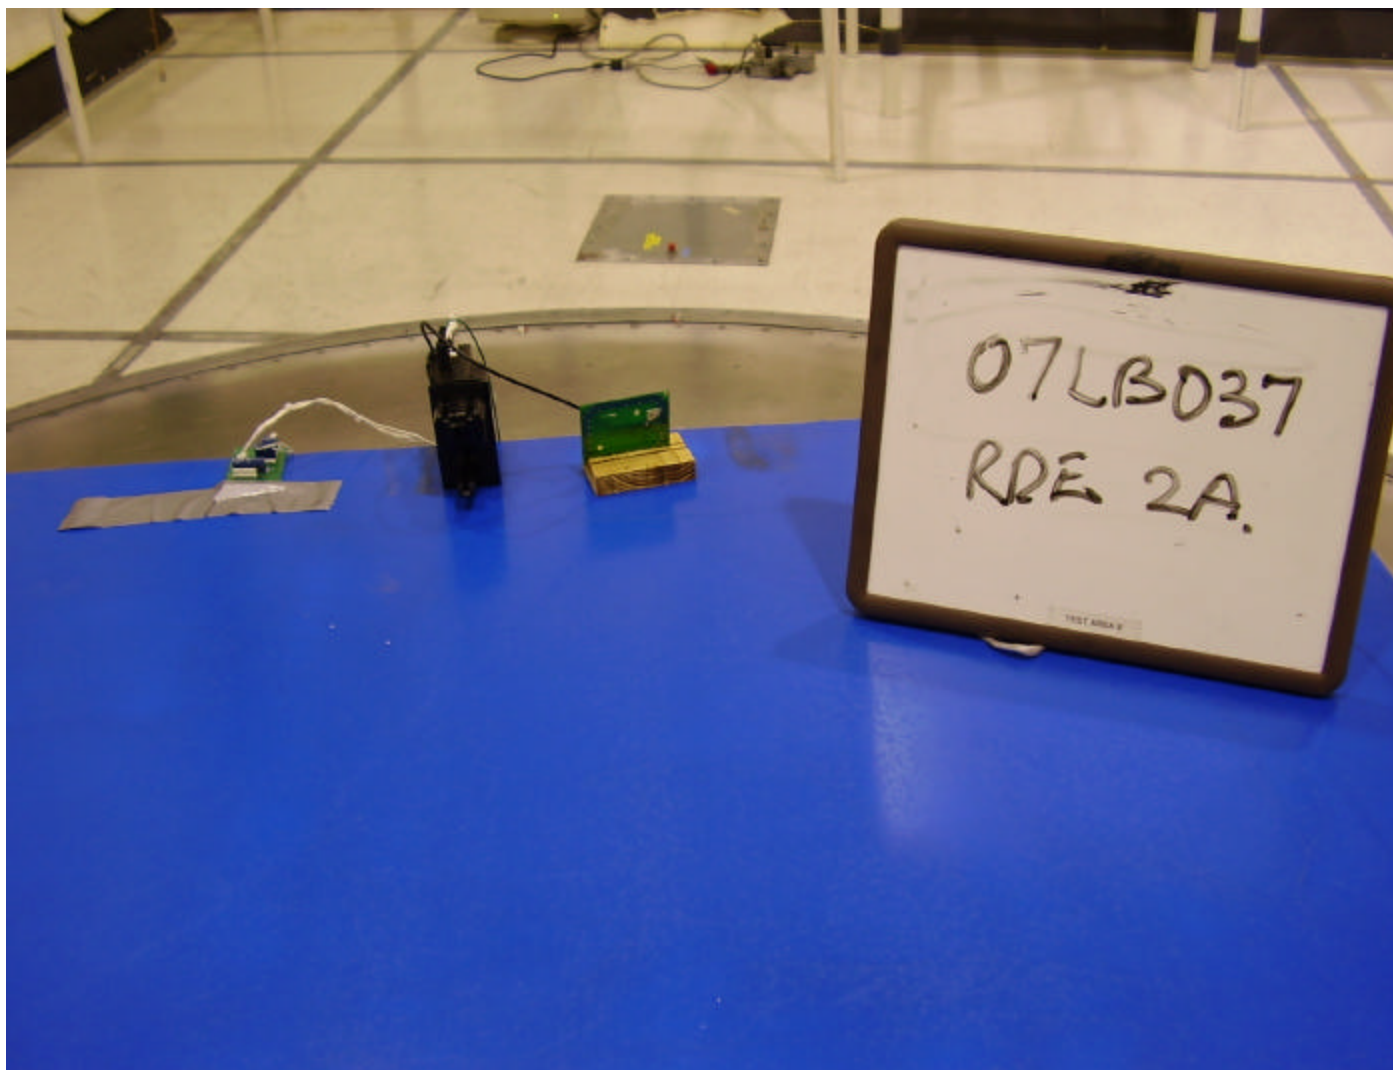
RFID Reader (EUT) in center with power/data connection board on left, antenna on right. From preliminary testing it was determined that the reader was worst in the upright position as shown.

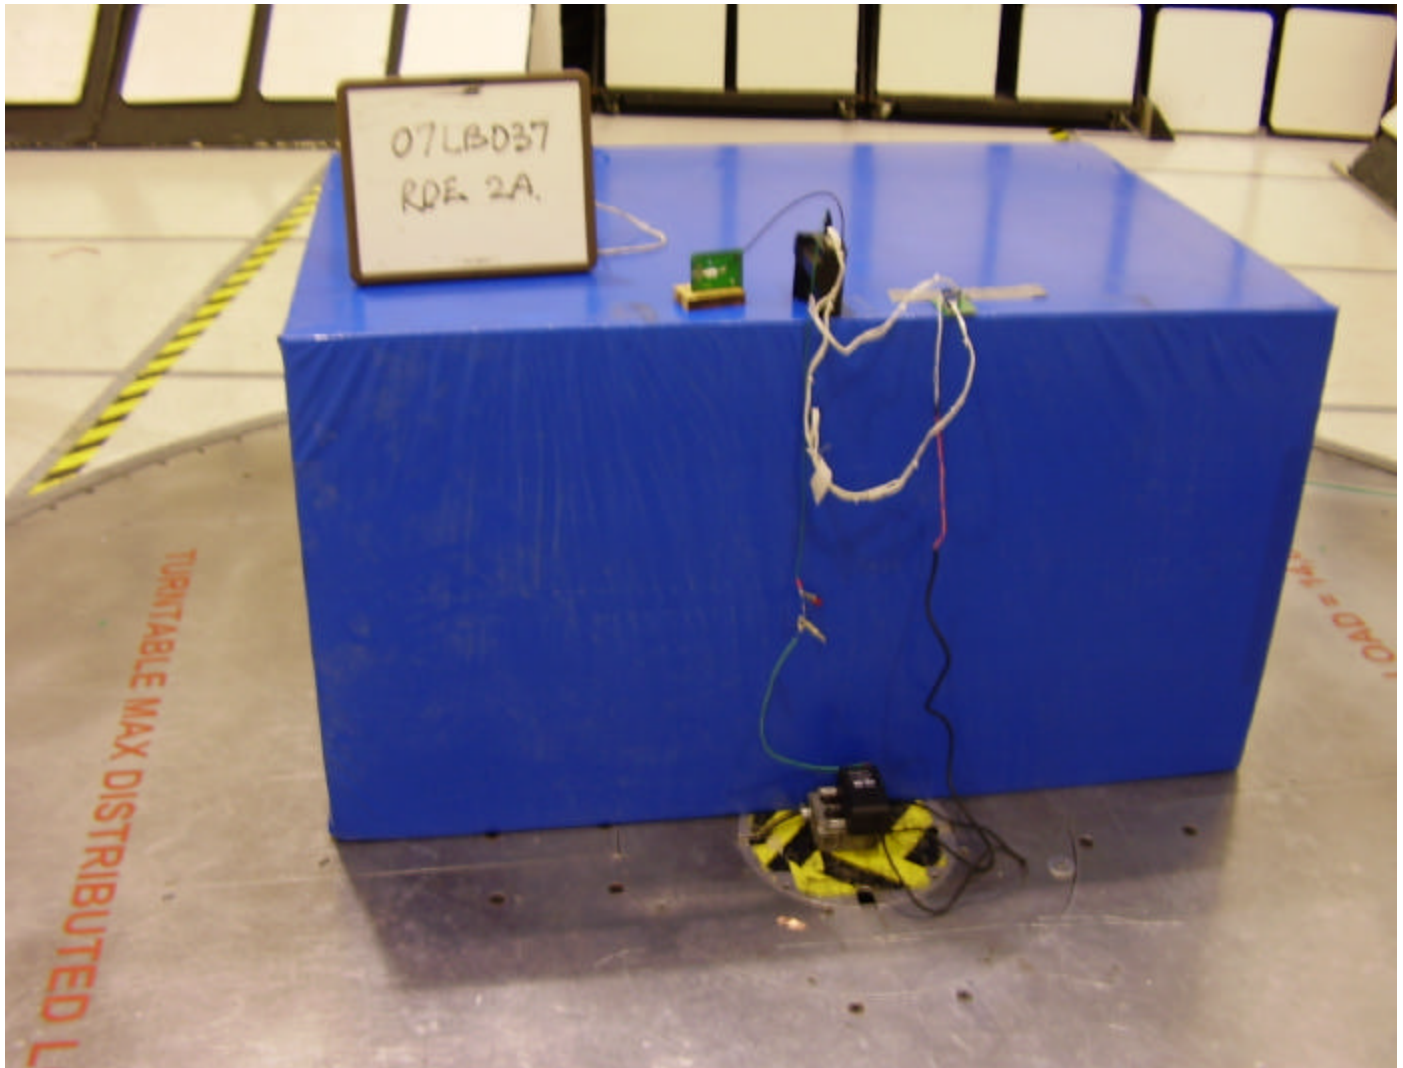
Test 2, Item A - Test Set-Up Photo:

Radiated Disturbance Emissions - 30 to 1000 MHz Electric Field

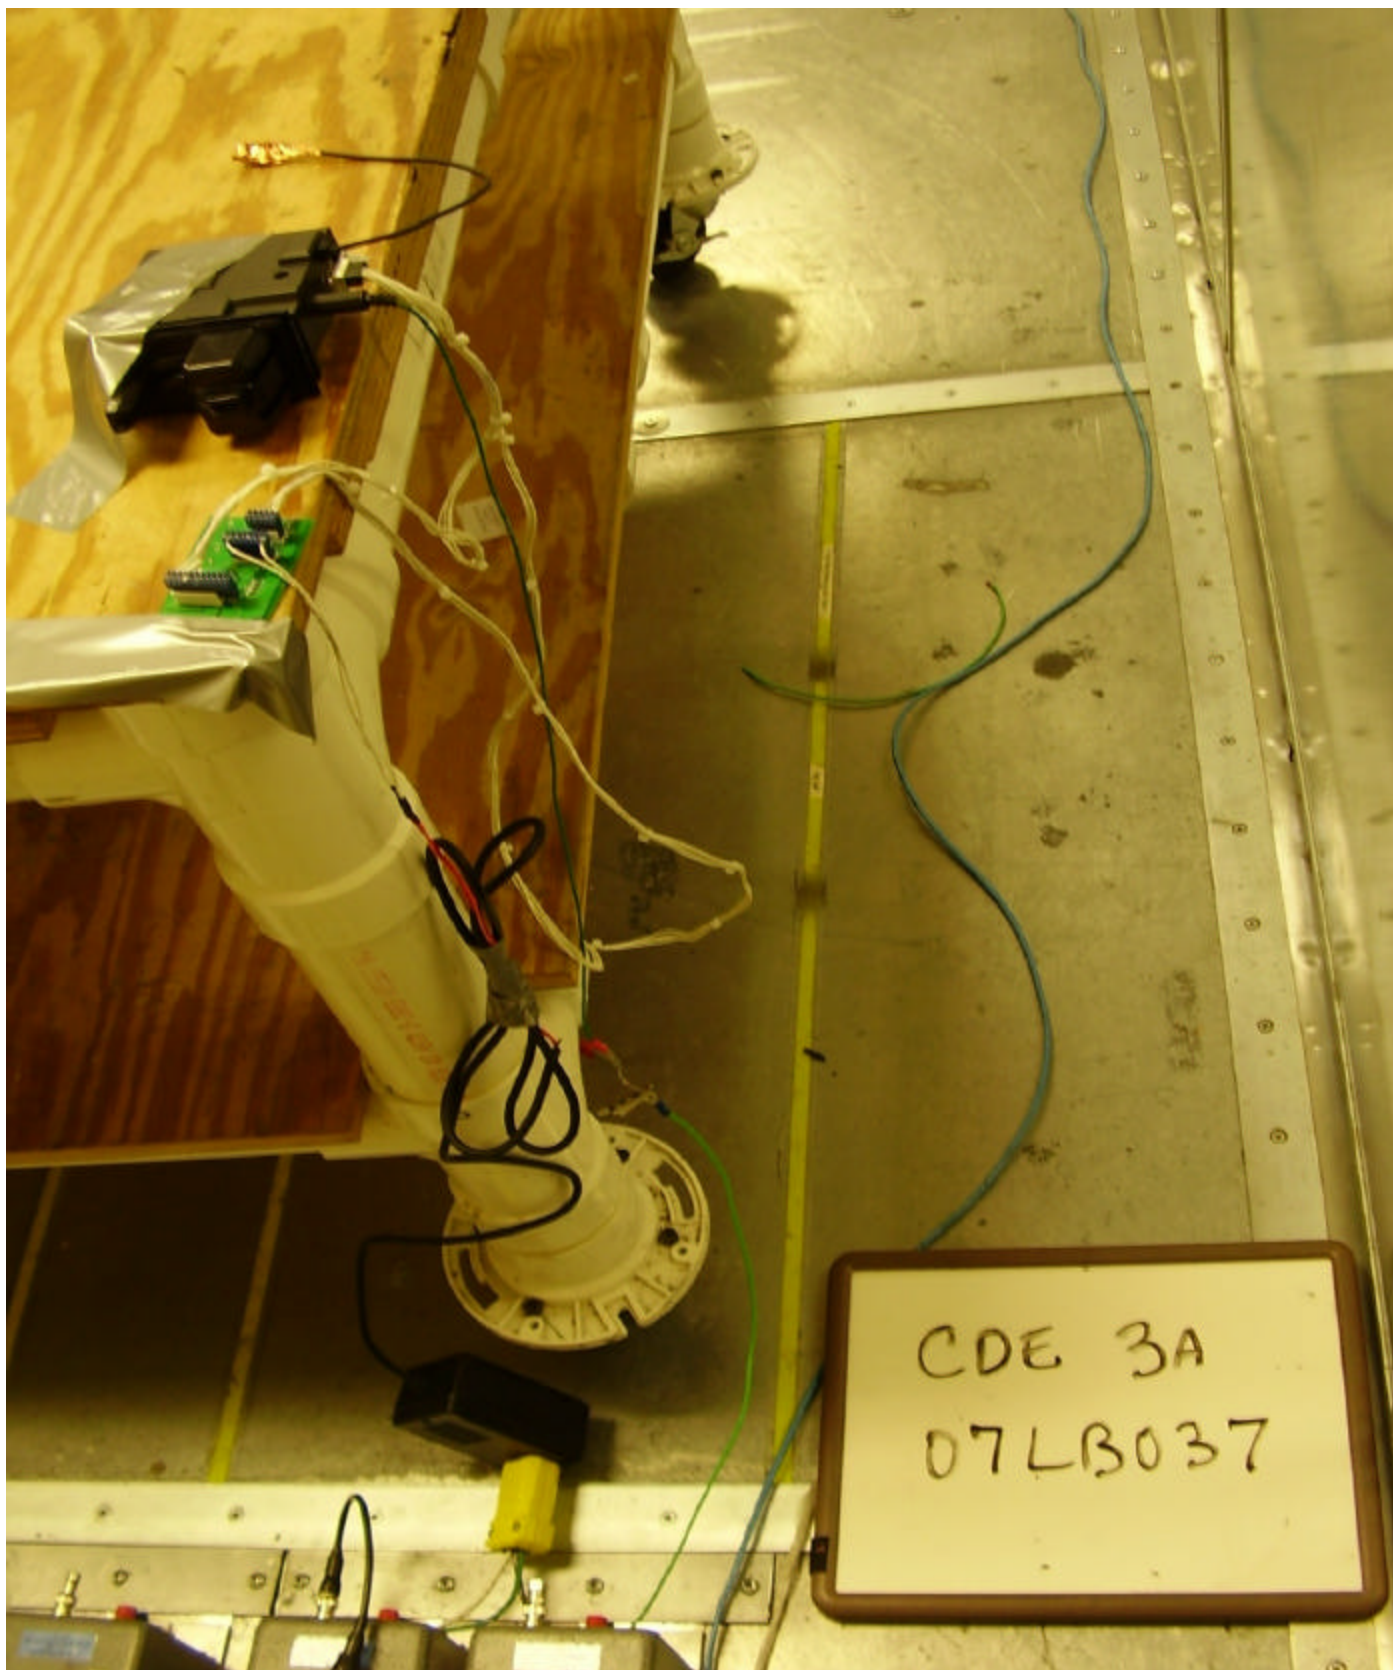
Test 3, Item A (with matched load) - Test Set-Up Photo:

Conducted Emissions - Voltage

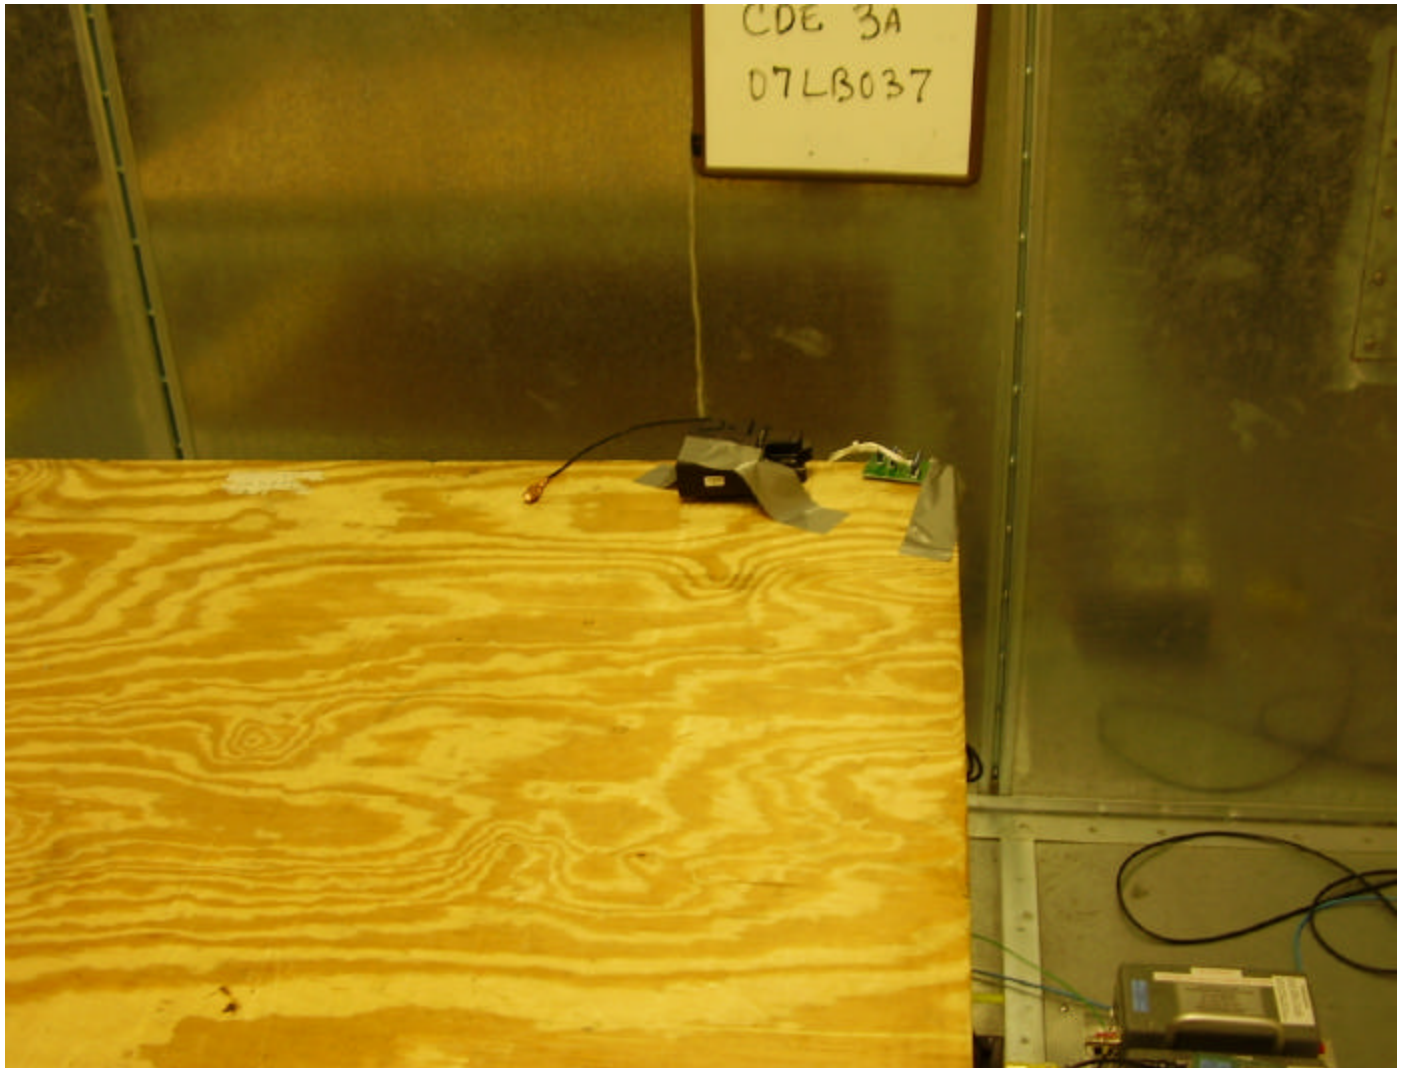
Test 3, Item A (with matched load) - Test Set-Up Photo:

Conducted Disturbance Emissions - Voltage
