**APPENDIX 3: Photographs of test setup**

**Radiated Spurious Emission**

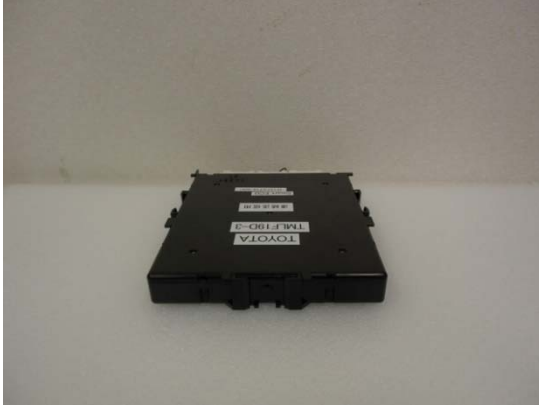
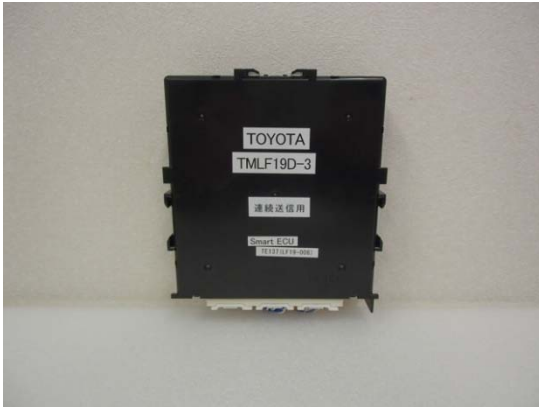
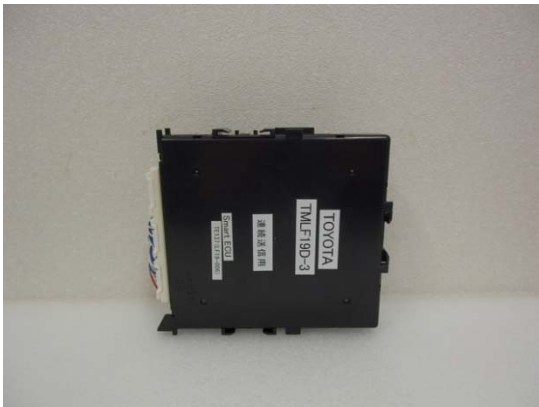
**ECU**  
Below 30 MHz: X-axis  
Above 30 MHz (Horizontal: X / Vertical: X)  
**X-axis**

**Y-axis**

**Z-axis**

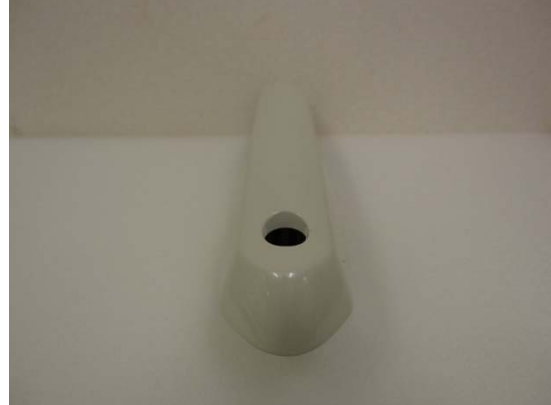
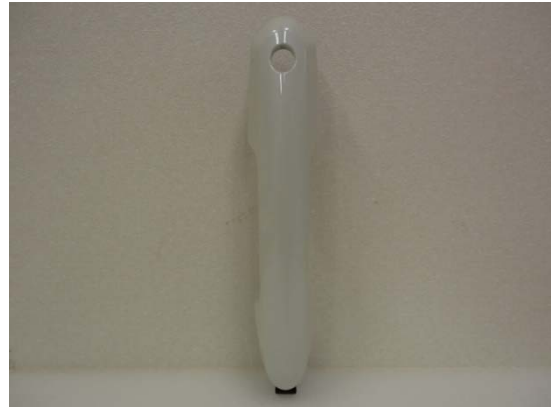
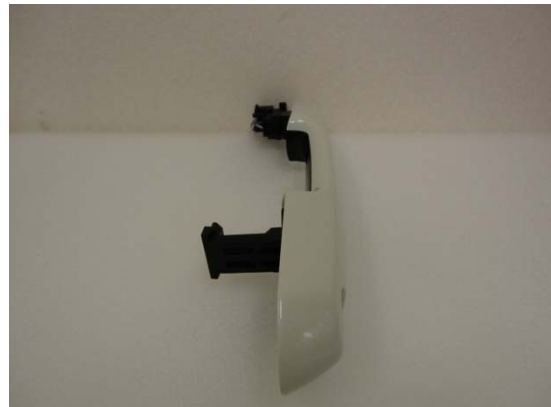
**Outside Antenna**  
Below 30 MHz: X-axis  
Above 30 MHz (Horizontal: X / Vertical: X)  
**X-axis**

**Y-axis**

**Z-axis**

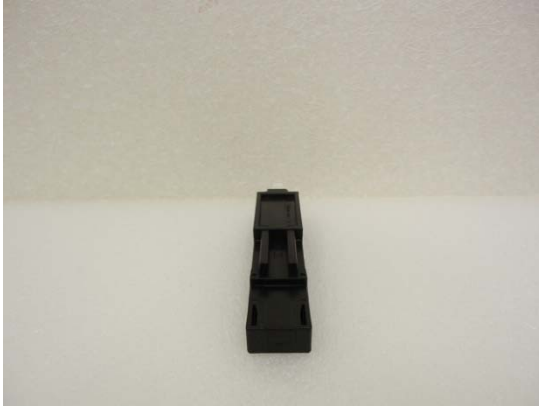
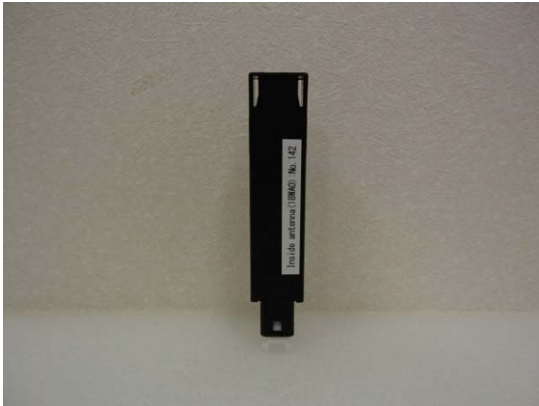
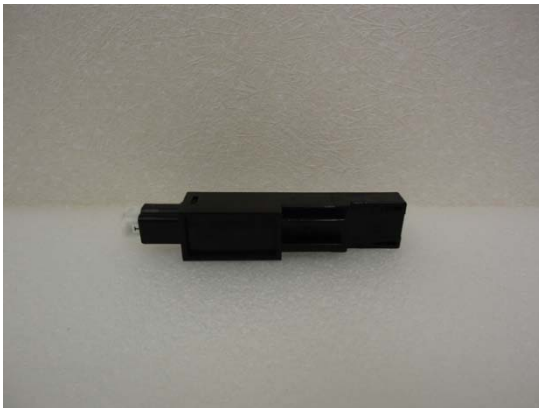
**Inside Antenna**  
Below 30 MHz: X-axis  
Above 30 MHz (Horizontal: X / Vertical: X)  
**X-axis**

**Y-axis**

**Z-axis**

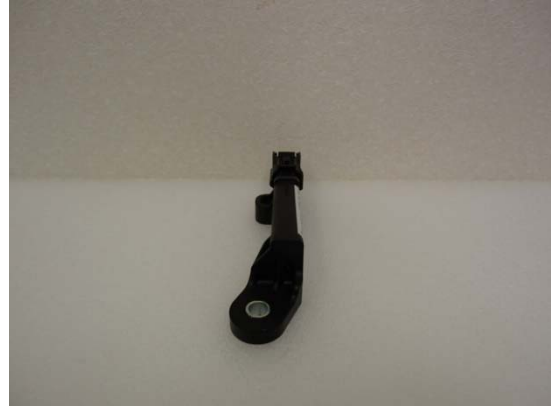
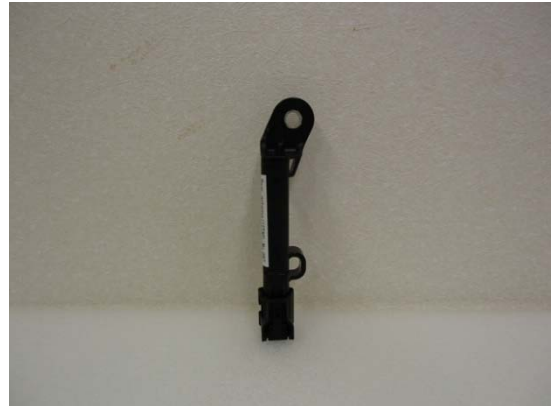
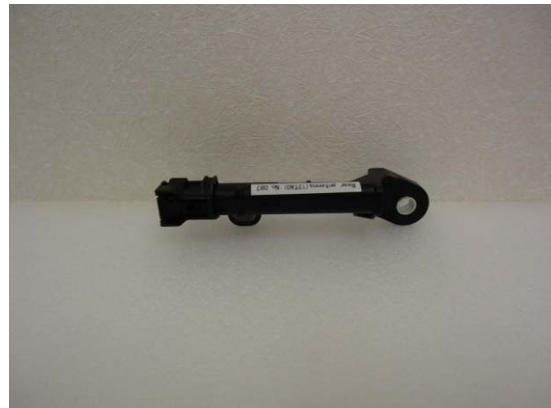
**Rear Antenna**  
Below 30 MHz: X-axis  
Above 30 MHz (Horizontal: X / Vertical: X)  
**X-axis**

**Y-axis**

**Z-axis**

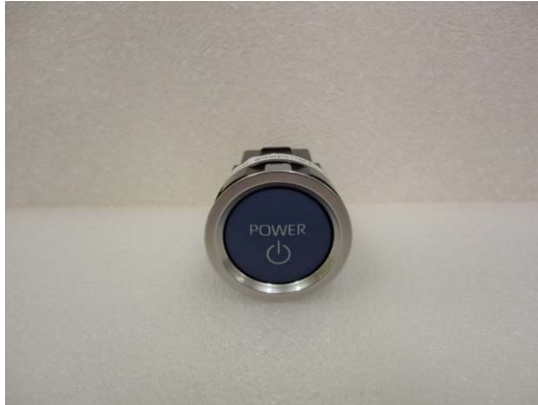
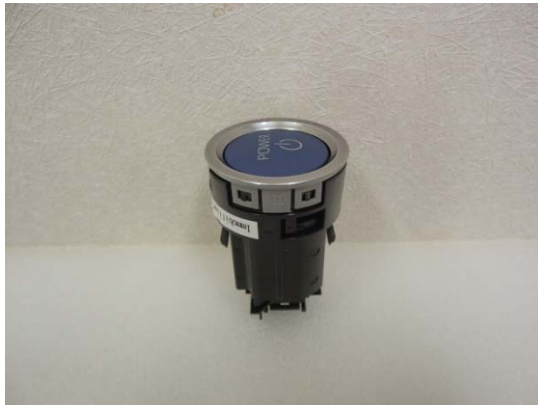
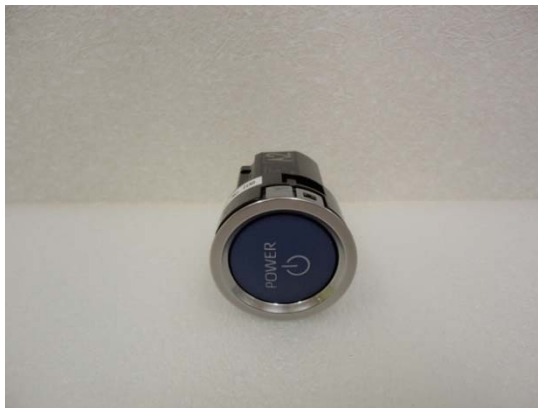
### Immobilizer Antenna

Below 30 MHz: X-axis

Above 30 MHz (Horizontal: X / Vertical: X)

**X-axis**

**Y-axis**

**Z-axis**

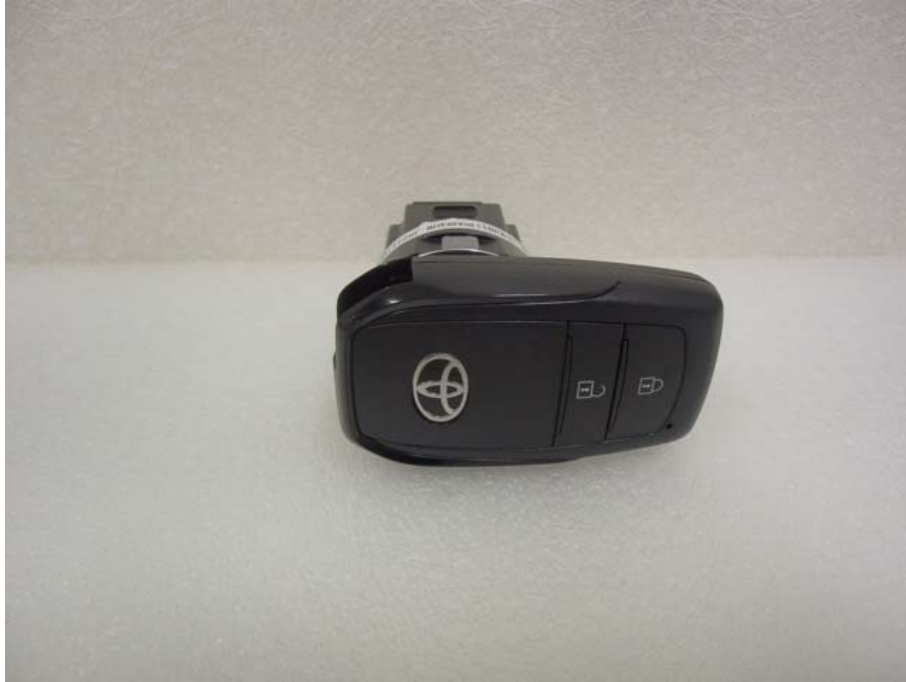
**With key**

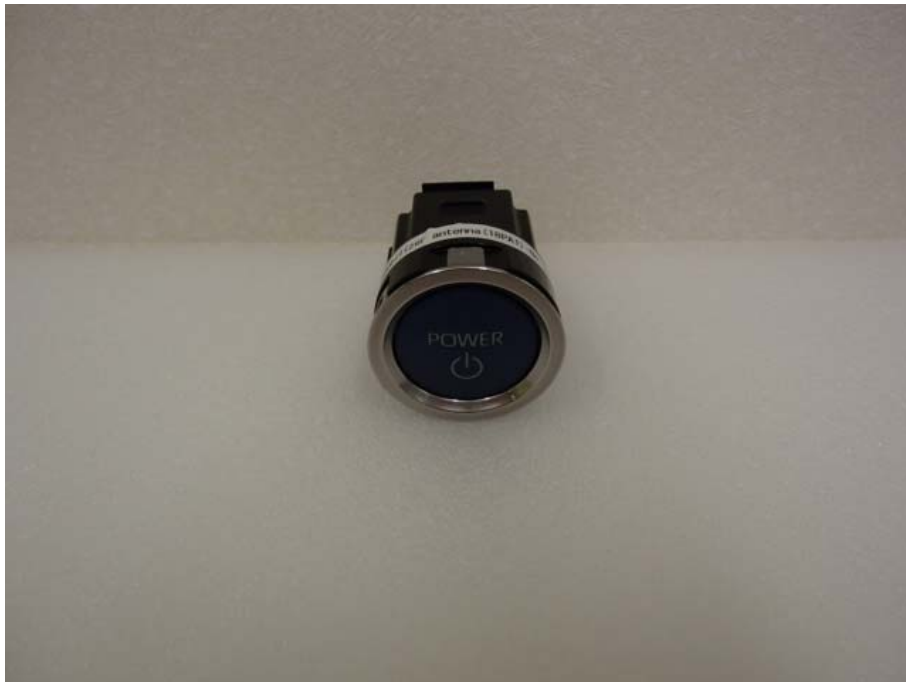
**Without key (Worst)**
