ANNEX 2 - PHOTOGRAPHS OF RADIATED EMISSIONS MEASUREMENTS
Siemens Milltronics SITRANS LR

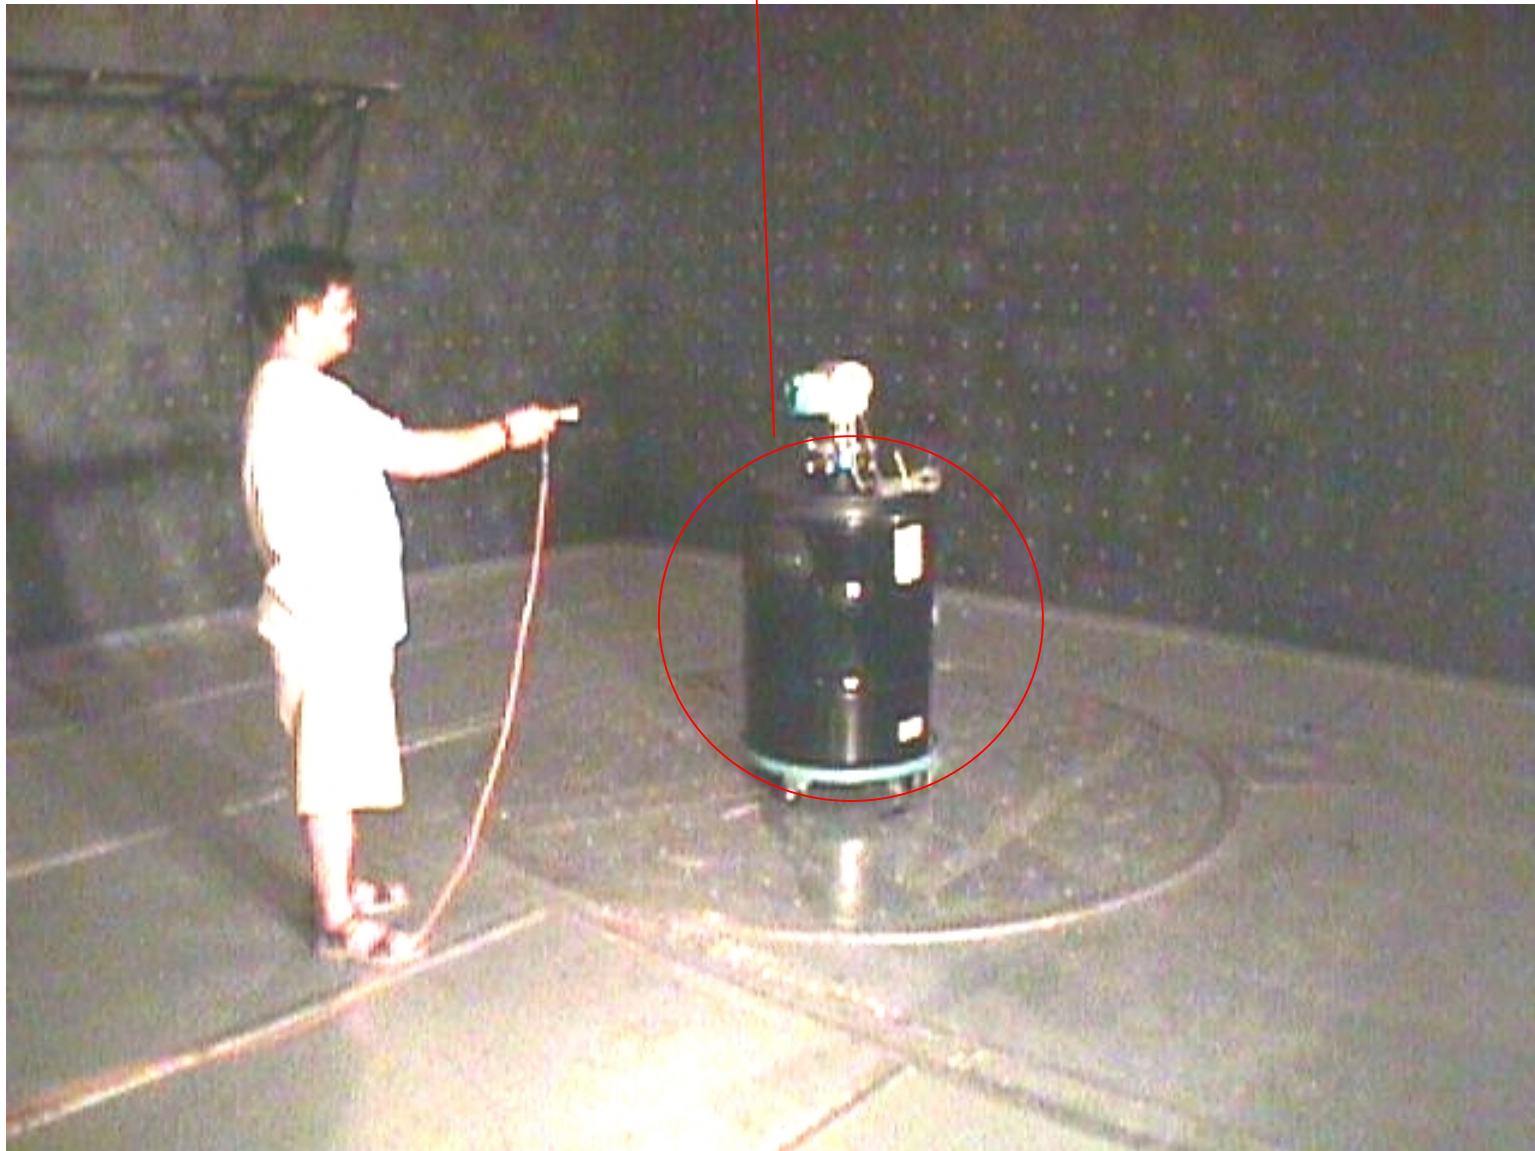
PHOTO # 3

Carrier and spurious/harmonic emissions from the Siemens Milltronics SITRANS LR, which was mounted on top of the metal tank without ventilation, were scanned using a horn antenna at 0.5, 1.0 and 3 meters distances.

Metal tank

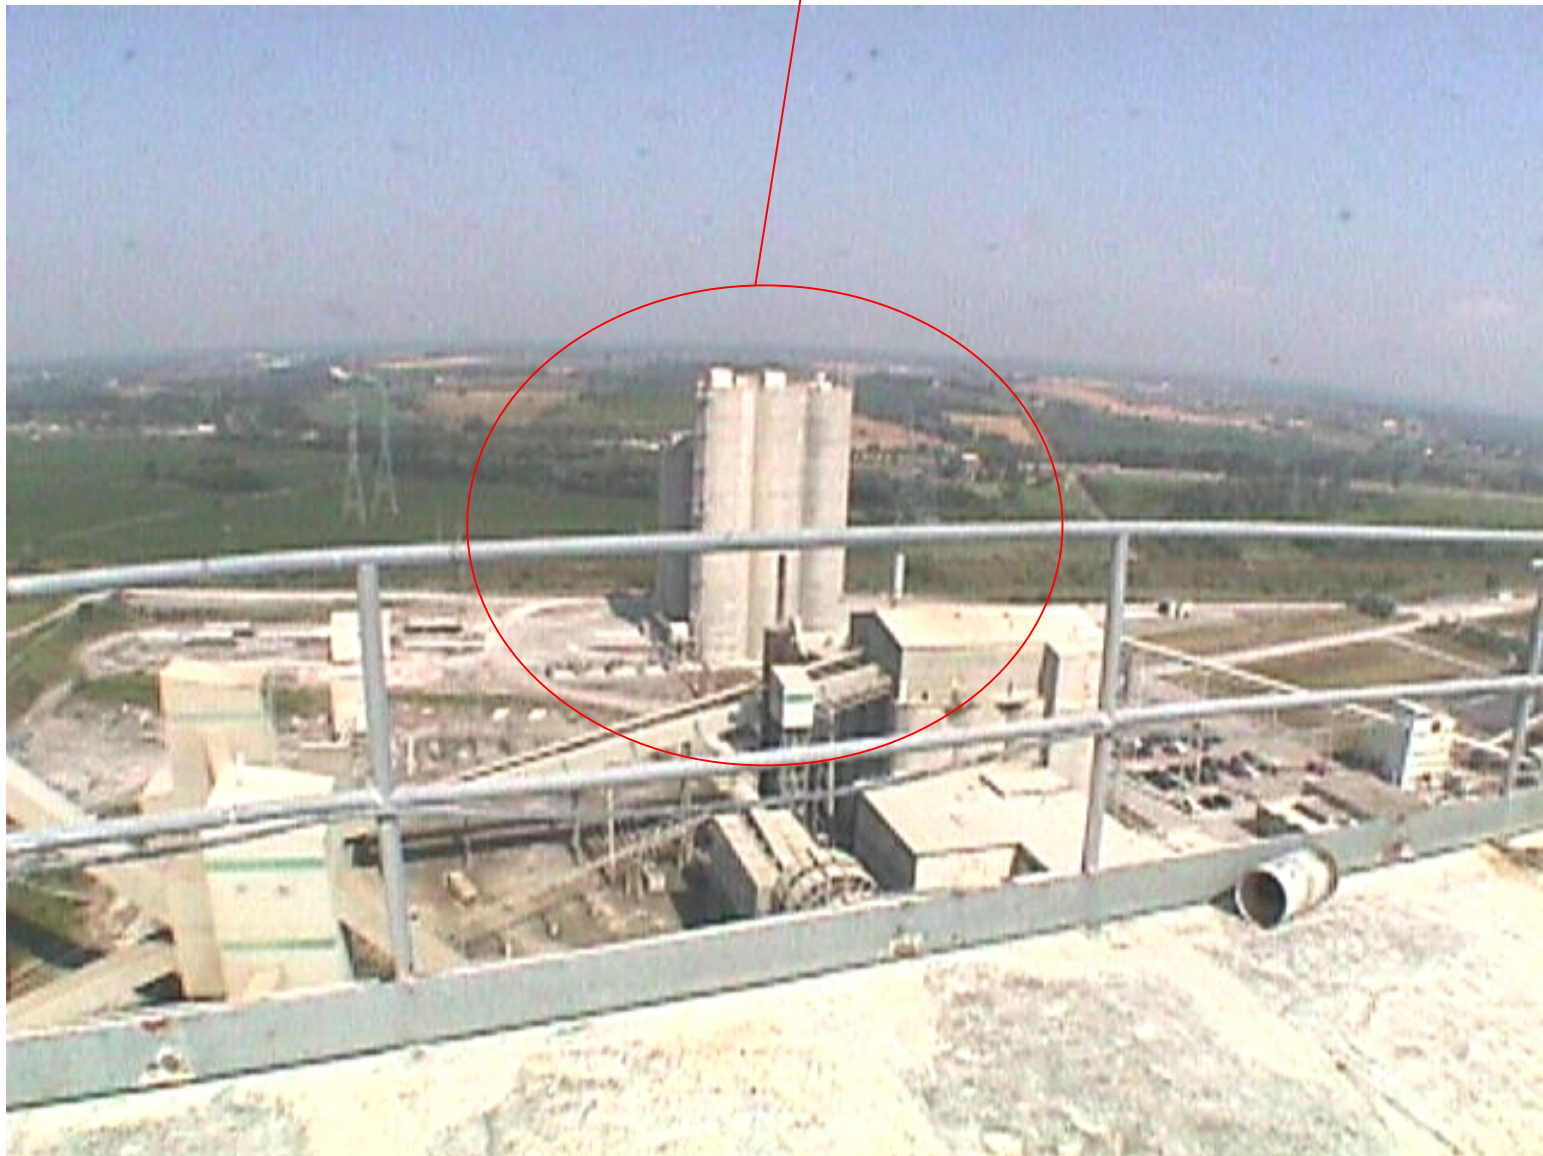
Concrete cement tank contains cement

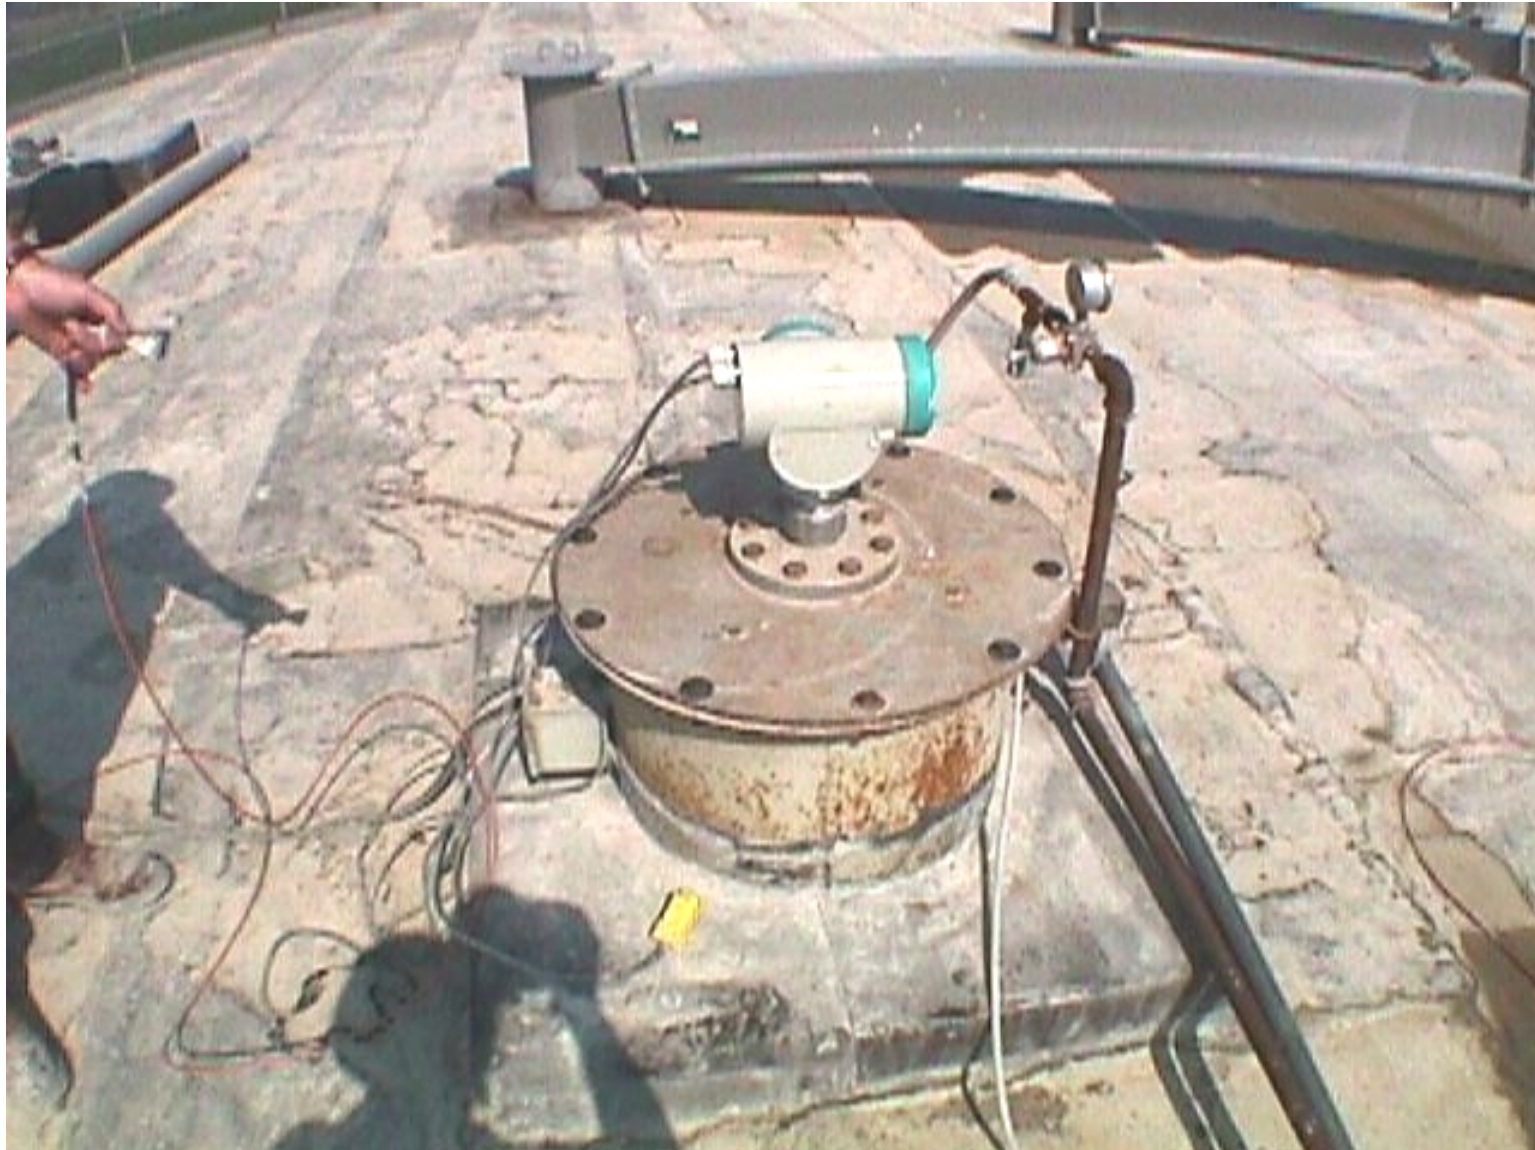
The Siemens Milltronics SITRANS LR mounted on top of the mouth of the Concrete Tank

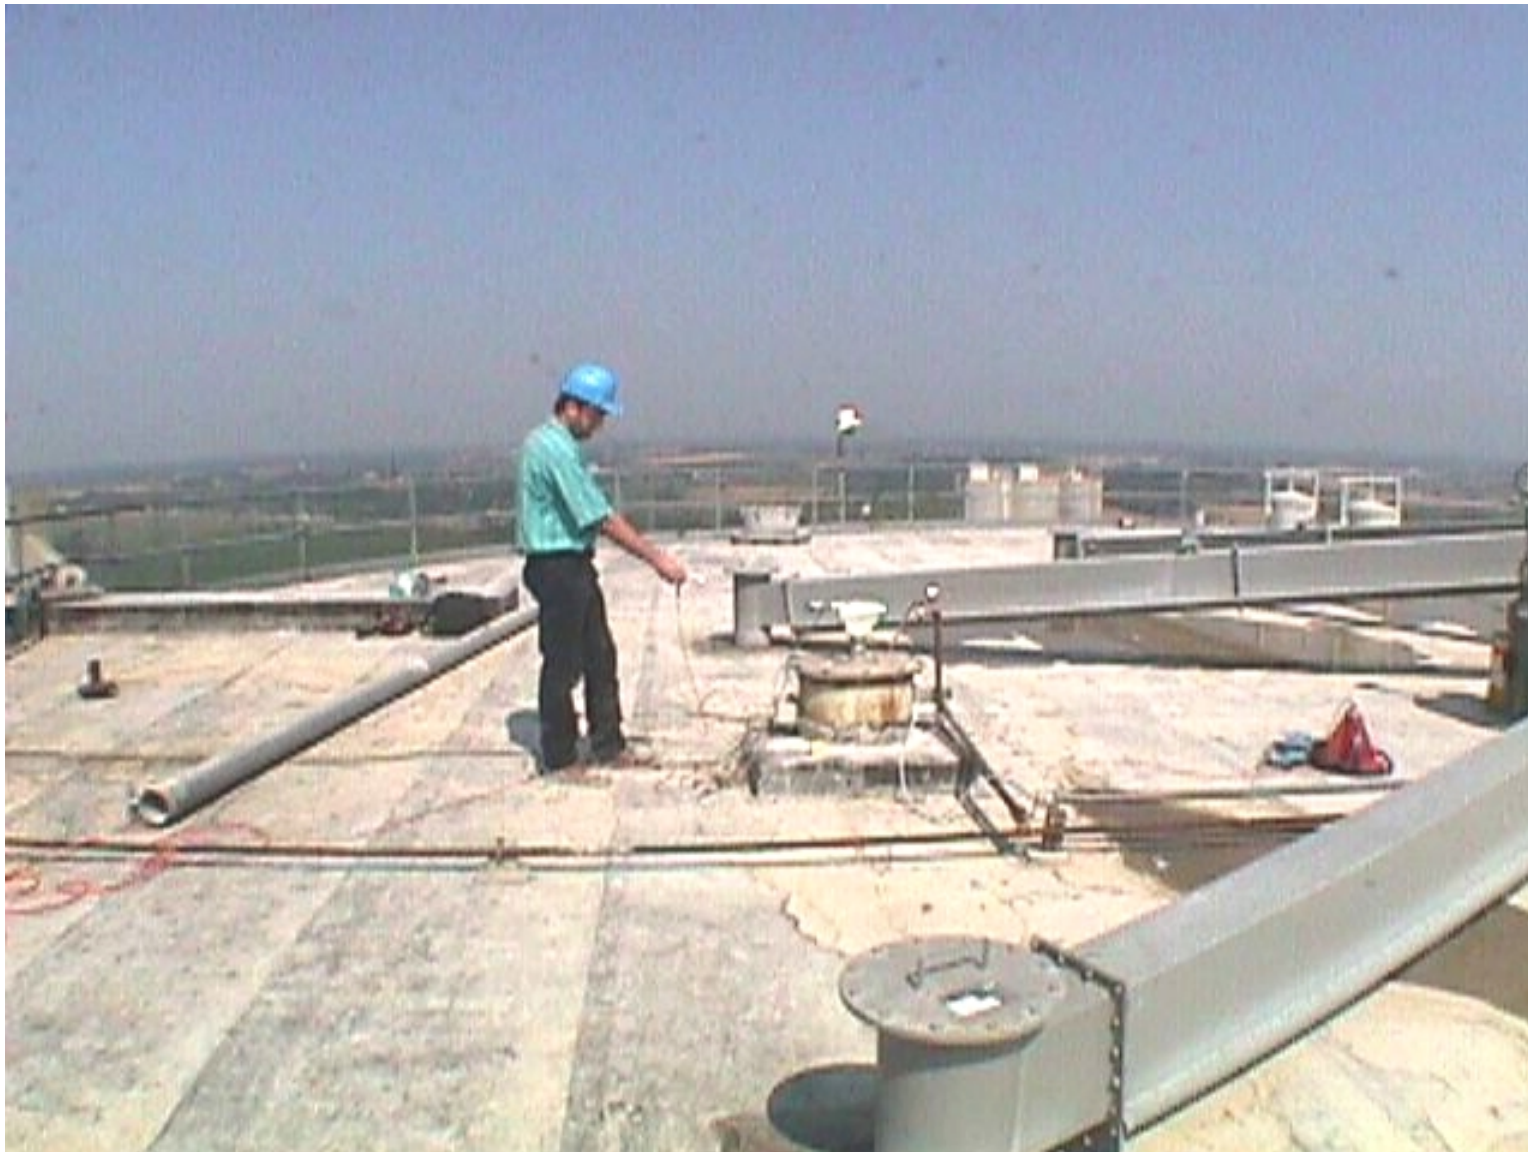
PHOTO # 6

Carrier and spurious/harmonic emissions from the Siemens Milltronics SITRANS LR , which was mounted on top of the concrete tank, were scanned using a horn antenna at 0.5, 1.0 and 3 meters distances.
