Report No.: 9807849

Tested By: Hong, Report No.: 9807849

**ITS** Intertek Testing Services  
ETL Testing Laboratories

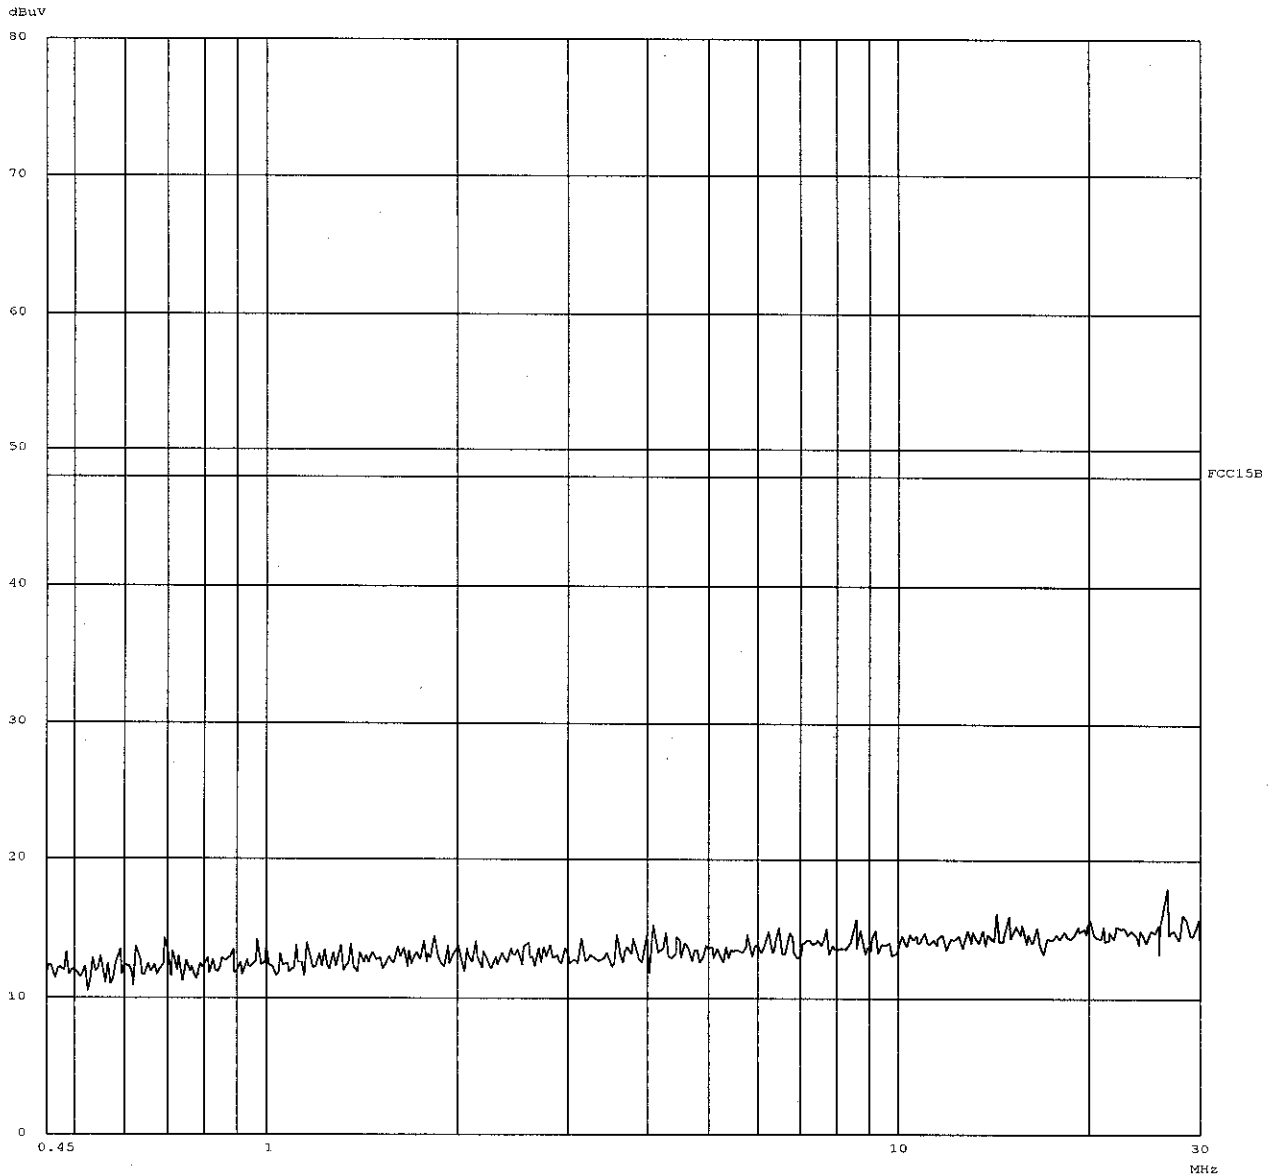
Tx

Scan Settings (1 Range)  
 |--- Frequencies ---| |--- Receiver Settings ---|

Start	Stop	Step	IF BW	Detector	M-Time	Atten	Preamp	OpRge
450k	30M	5k	10k	PK	20ms	AUTO	LN OFF	60dB

Final Measurement: X QF  
 Meas Time: 1 s  
 Subranges: 16  
 Acc Margin: 20dB

Transducer No.	Start	Stop	Name
3	9k	30M	E1078

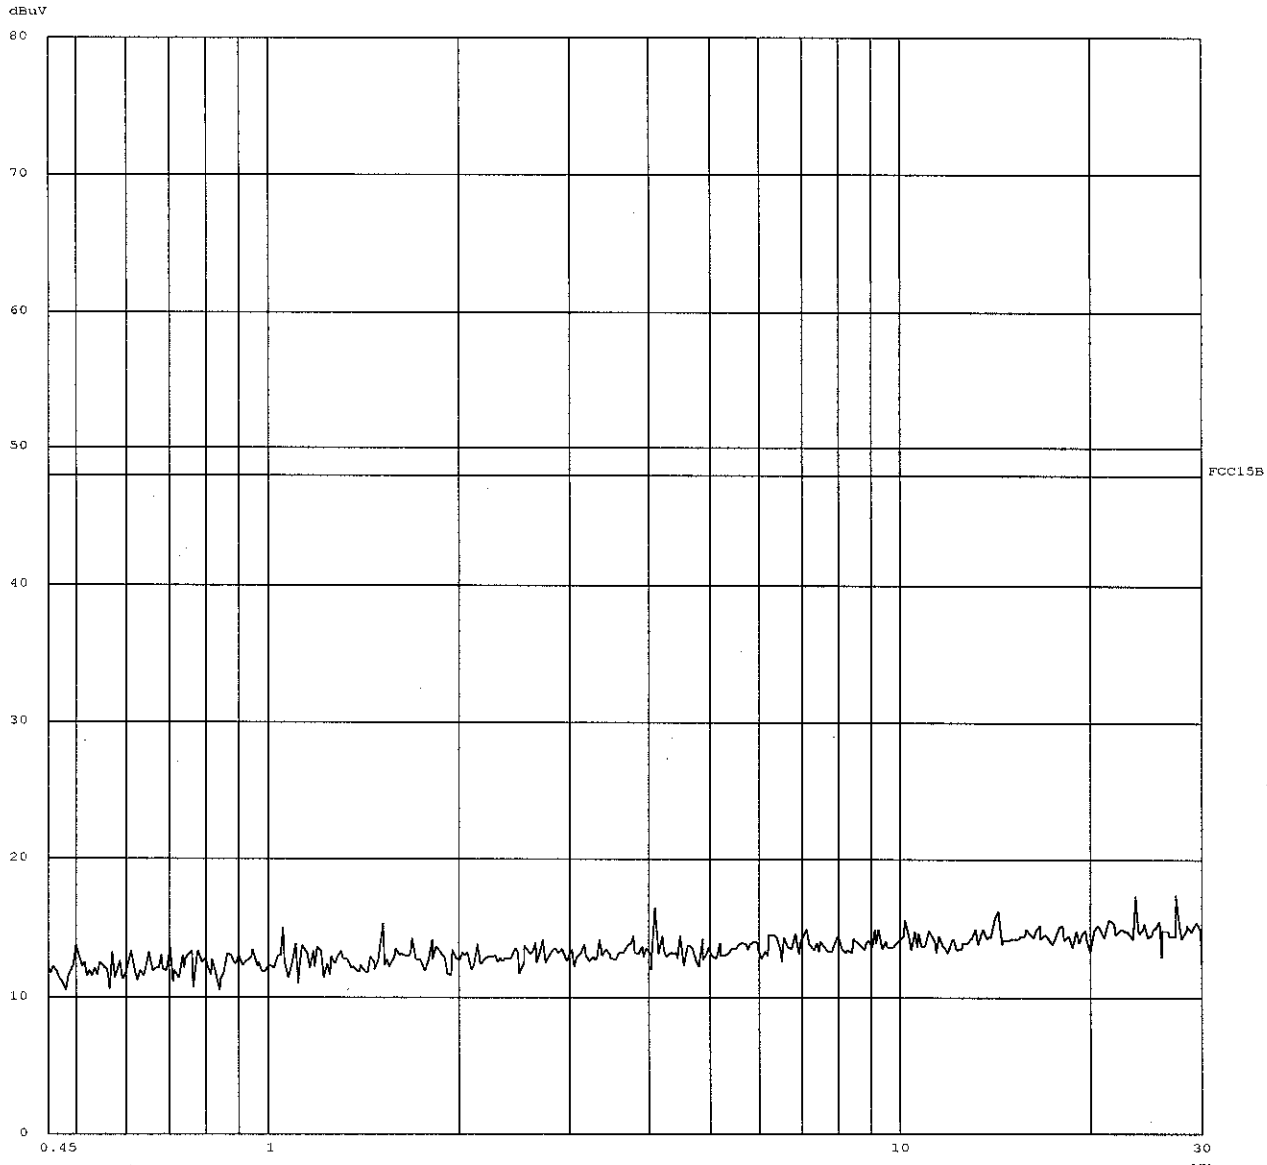
*Stand-by*

Scan Settings (1 Range)

Frequencies			Receiver Settings					
Start	Stop	Step	IF BW	Detector	M-Time	Atten	Preamplifier	OpRge
450k	30M	5k	10k	PK	20ms	AUTO	LN OFF	60dB

Final Measurement:	x	QP	Transducer No.	Start	Stop	Name
Meas Time:	1	s	3	9k	30M	E1078
Subranges:	16					
Acc Margin:	20dB

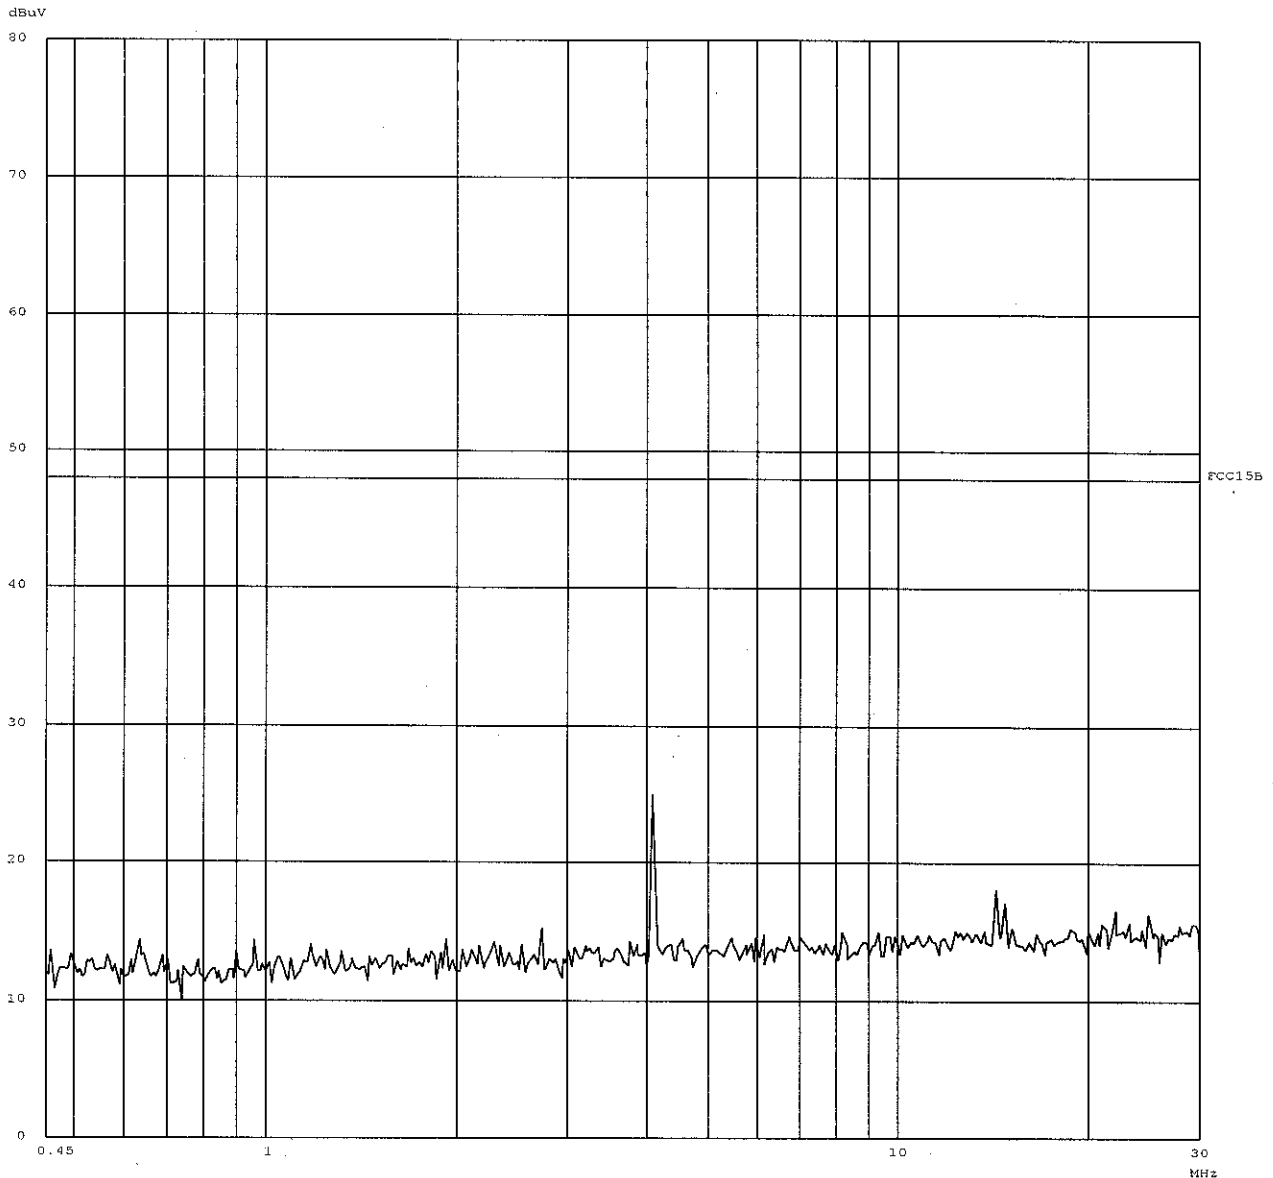
*Charging*

Tested By: Hong, Report No.: 9807849  
 Scan Settings (1 Range)

Frequencies			Receiver Settings					
Start	Stop	Step	IF BW	Detector	M-Time	Atten	Preamp	OpRge
450k	30M	5k	10k	PK	20ms	AUTO	LN OFF	60dB

Final Measurement: x QP  
 Meas Time: 1 s  
 Subranges: 16  
 Acc Margin: 20dB

Transducer No. Start Stop Name  
 3 9k 30M EI078
