Report No.: 9901556

Mode = TX

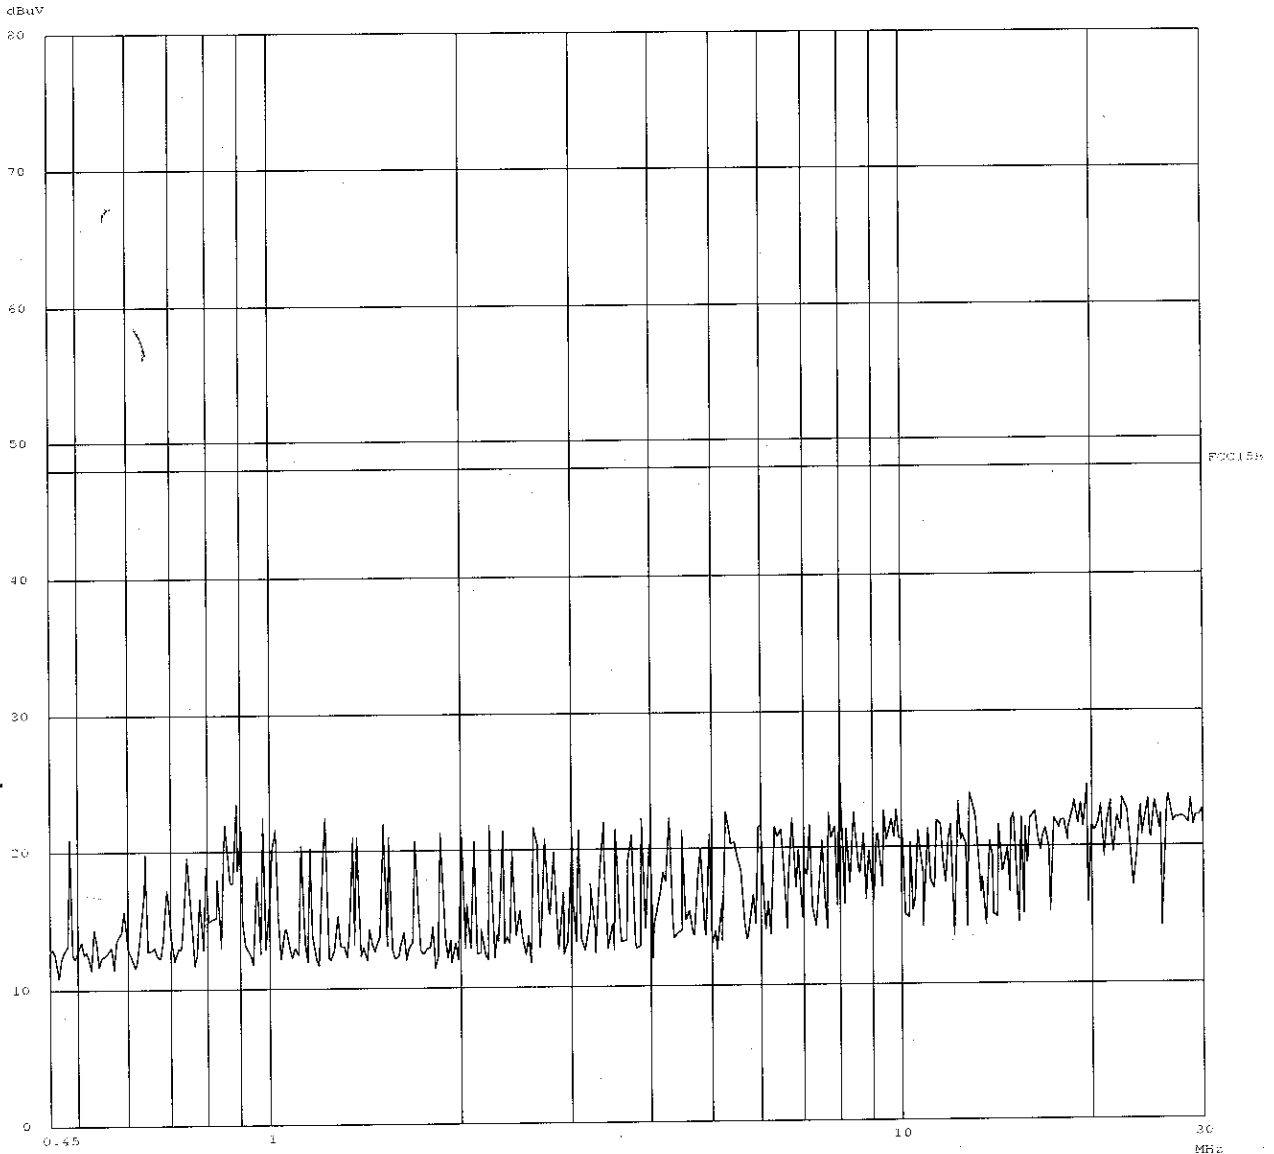
Scan Settings (2 Range)

Frequencies			Receiver Settings				
Start	Stop	Step	IF BW	Detector	M-Time	Atten	Preamplifier
450K	30M	5K	10K	PK	20ms	AUTO	LN OFF 60dB

Final Measurement: N OP	Transducer No.	Start	Stop	Name
	2	9K	30M	BI078
Meas Time: 1 s				
Subranges: 16				
Acc Margin: 20dB
