INTERTEK TESTING SERVICES

3.6 Line Conducted Configuration Photograph - Base Unit

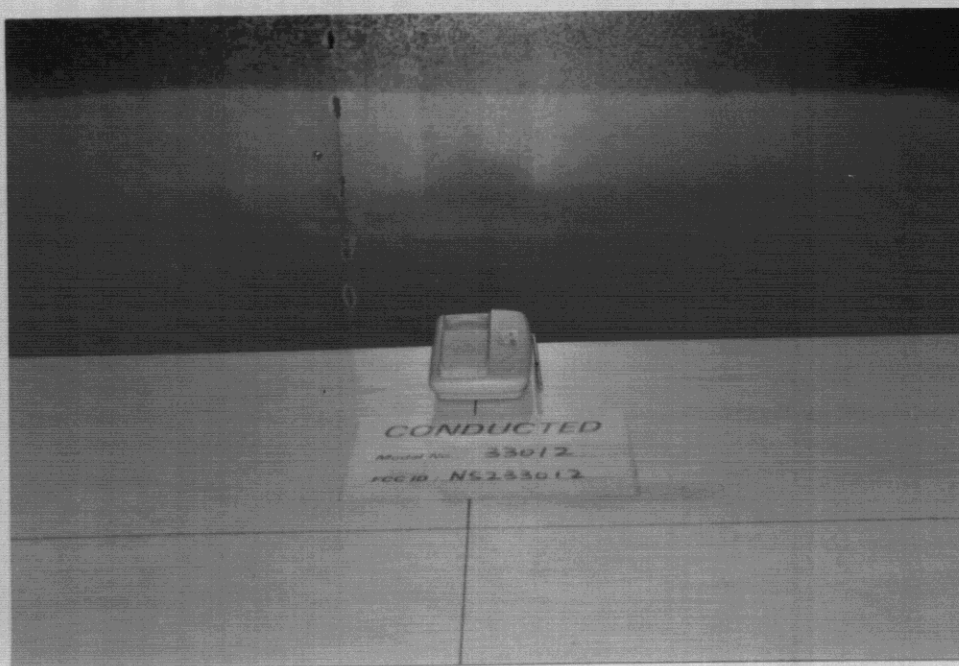
Worst Case Line-Conducted Configuration

Front View

at 29.735 MHz

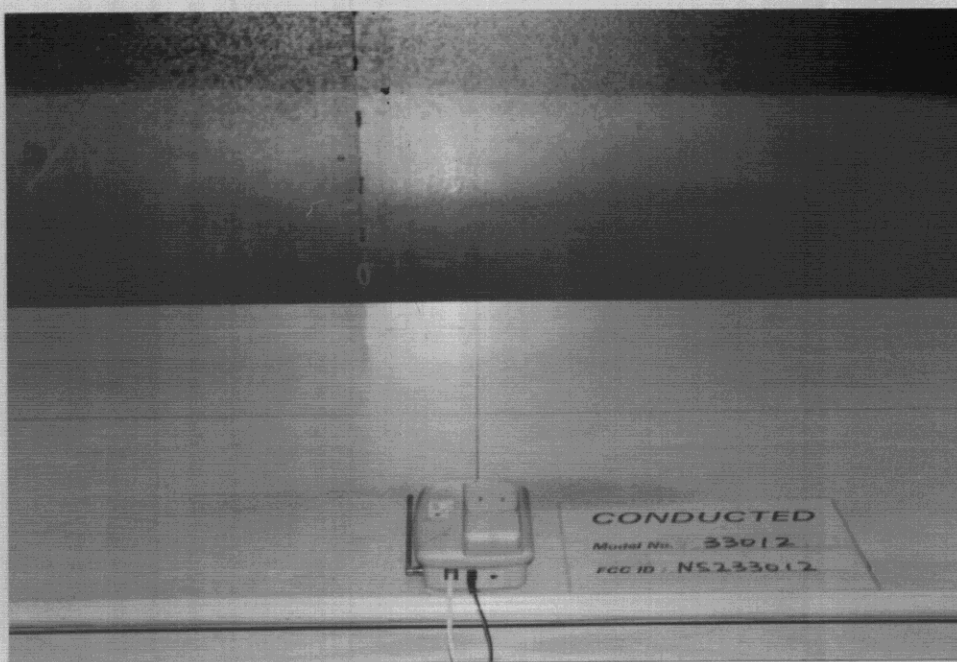
3.6 Line Conducted Configuration Photograph (cont.) - Base Unit

Worst Case Line-Conducted Configuration

Rear View

at 29.735 MHz

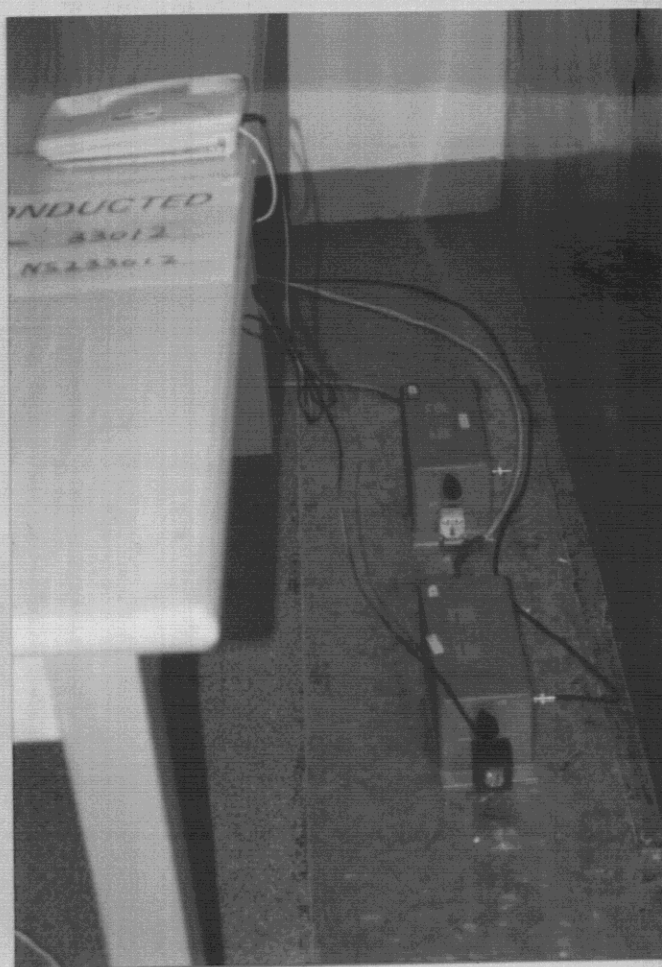
3.6 Line Conducted Configuration Photograph (cont.) - Base Unit

Worst Case Line-Conducted Configuration

Side View

at 29.735 MHz

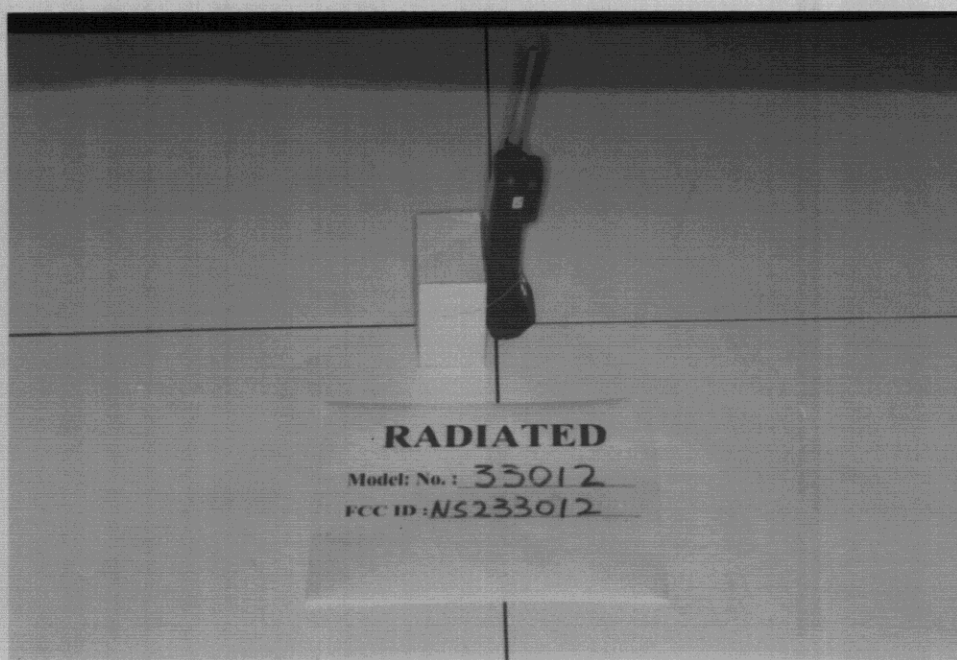
3.4 Radiated Emission Configuration Photograph - Handset

Worst Case Radiated Emission

Front View

at 49.991 MHz

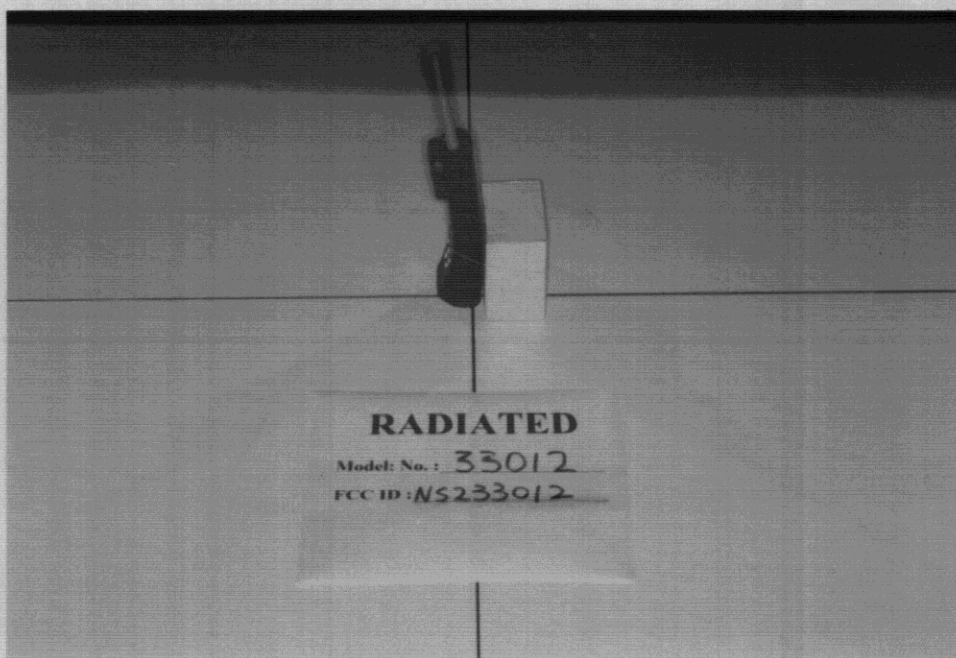
3.4 Radiated Emission Configuration Photograph (cont.) - Handset

Worst Case Radiated Emission

Rear View

at 49.991 MHz

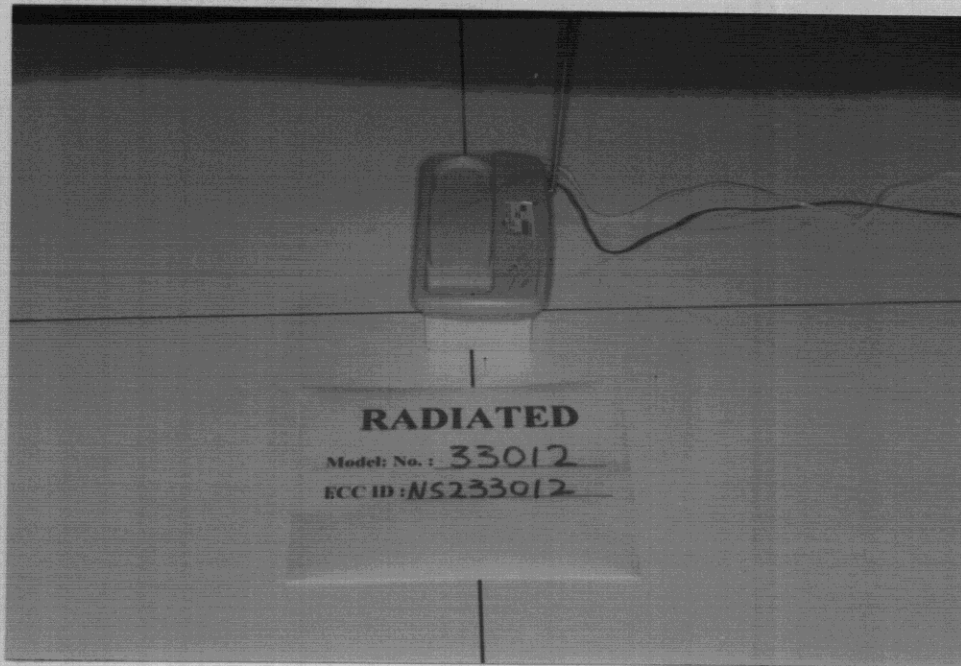
3.2 Radiated Emission Configuration Photograph - Base Unit

Worst Case Radiated Emission

Front View

at 46.971 MHz

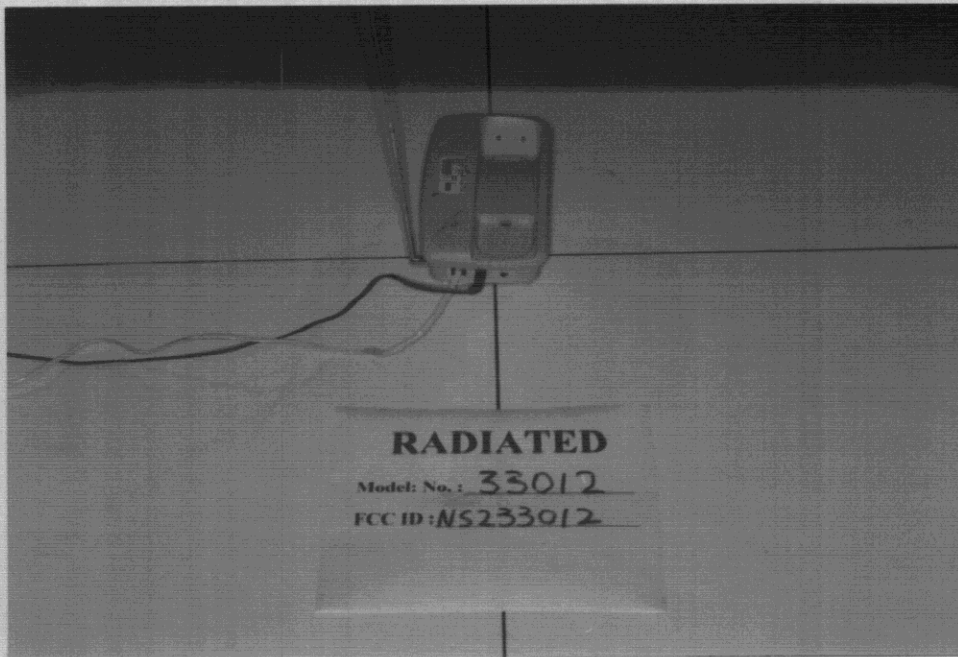
3.2 Radiated Emission Configuration Photograph (cont.) - Base Unit

Worst Case Radiated Emission

Rear View

at 46.971 MHz
