4.2.4 Radiated Test Configuration Photographs

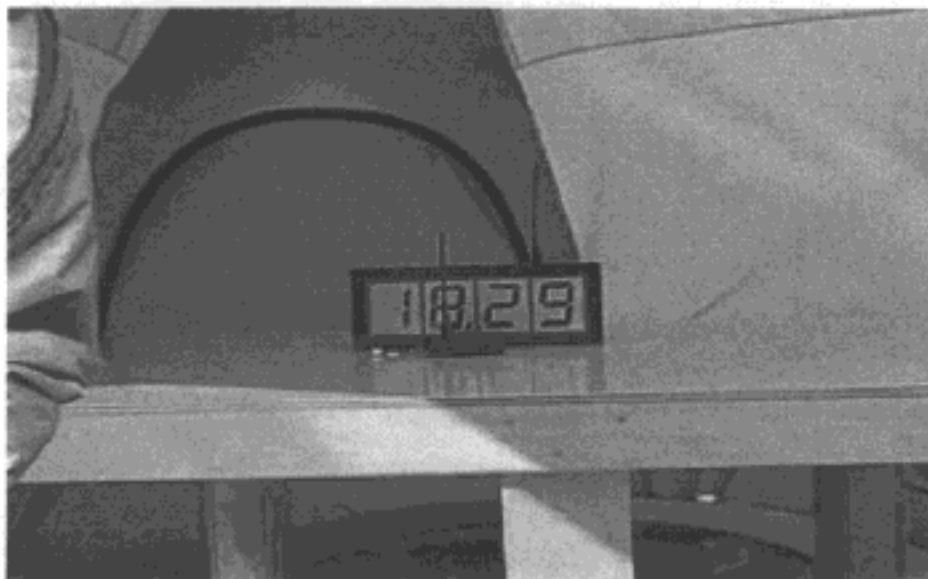
Figure 8 - Radiated Setup (Front View)
