FCC ID: 055705019

# 6. SAR System PHOTOGRAPHS

Report No.:LCS191223014AEB

## 7. SETUP PHOTOGRAPHS

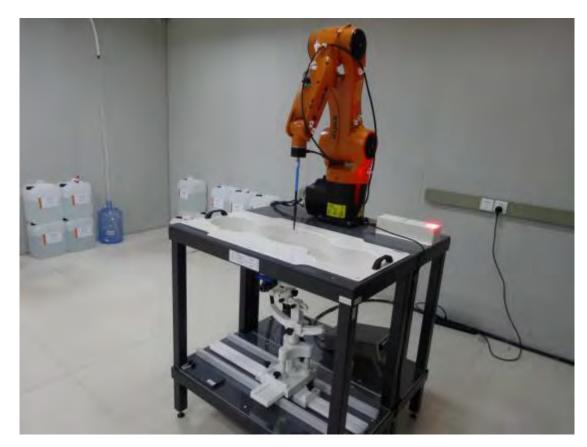
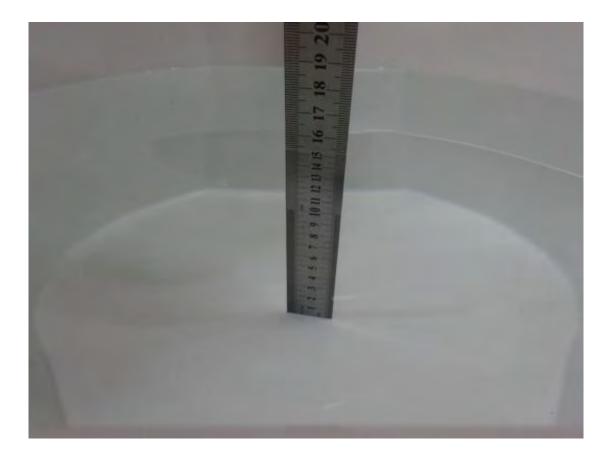
Liquid depth ≥15cm

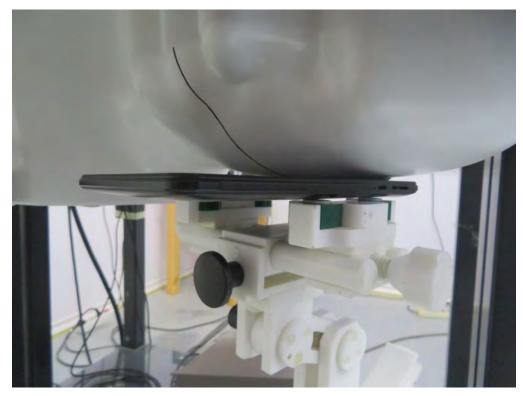
#### Head Setup Photo(Left Cheek)

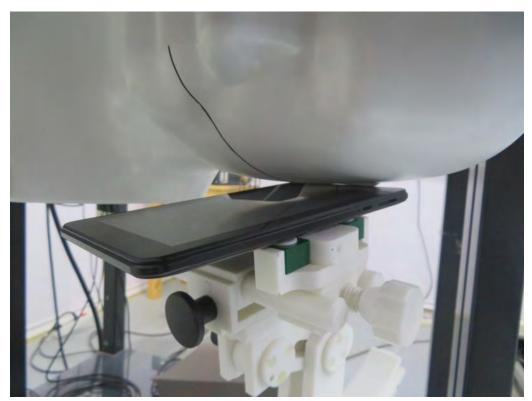
#### Head Setup Photo(Left Tilt)

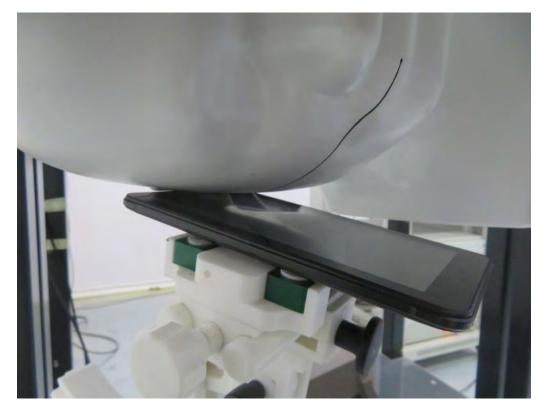
Head Setup Photo(Right Tilt)

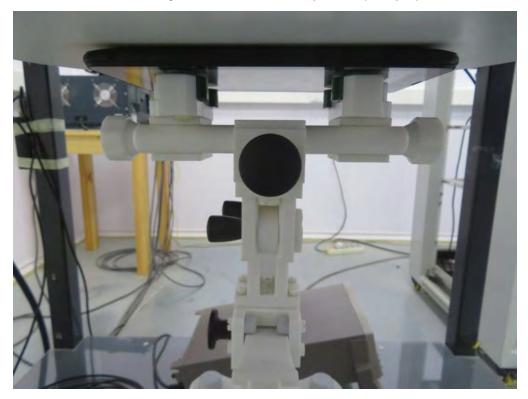
0mm body-worn Back Side Setup Photo(hotspot)

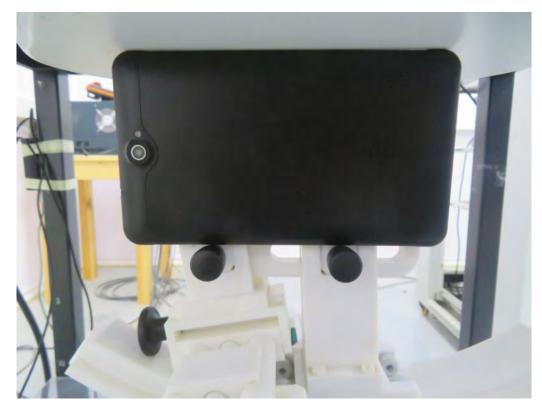
0mm body-worn Left Side Setup Photo(hotspot)

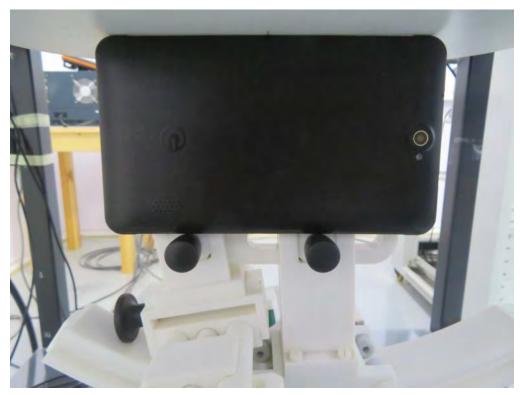
#### 0mm body-worn Right Side Setup Photo (hotspot)

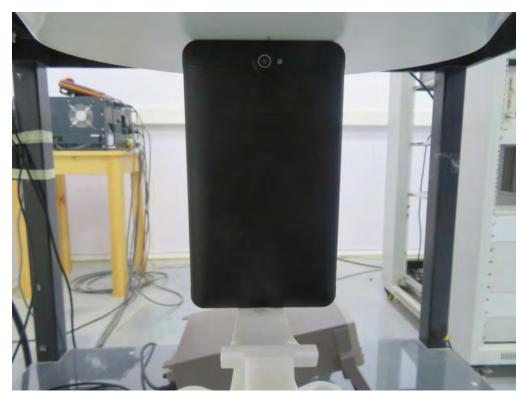
0mm body-worn Top Side Setup Photo (hotspot)

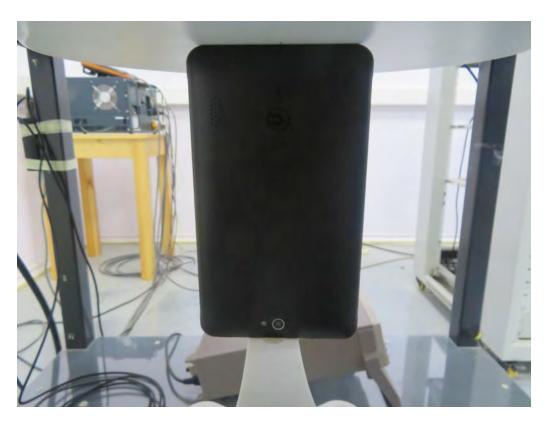
#### 0mm body-worn Bottom Side Setup Photo (hotspot)
