FCC SAR Test Report

<Photographs of EUT>

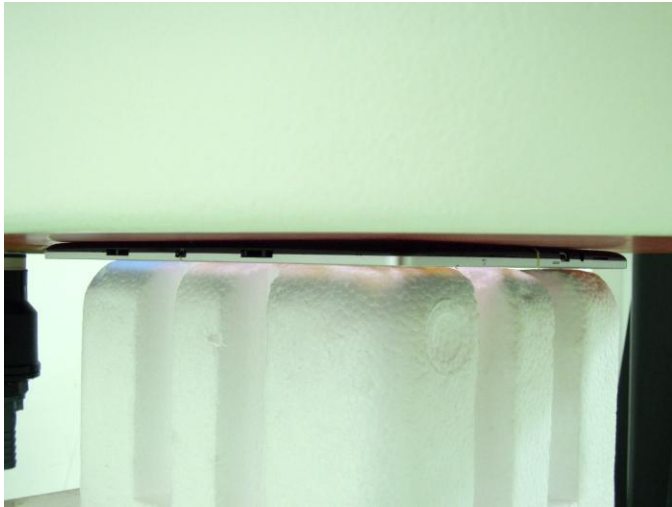
Rear Face of EUT with 0 cm Gap

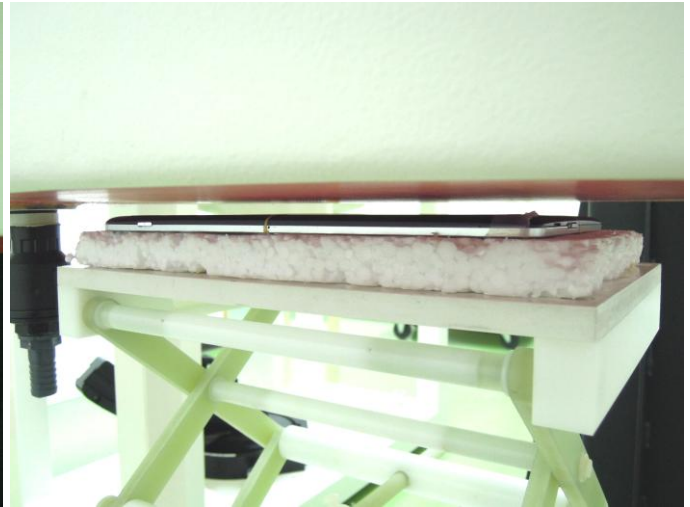
Rear Face of EUT with 0.7 cm Gap

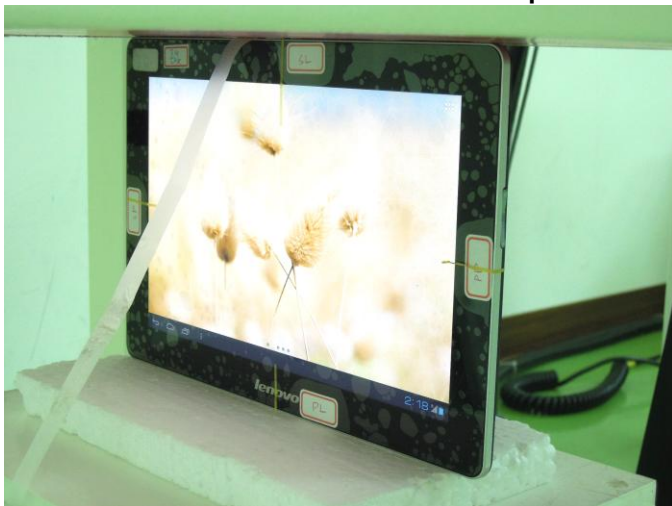
Secondary Landscape with 0 cm Gap

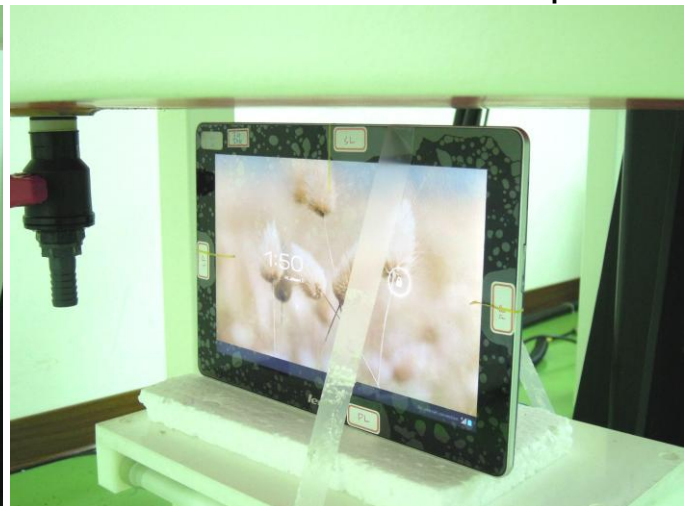
Secondary Landscape with 0.7 cm Gap

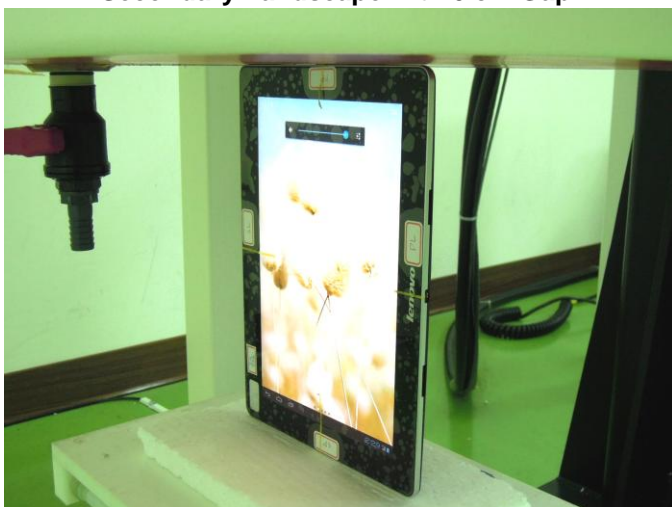
Primary Portrait with 0 cm Gap

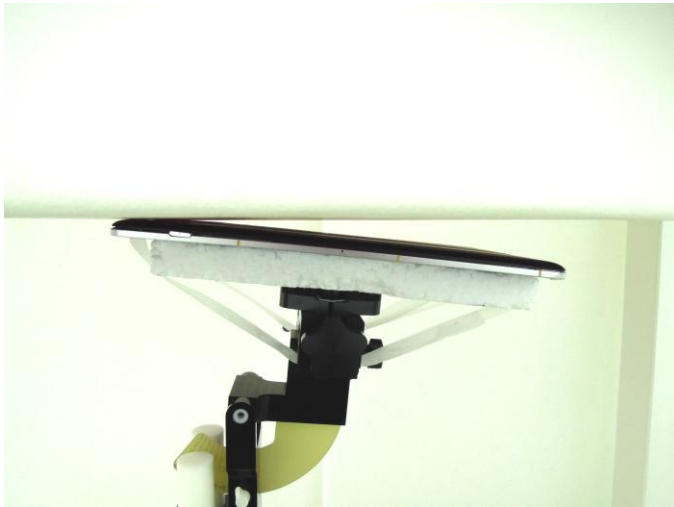
**Rear Face with 0 cm Gap
(Top Edge/Left Rear Corner at 5 degree)**
