Appendix B: photographs of test setup

Reference to the test report no. BLA-EMC-202404-A4901

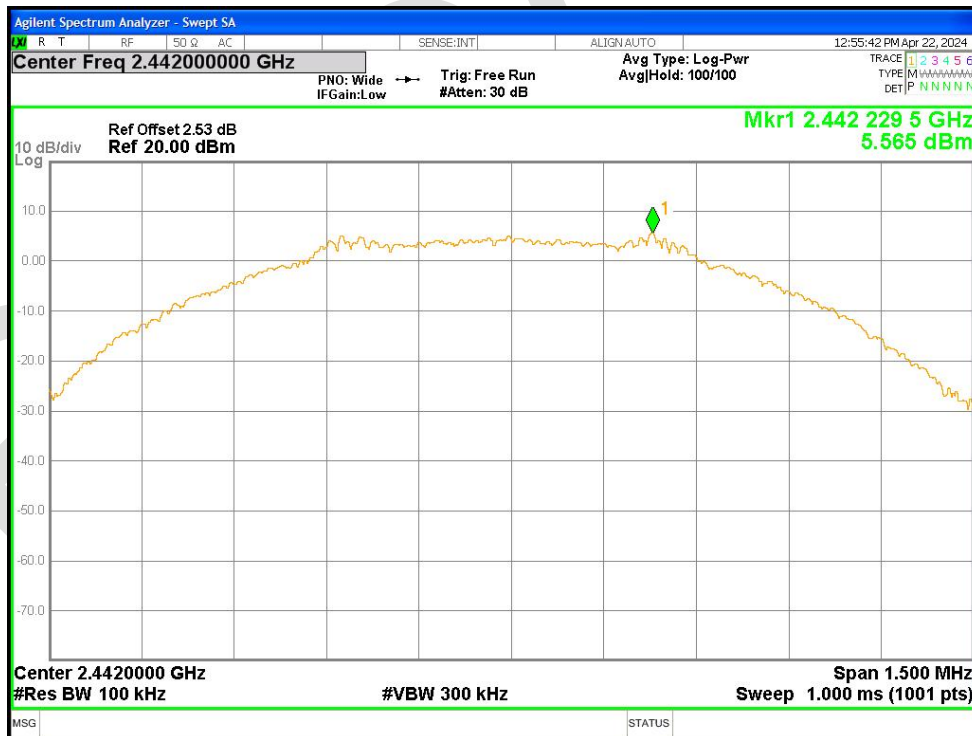
Tx. Spurious NVNT BLE 1M 2442MHz Ant1 Emission

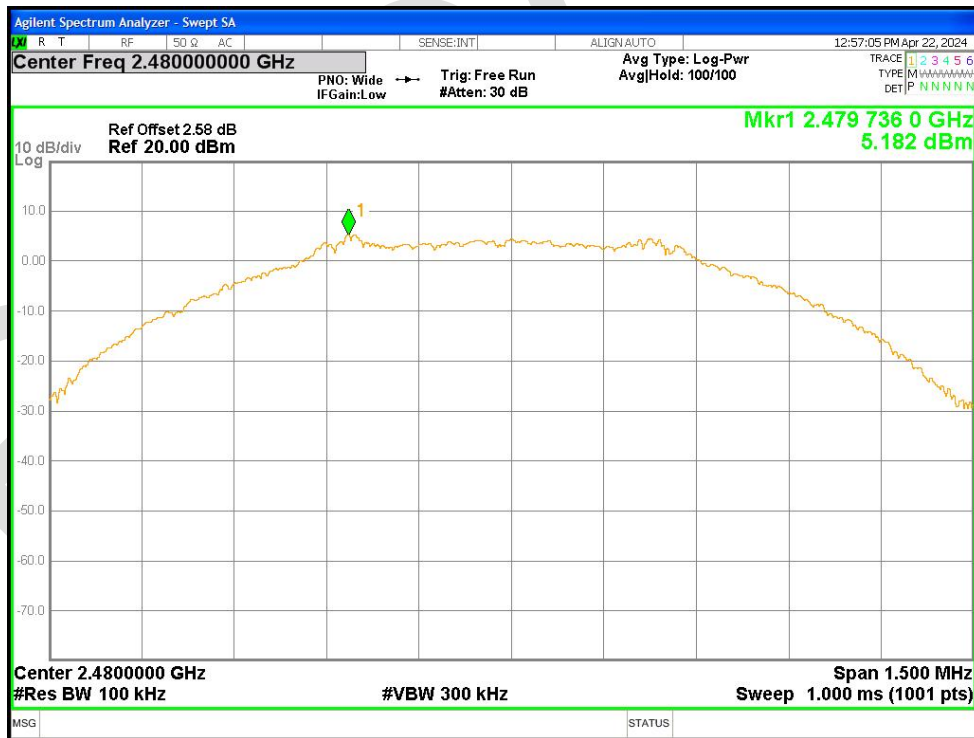
Tx. Spurious NVNT BLE 1M 2480MHz Ant1 Emission

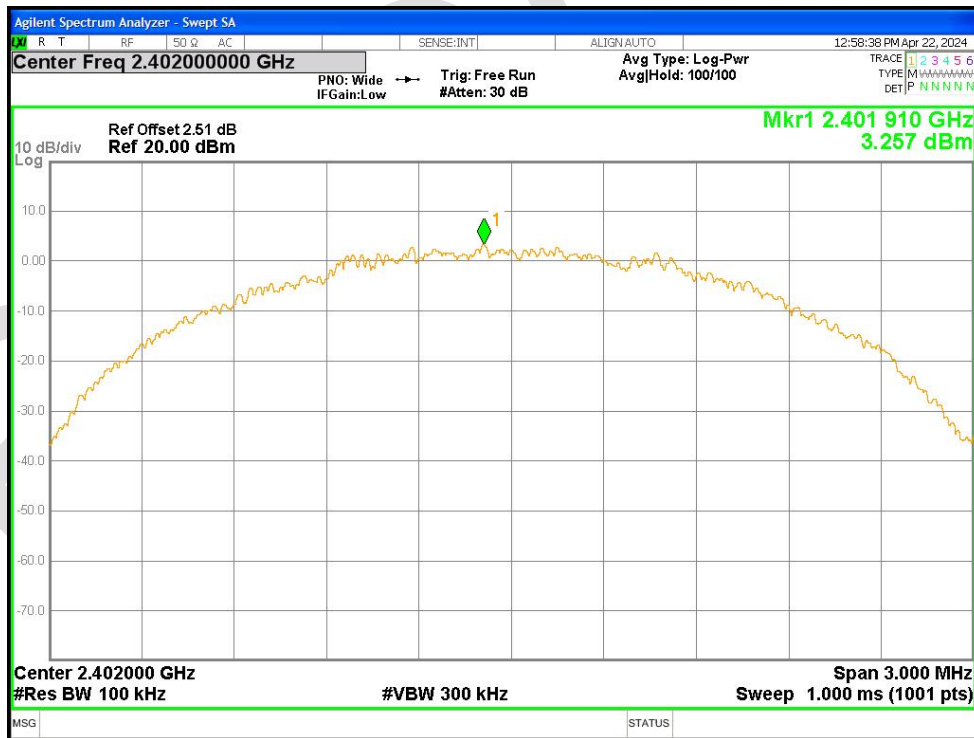
Tx. Spurious NVNT BLE 2M 2402MHz Ant1 Emission

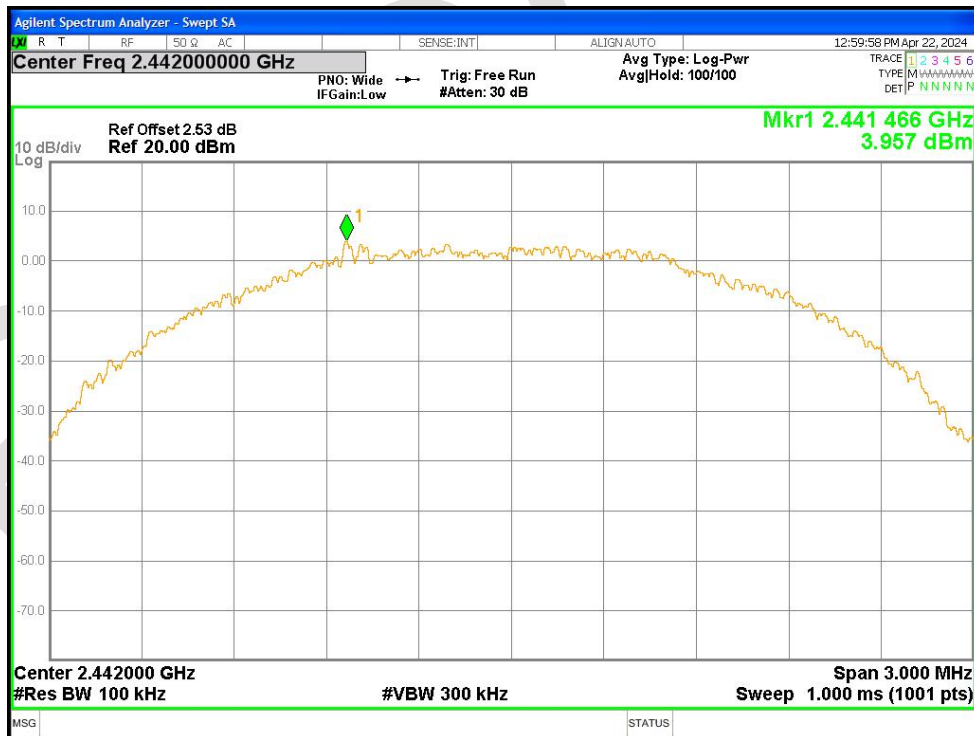
Tx. Spurious NVNT BLE 2M 2442MHz Ant1 Emission

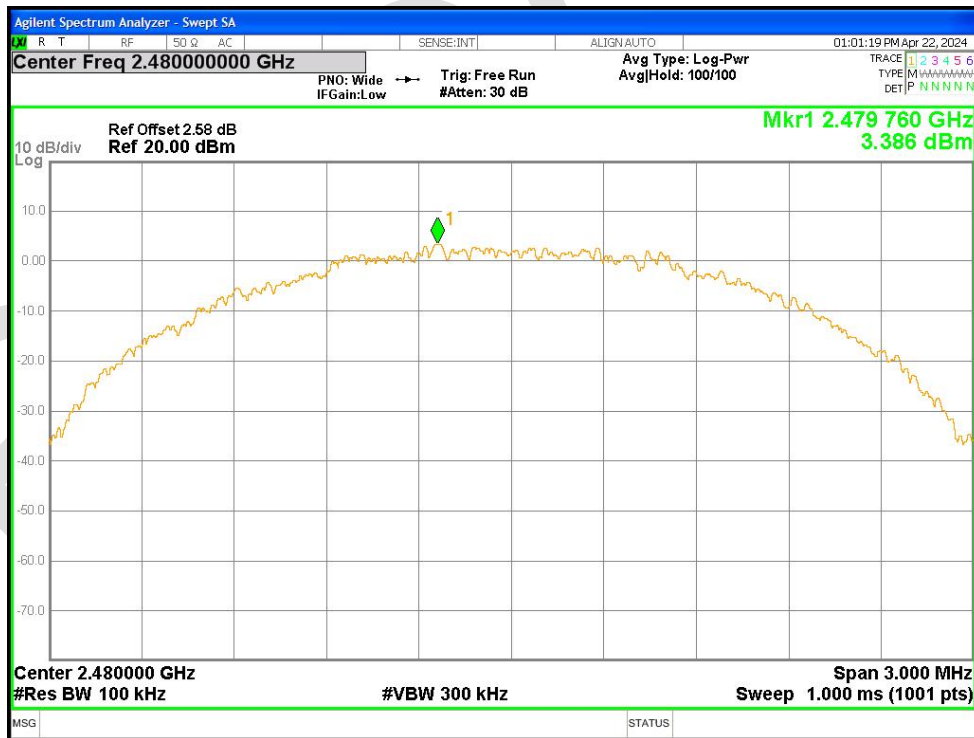
Tx. Spurious NVNT BLE 2M 2480MHz Ant1 Emission

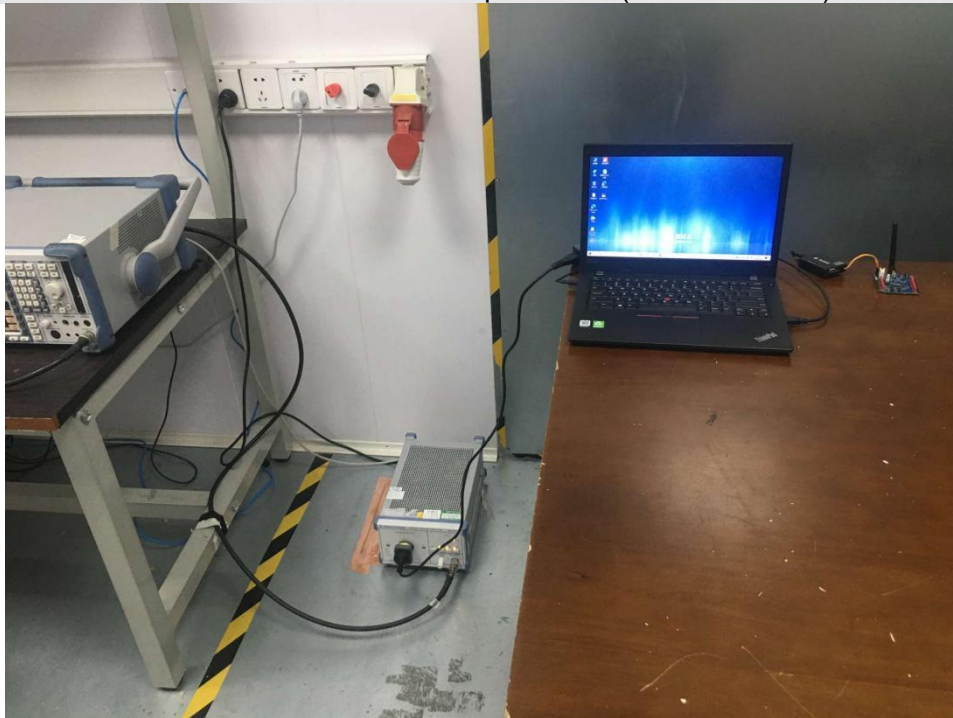
Conducted emissions at AC power line (150kHz-30MHz)

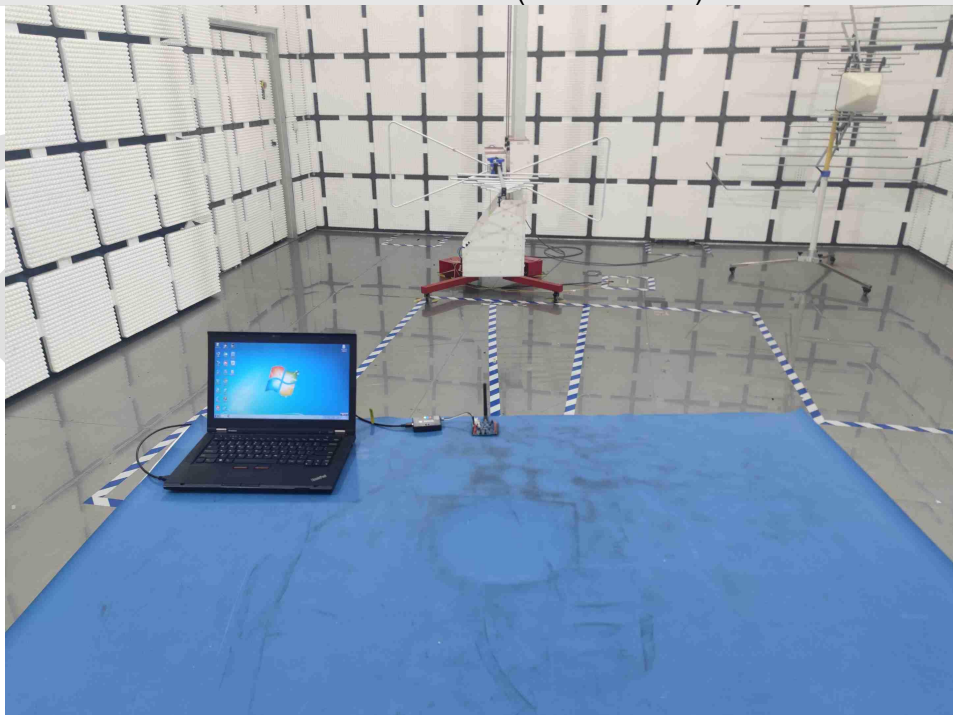
Radiated Emissions (30MHz-1GHz)

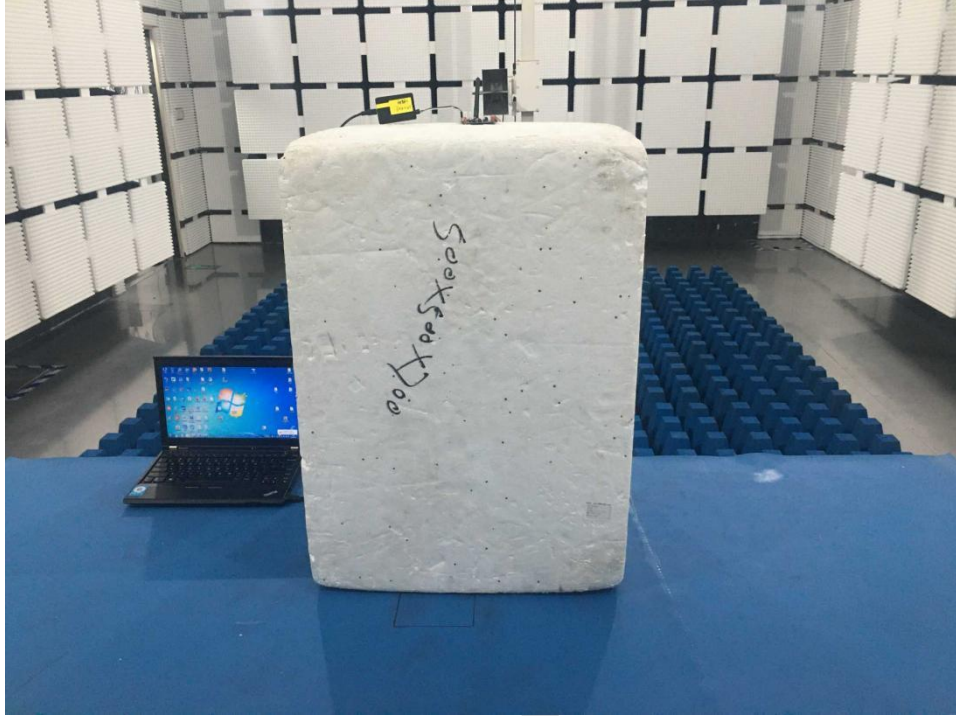
Radiated Emissions (above 1GHz)
