## PRC7332 Liberty Photos, Internal

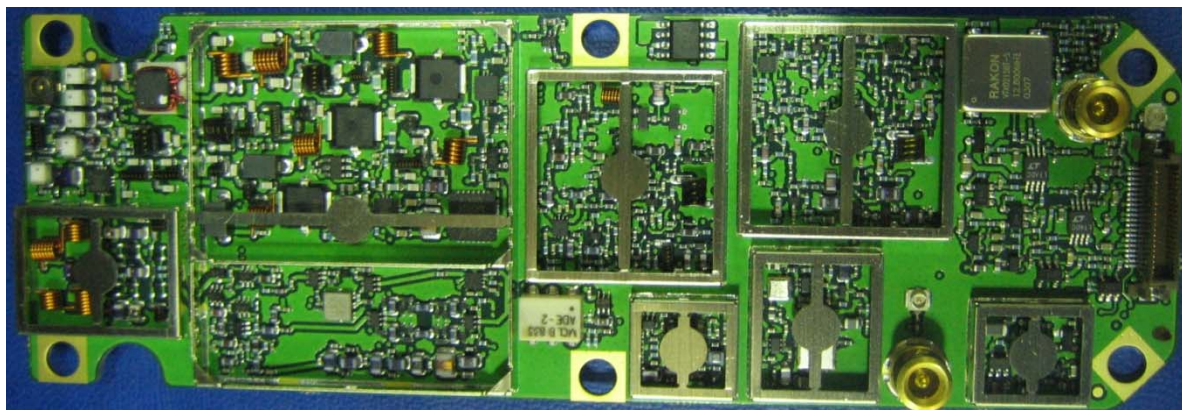
Figure 1 – 4102056-501, XCVR PWB Top (Without Shield Lids)

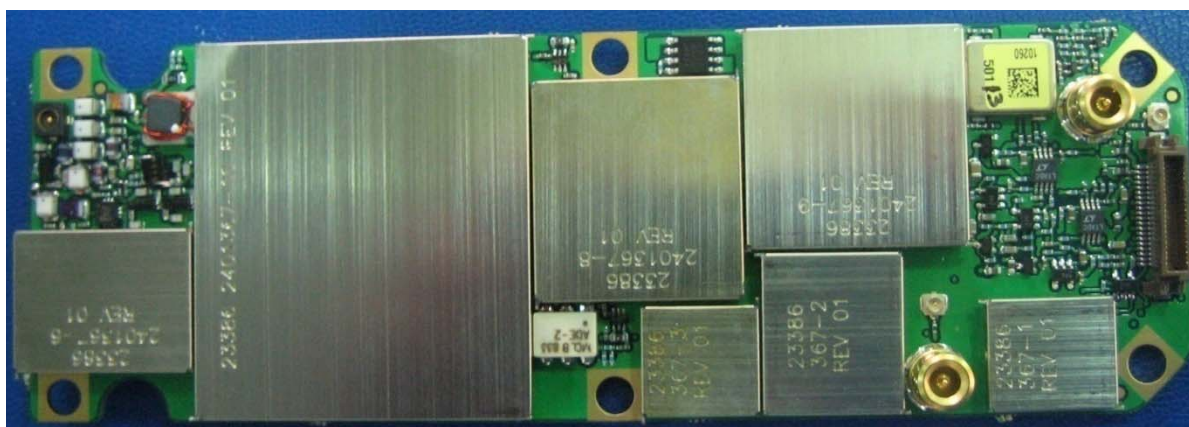
Figure 2 – 4102056-501, XCVR PWB Top (With Shield Lids)

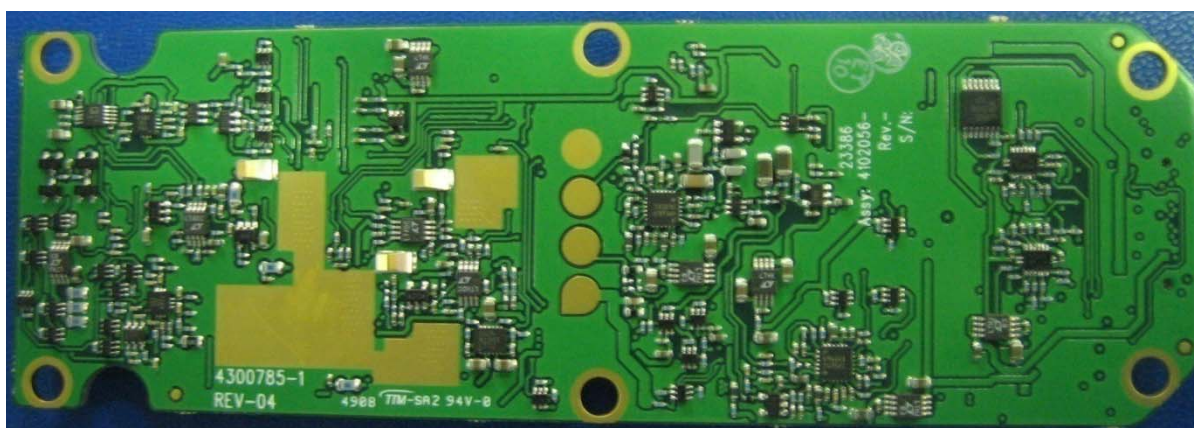
Figure 3 – 4102056-501, XCVR PWB Bottom

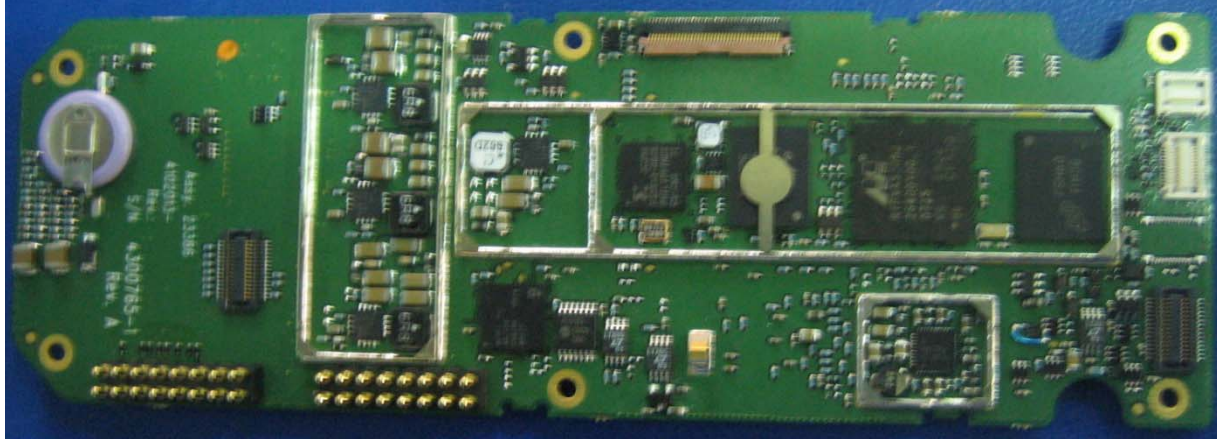
Figure 4 – 4102013-501, Control PWB Top (Without Shield Lids)

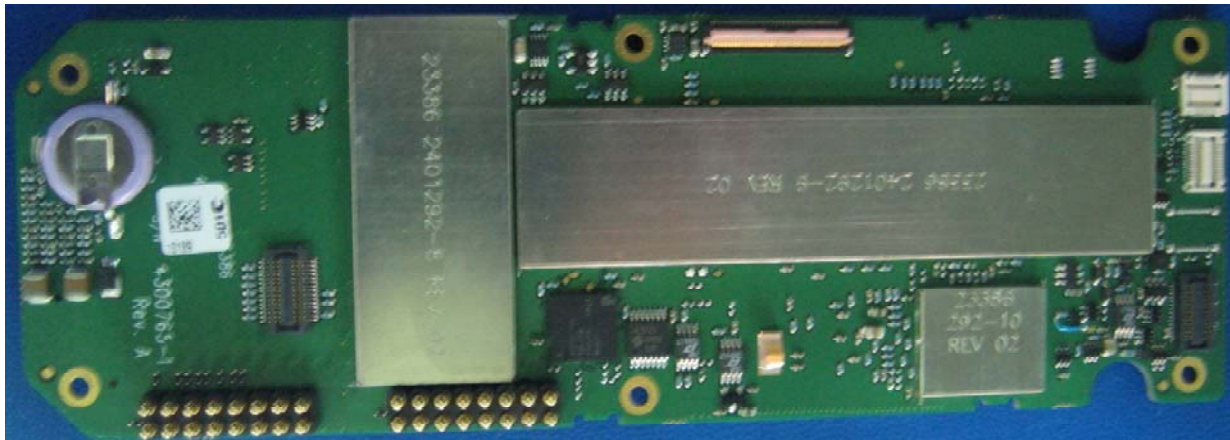
Figure 5 – 4102013-501, Control PWB Top (With Shield Lids)

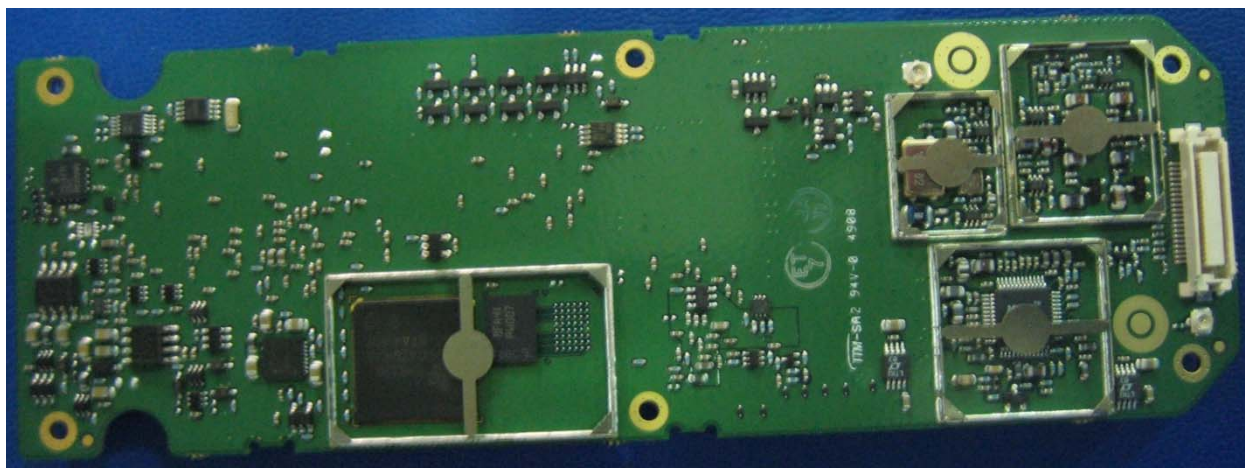
Figure 6 – 4102013-501, Control PWB Bottom (Without Shield Lids)

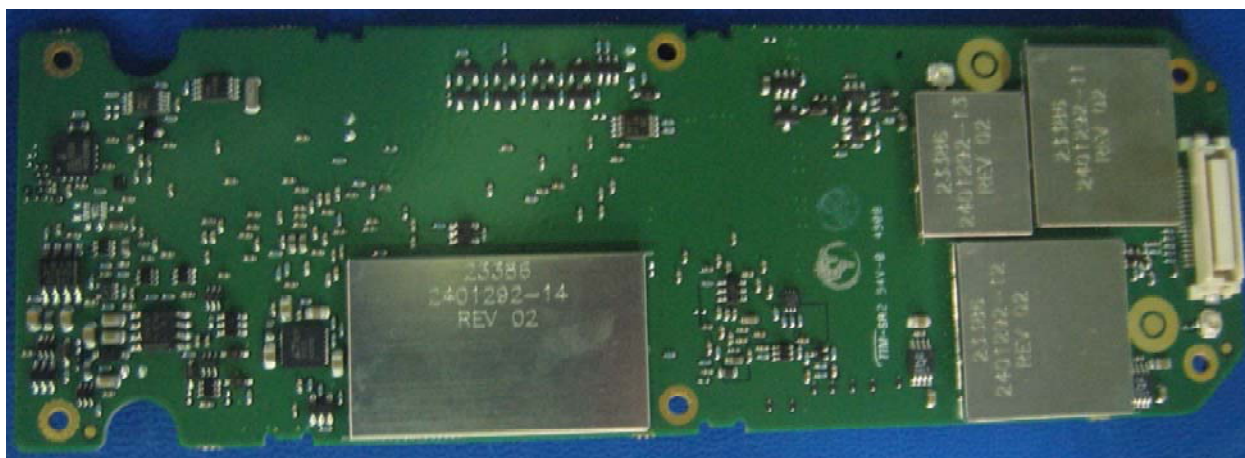
Figure 7 – 4102013-501, Control PWB Bottom (With Shield Lids)

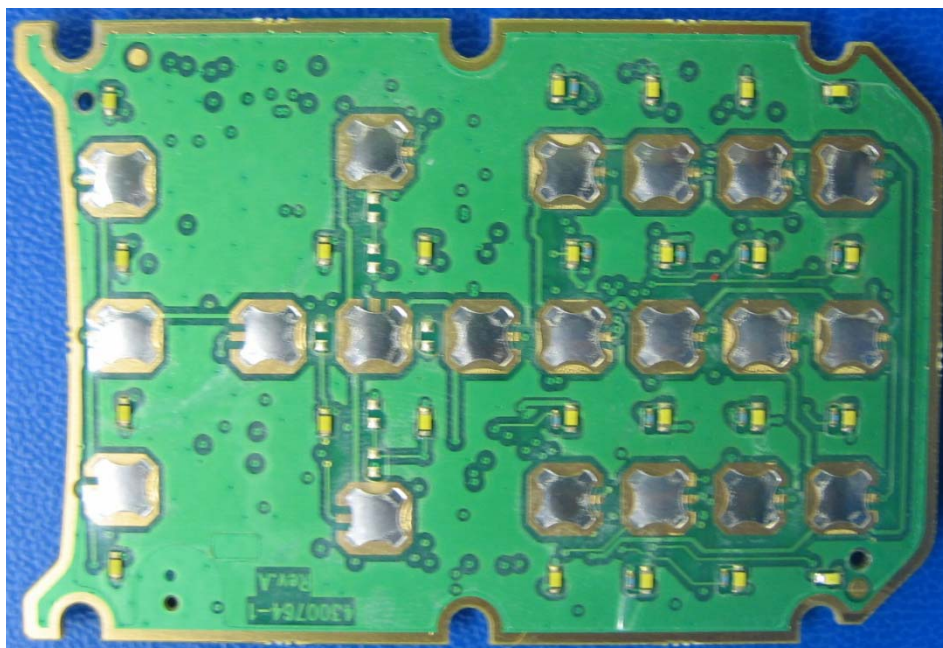
Figure 8 – 4102010-501, Keypad PWB Top

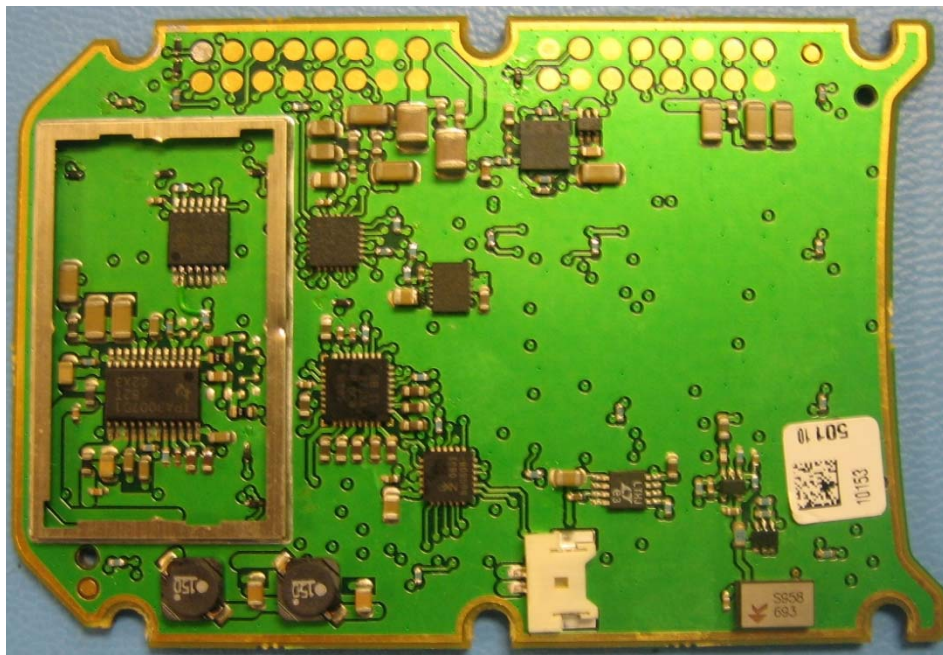
Figure 9 – 4102010-501, Keypad PWB Bottom (Without Shield Lids)

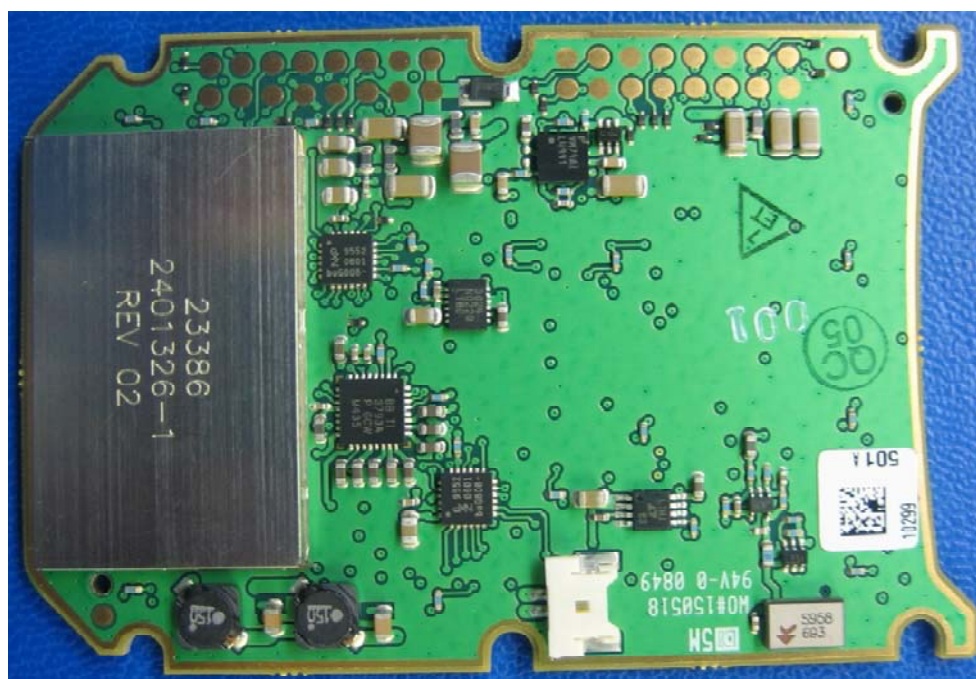
Figure 10 – 4102010-501, Keypad PWB Bottom (With Shield Lids)

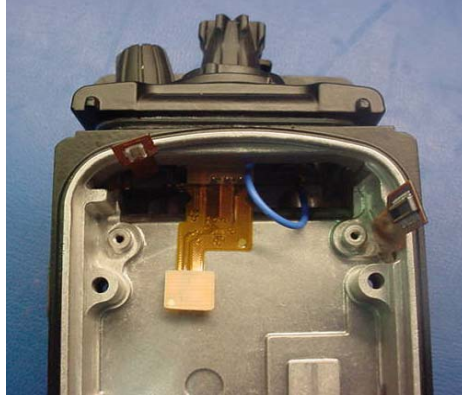
Figure 11 – View of Chassis Top Plate assembly with the radio chassis.

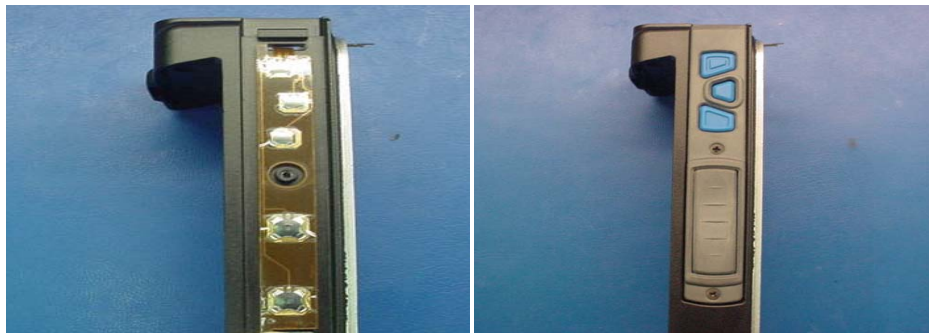
Figure 12 – View of Side PTT Flex Assembly onto Radio Chassis.

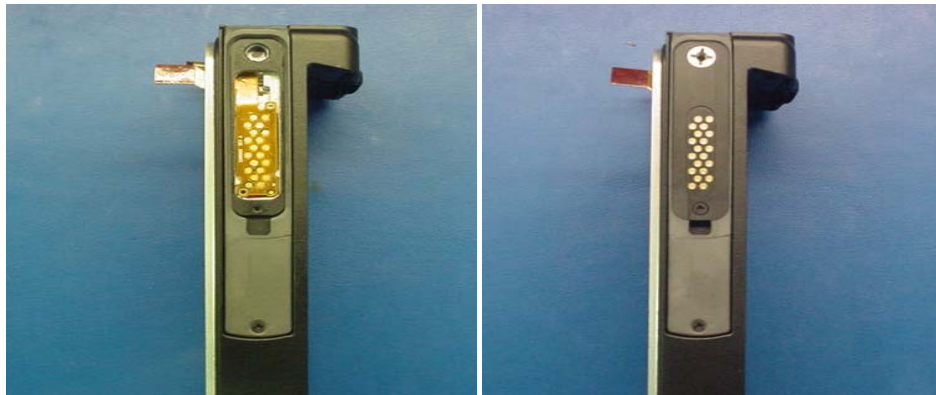
Figure 13 – View of Side Accessory Flex Assembly onto Radio Chassis.

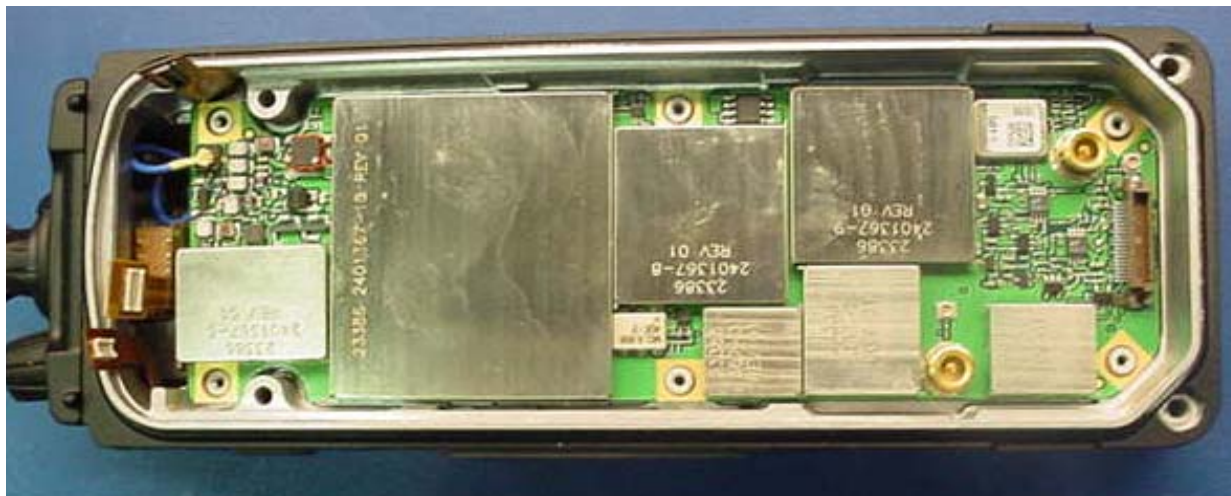
Figure 14 – View of XCVR PWB (4102056-501) installation into radio chassis.

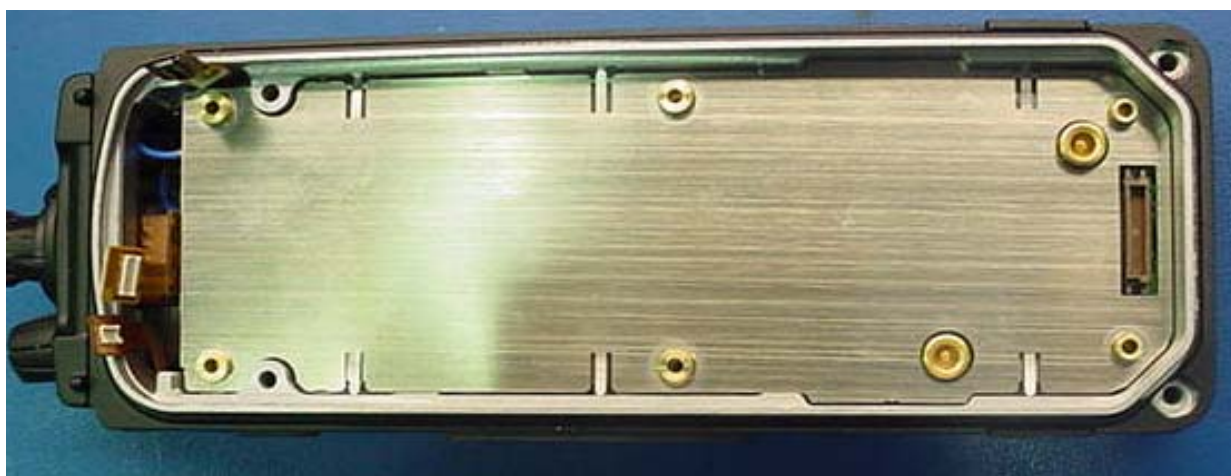
Figure 15 – View of inner shield installation over the XCVR PWB (4102056-501) assembly.

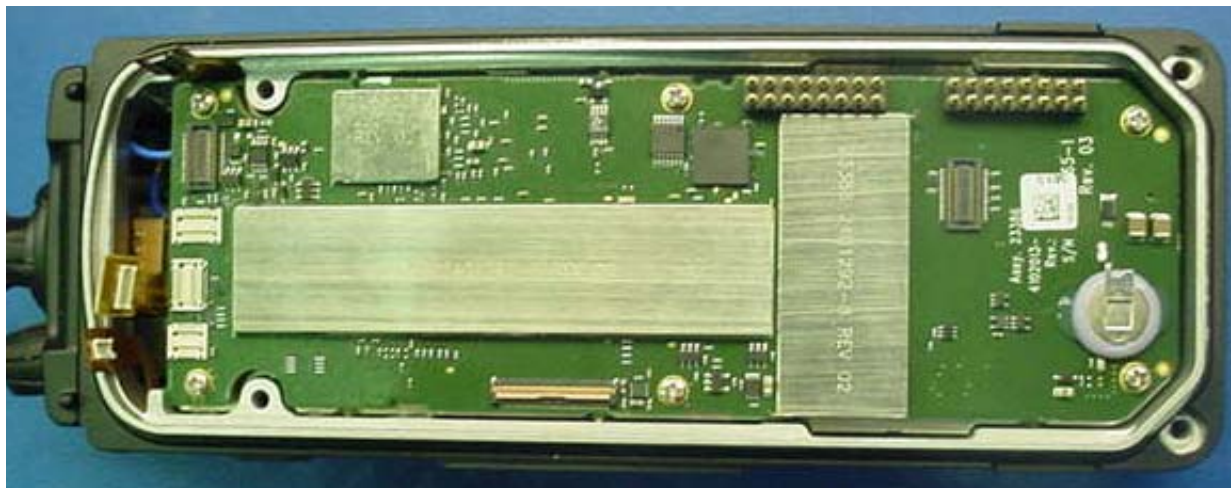
Figure 16 – View of Control PWB (4102013-501) installed over the XCVR PWB (4102056-501) and inner shield assemblies.

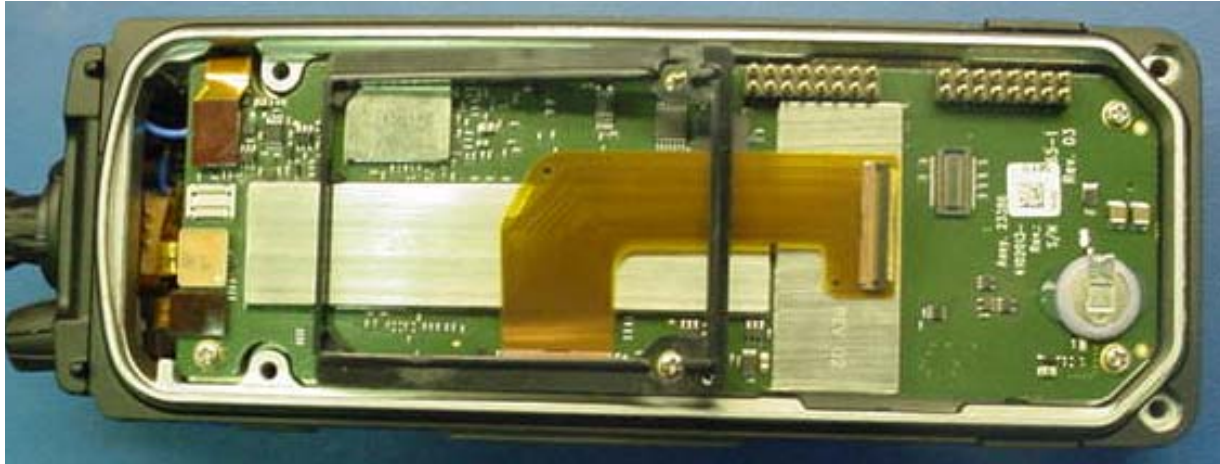
Figure 17 – View of LCD Bracket and Flex Circuit onto the Control PWB (4102013-501)

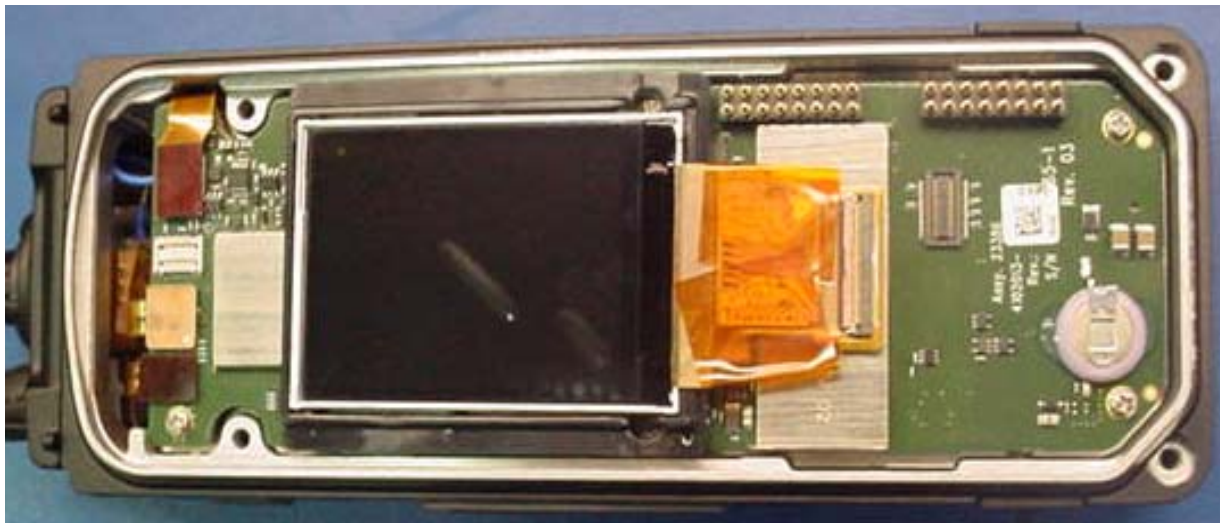
Figure 18 – View of LCD Assembly onto the Control PWB (4102013-501) and connection to LCD Flex Circuit.

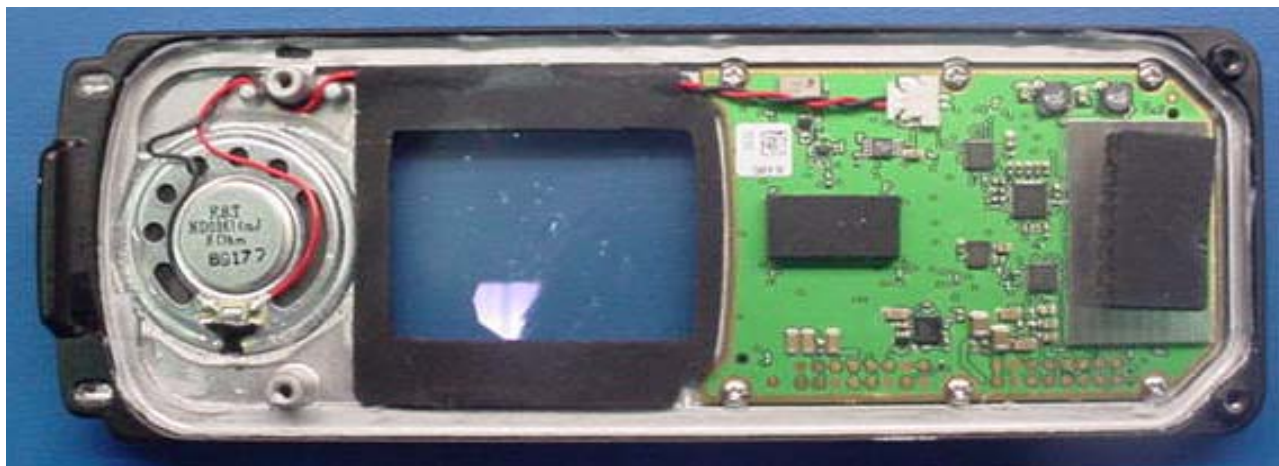
Figure 19 – View of Keypad PWB (4102010-501) onto the Radio Front Cover assembly.

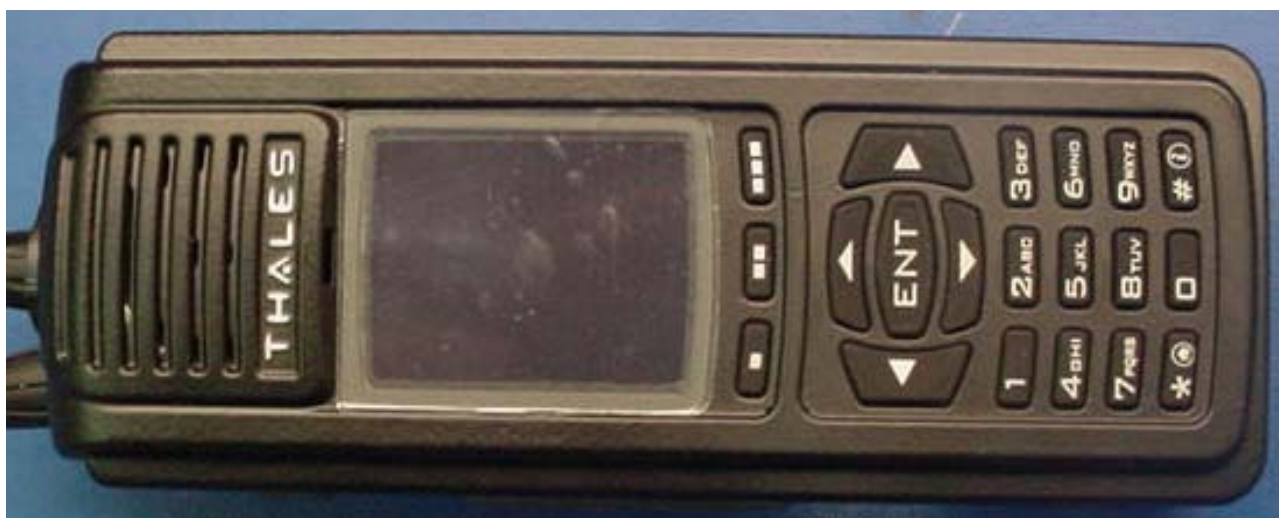
Figure 20 – View of Front Cover Assembly onto the Radio Chassis.

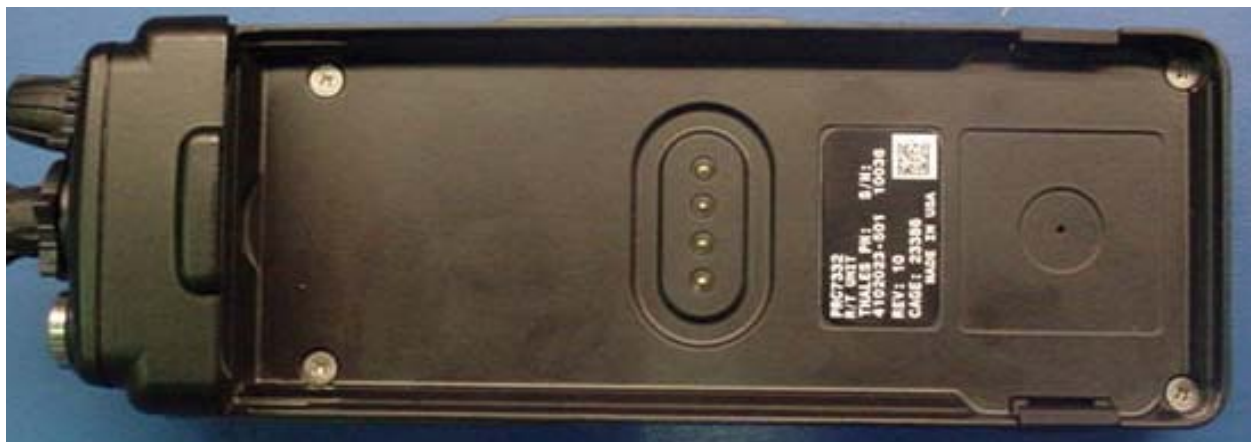
Figure 21 – View of 4 mounting screws to secure the front cover assembly onto the radio chassis assembly.

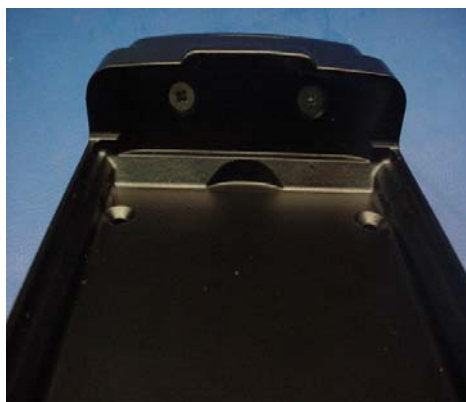
Figure 22 – View of 2 mounting screws to secure the Top Plate assembly onto the radio chassis
