APPENDIX 3: Photographs of test setup

Radiated Spurious Emission

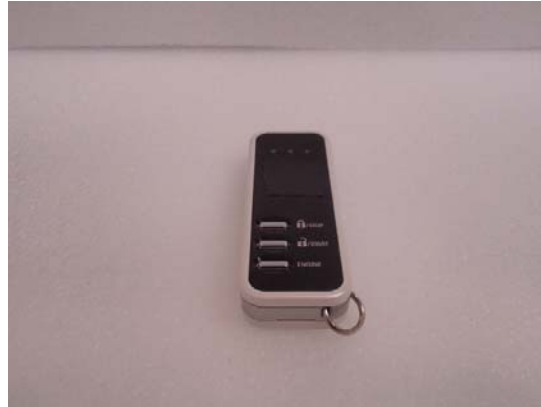
X-axis

Worst Case Position

Below 1GHz (Horizontal: X-axis/ Vertical:Y-axis)

Above 1GHz (Horizontal: X-axis/ Vertical:Z-axis)
