APPENDIX 3: Photographs of test setup

Radiated Emission

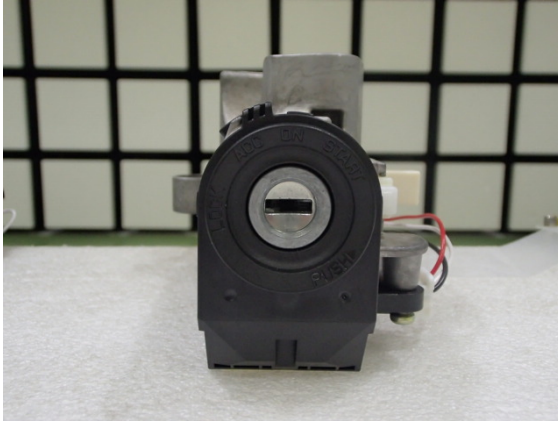
Immobilizer

Below 30MHz: X
Above 30MHz: Horizontal X, Vertical X
X-axis

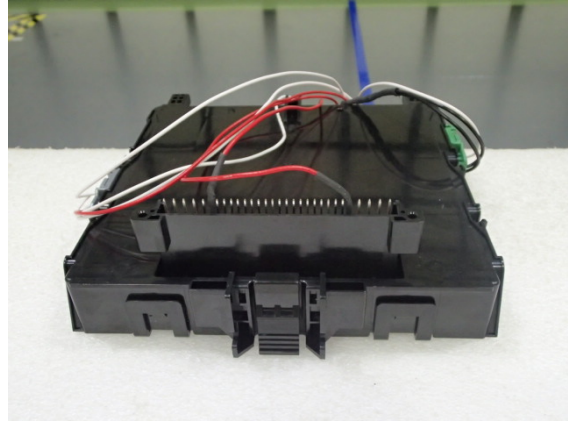
ECU

Below 30MHz: X
Above 30MHz: Horizontal X, Vertical X
X-axis

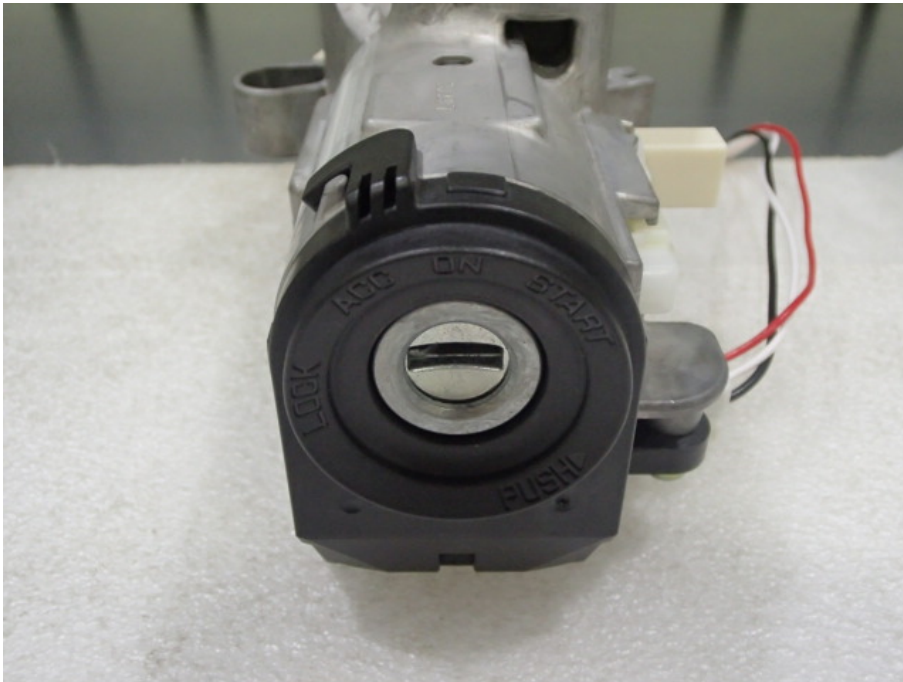
Worst case position

Mechanical Key (Not Inserted) Worst

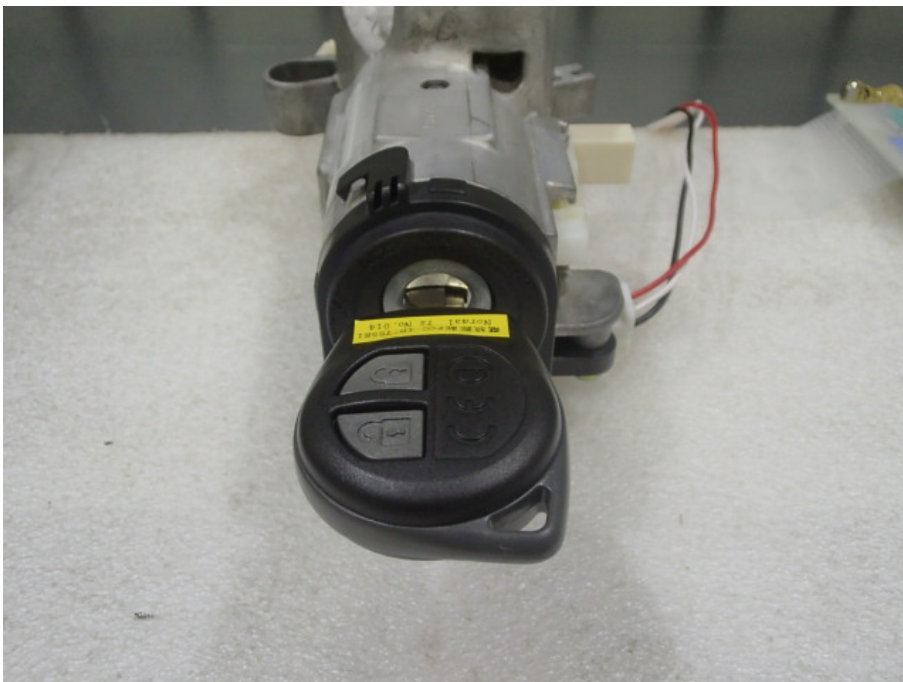
Mechanical Key (Inserted)
