Setup photos for HAC RF Emissions and T-Coil Test Report

HAC_Photo_RM-877_03 3.0 TCC Nokia Salo Laboratory

ANSI C63.19-2007

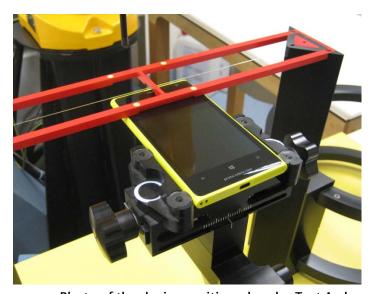
The device was positioned such that Device Reference plane was touching the bottom of the Test Arch. The scan is centered at the acoustic output by aligning the acoustic output with the intersection of the Test Arch's middle bar and dielectric wire.

Photo of the device positioned under Test Arch
