## Setup photos for HAC RF Emissions and T-Coil Test Report

| Test report no.: | HAC_Photo_RM-975_03 | Date of report: | 2014-05-05 |
| Tested devices: | RM-975 | | |
| Testing has been carried out in accordance with: | <b>ANSI C63.19-2011</b><br>American National Standard for Methods of Measurement of Compatibility between Wireless Communications Devices and Hearing Aids | | |

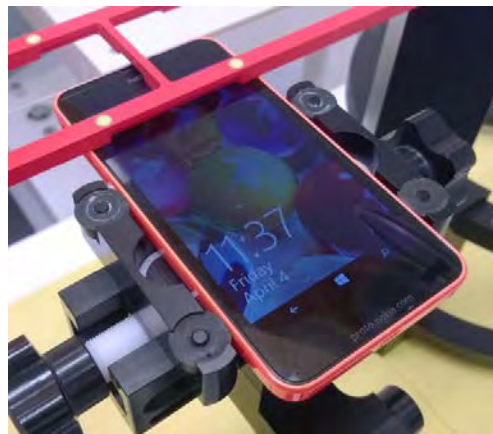
The device was positioned such that Device Reference plane was touching the bottom of the Test Arch. The scan is centered at the acoustic output by aligning the acoustic output with the intersection of the Test Arch's middle bar and dielectric wire.

Photo of the device positioned under Test Arch
