Appendix C – SAR Test Setup Photos

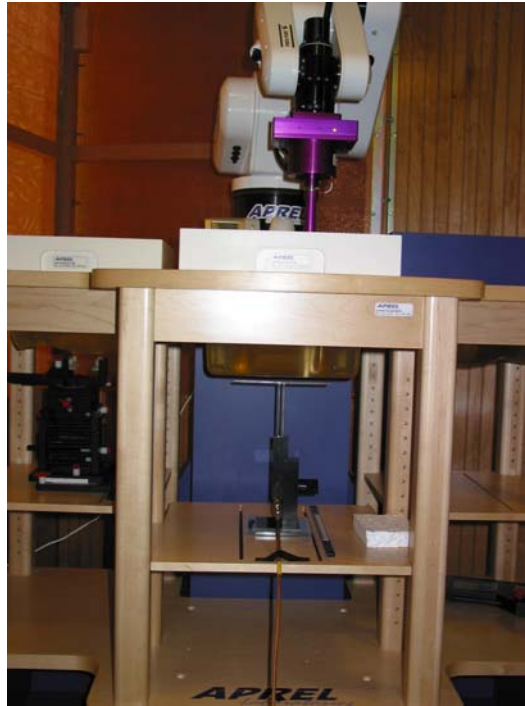
System Body Configuration

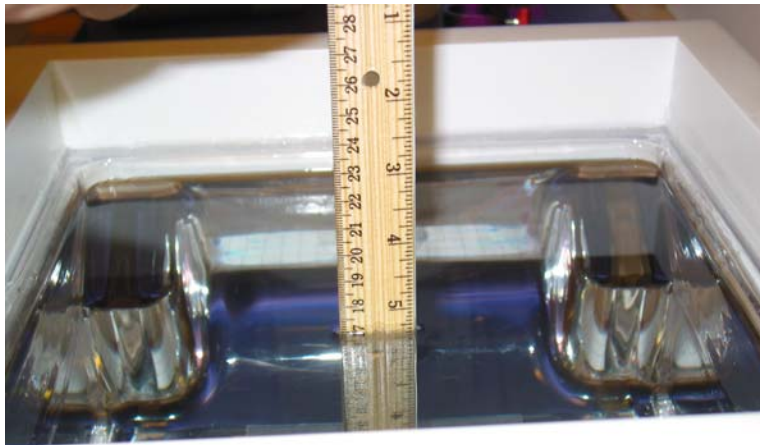
Body Tissue Depth

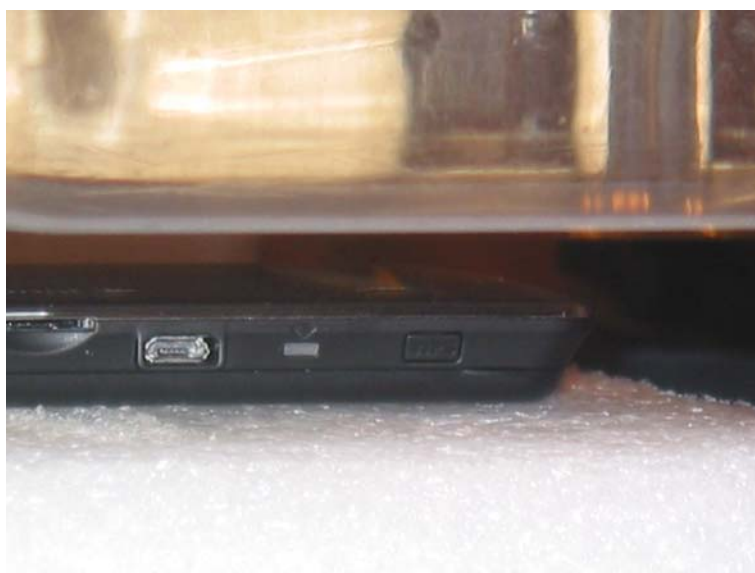
Top Test Position 12 mm Gap

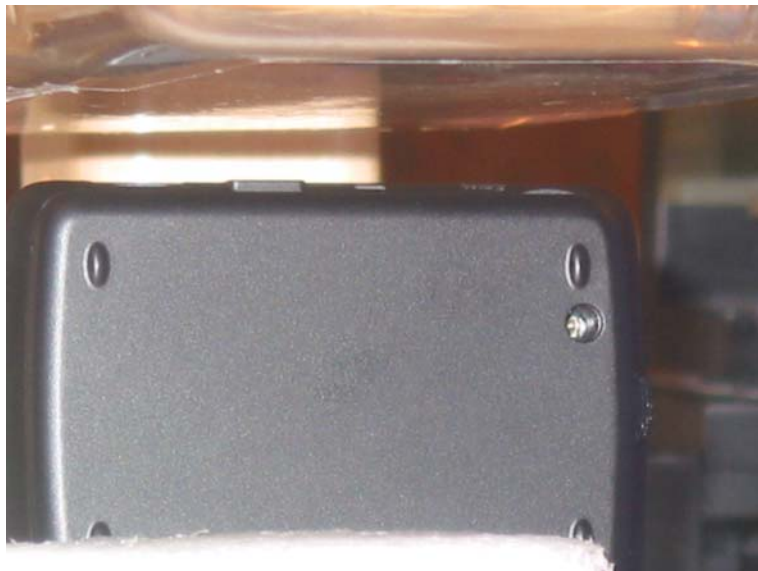
Right Test Position 12 mm Gap

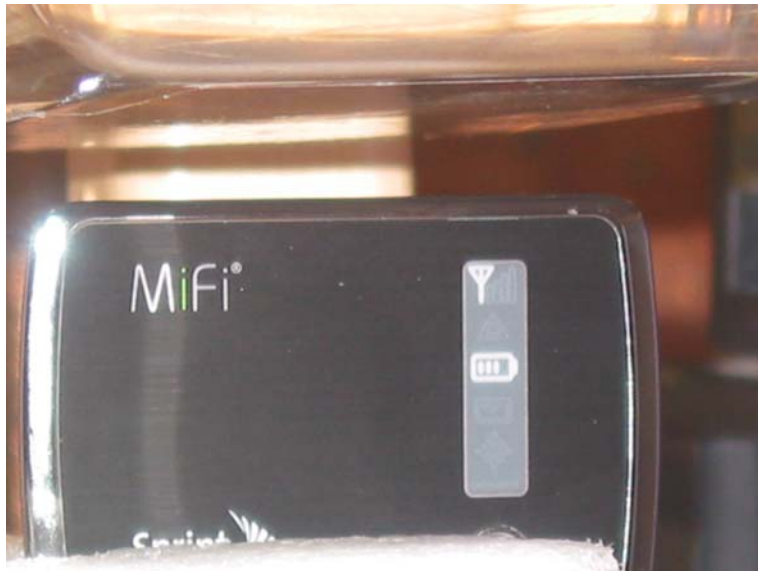
Left Test Position 12 mm Gap

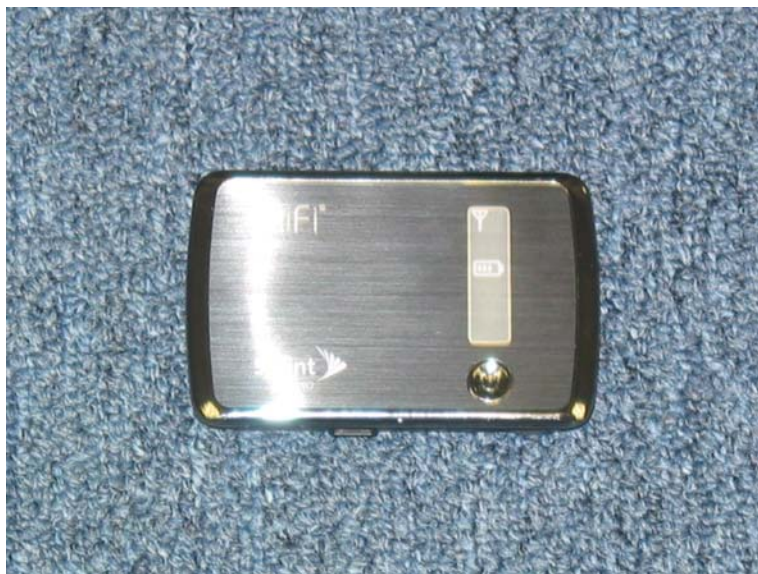
Front of Device

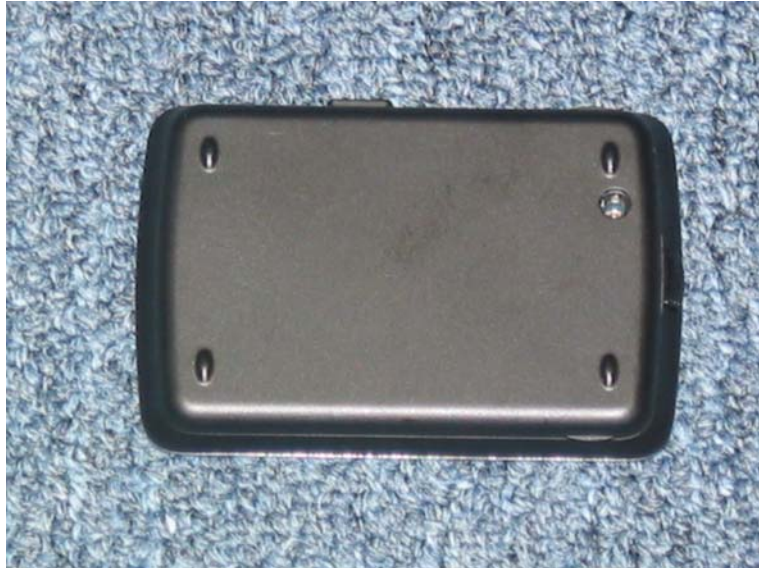
Back of Device

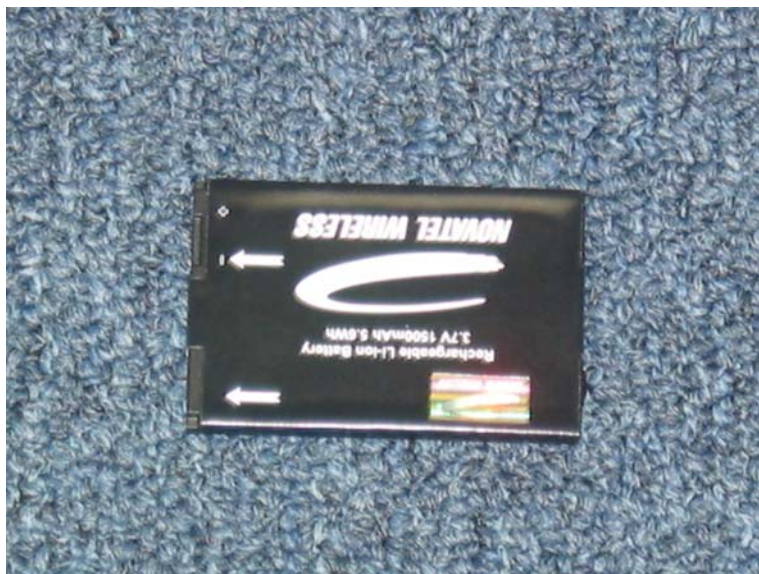
Front Battery
