L155 Wireless Hearing Device – Internal Photos

10/27/2017

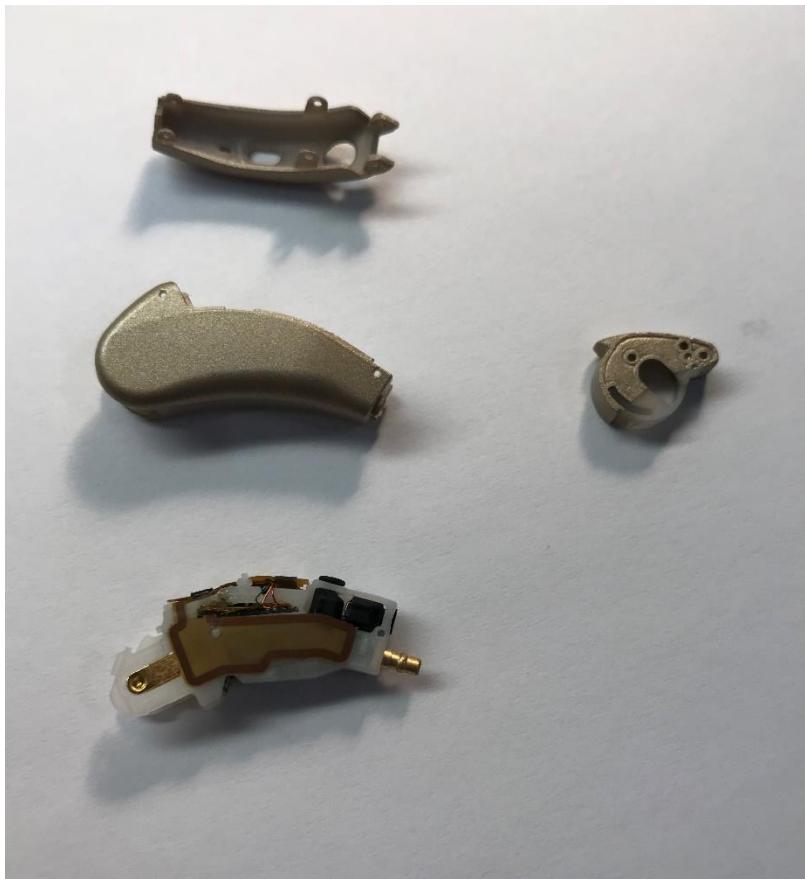
Figure 1: Shell disassembly
