## Setup photos for HAC RF Emissions and T-Coil Test Report

<b>Test report no.:</b>	HAC_Photo_RM509_02	<b>Date of report:</b>	2010-02-10
<b>Template version:</b>	3.0	<b>Number of pages:</b>	3
<b>Testing laboratory:</b>	TCC Nokia Salo Laboratory P.O.Box 86 Joensuunkatu 7H / Kiila 1B FIN-24101 SALO, FINLAND Tel. +358 (0) 7180 08000 Fax. +358 (0) 7180 45220	<b>Client:</b>	Nokia Corporation Lise Meitner Strasse 10 89081 ULM GERMANY Tel. +49 731 1754 0 Fax. +49 731 1754 6800
<b>Responsible test engineer:</b>	Heikki Kuusela	<b>Product contact person:</b>	Ralph Schwarz
<b>Measurements made by:</b>	Janne Hirsimäki		
<b>Tested devices:</b>	RM-509		
<b>FCC ID:</b>	PPIRM-509H	<b>IC:</b>	661U-RM509
<b>Supplement reports:</b>	RF_RM-509_01, T-Coil_RM-509_03		
<b>Testing has been carried out in accordance with:</b>	<p><b>ANSI C63.19-2007</b> American National Standard for Methods of Measurement of Compatibility between Wireless Communications Devices and Hearing Aids</p>

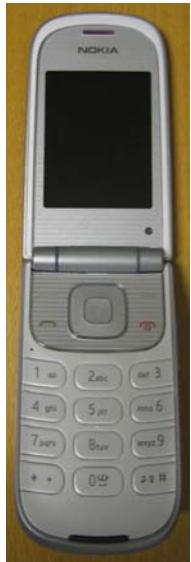
## 1.1 Picture of Device

Flip open

Flip closed

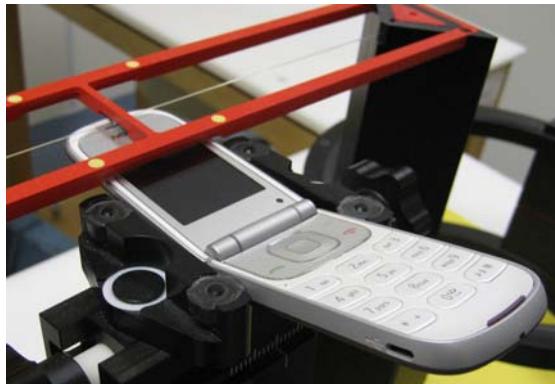
The device was positioned such that Device Reference plane was touching the bottom of the Test Arch. The scan is centered at the acoustic output by aligning the acoustic output with the intersection of the Test Arch's middle bar and dielectric wire.

Photo of the device positioned under Test Arch
