## Setup photos for HAC RF Emissions and T-Coil Test Report

Test report no.:	HAC_Photo_RM-511_03	Date of report:	2009-08-11
Template version:	1.1	Number of pages:	3
Testing laboratory:	TCC Nokia Salo Laboratory P.O.Box 86 Joensuunkatu 7H / Kiila 1B FIN-24101 SALO, FINLAND Tel. +358 (0) 7180 08000 Fax. +358 (0) 7180 45220	Client:	Nokia Corporation Lise Meitner Strasse 10 89081 ULM GERMANY Tel. +49 731 1754 0 Fax. +49 731 1754 6800
Responsible test engineer:	Heikki Kuusela	Product contact person:	Ralph Schwarz
Measurements made by:	Heikki Kuusela		
Tested devices:	RM-511 (Hearing aid mode active)		
FCC ID:	PPIRM-511	IC:	661U-RM511
Supplement reports:	RF_RM-511_01, T-Coil_RM-511_02		
Testing has been carried out in accordance with:	<b>ANSI C63.19-2007</b> American National Standard for Methods of Measurement of Compatibility between Wireless Communications Devices and Hearing Aids		
Documentation:	The documentation of the testing performed on the tested devices is archived for 15 years at TCC Nokia.

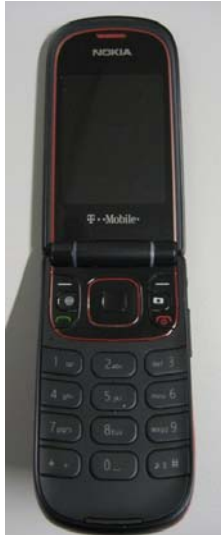
Flip open

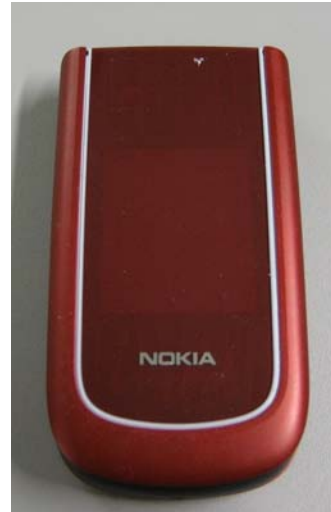
Flip closed

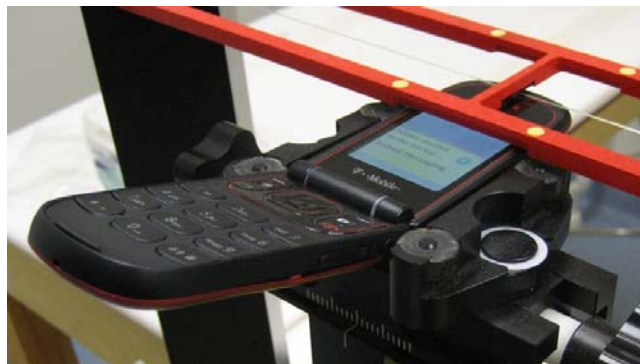
The device was positioned such that Device Reference plane was touching the bottom of the Test Arch. The scan is centered at the acoustic output by aligning the acoustic output with the intersection of the Test Arch's middle bar and dielectric wire.

Photo of the device positioned under Test Arch
