Conducted Harmonic and spurious signals

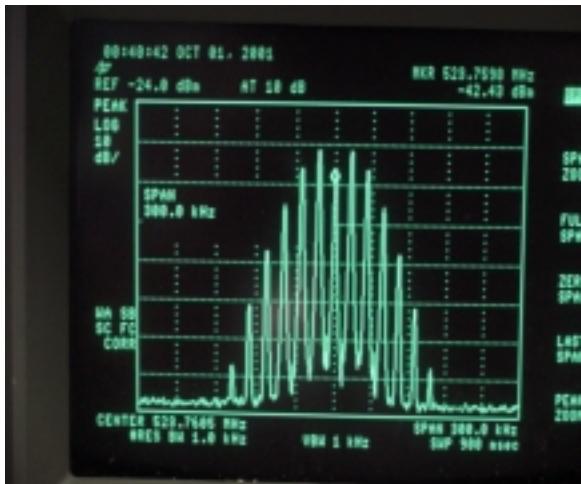
Input Signal measured directly before solid state amplifier.
The occupied bandwidth photos provide evidence of meeting FCC rule 2.1079.

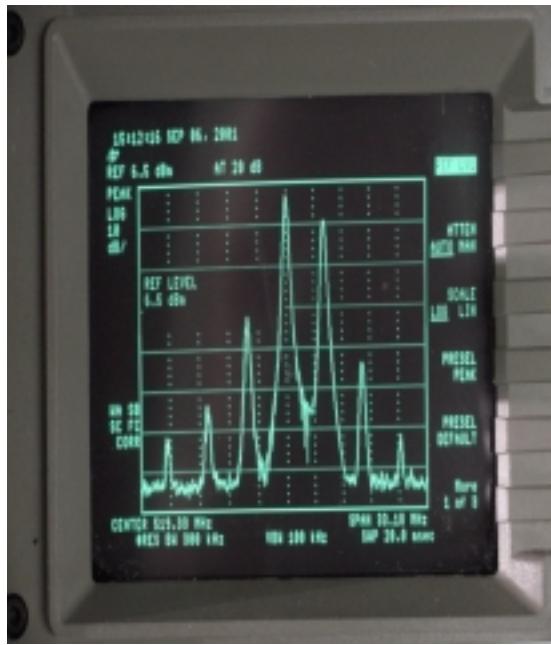
Adjacent channel spurious (input to amplifier)

The equipment was configured as shown in Figure 1. The translator was operated at 1100 watts peak power with a 10 dB visual/aural ratio. Measurements were recorded in the RF chain both before the retrofit amplifier and at the translator output. The figures beginning on the next page indicate the spurs outside the channel and harmonics present at the input of the retrofit amplifier. The top of the spectrum analyzer screen is the level of the fundamental signal (i.e. harmonics are ~ -40 dB on the input). The output cable and directional coupler were calibrated for loss at each spurious and harmonic frequency identified and the final harmonic/spurious values were calculated using the appropriate correction factors. All other harmonic or spurious products were >-80 dB and thus not recorded. The figures on the following pages indicate that the spurious components outside the channel and the harmonics meet the requirement outlined in 74.751(c).

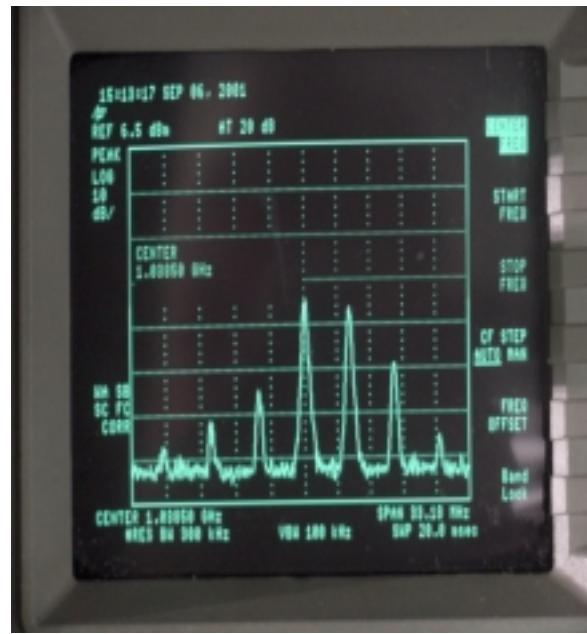
2nd Harmonic area spectrum (input)
(Fundamental power is top of display)
