Prüfbericht - Nr.:
Test Report No.:

16026515 001

6 Photographs of the Test Set-Up

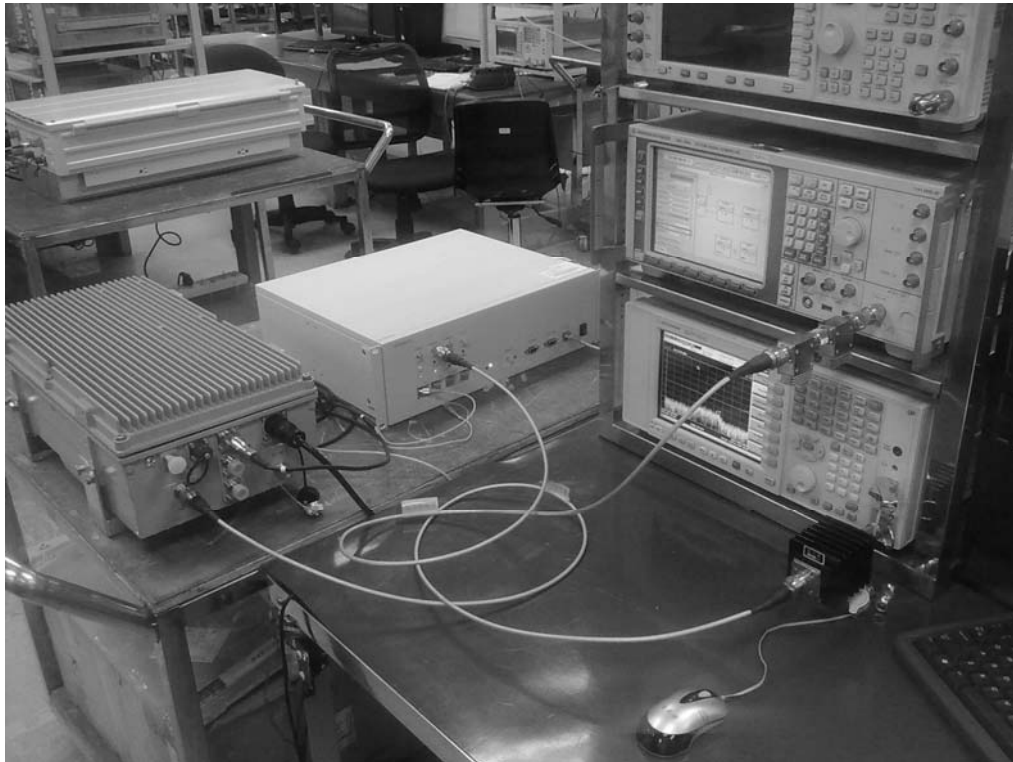
Photograph 1: Set-up for RF power, Occupied Bandwidth, Out-of-Band emissions, Intermodulation test, Spurious Emissions at antenna terminal

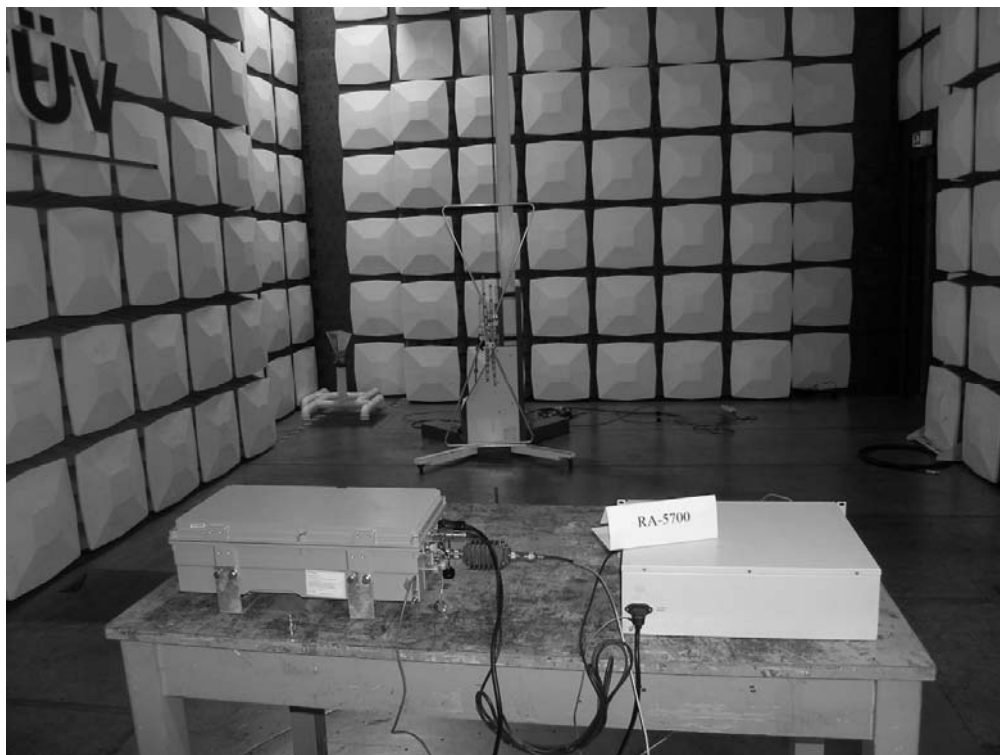
Photograph 2: Set-up for Radiation Measurement Below 1GHz

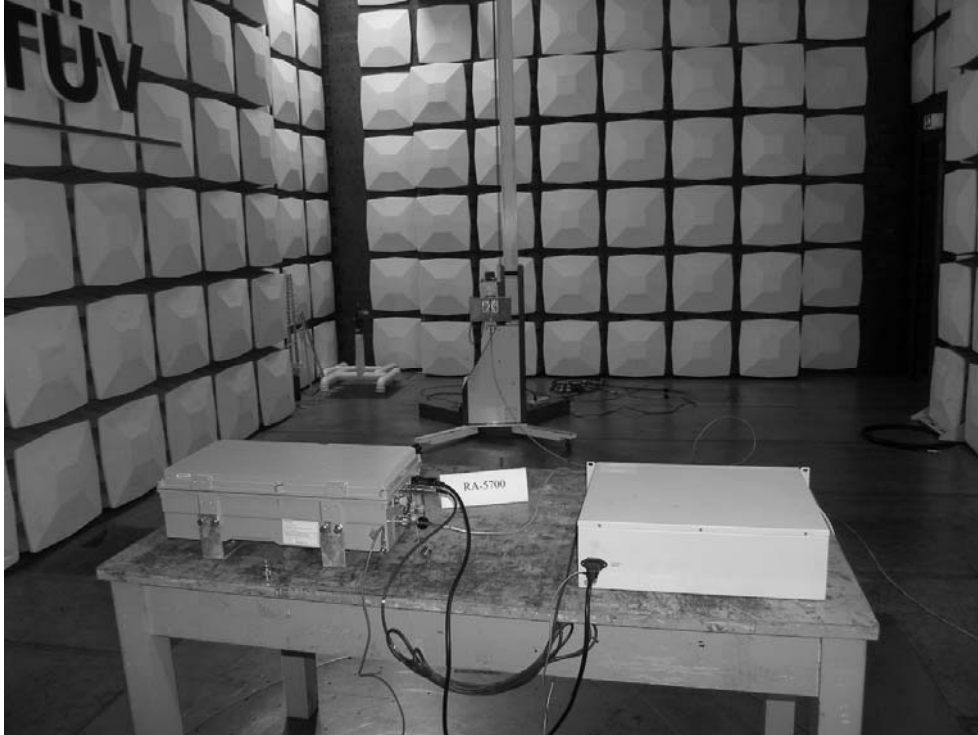
Photograph 3: Set-up for Radiation Measurement above 1GHz

1 GHz to 18 GHz

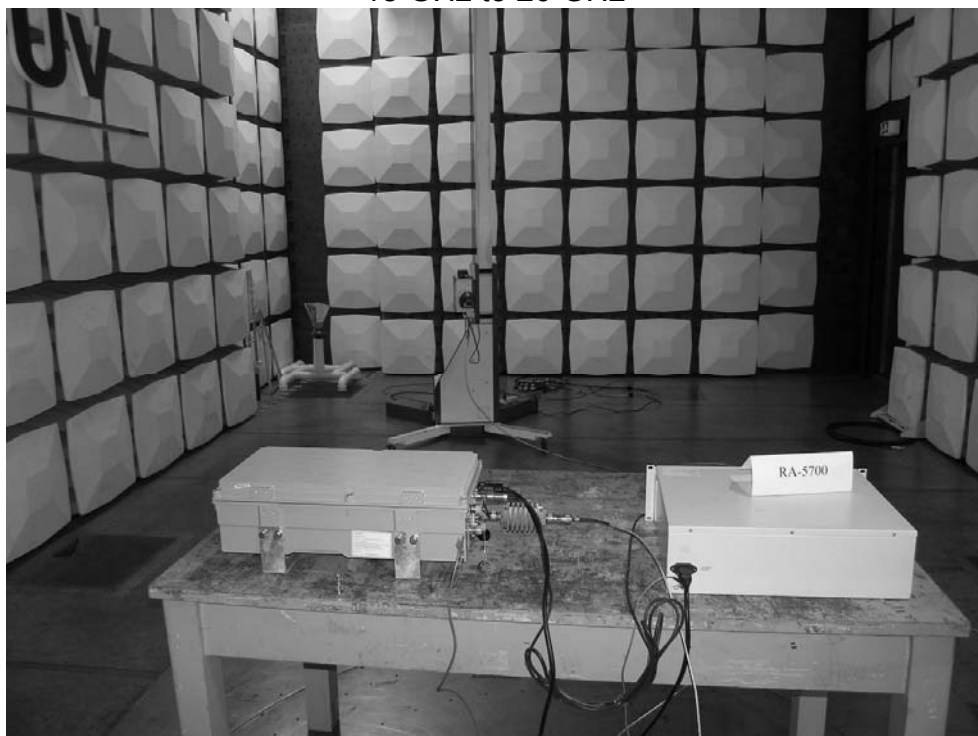
18 GHz to 20 GHz
