### Setup photos for HAC RF Emissions and T-Coil Test Report

| <b>Test report no.:</b> | HAC_Photo_RM-1073_03 | <b>Date of report:</b> | 2014-12-19 |
| <b>Tested devices:</b> | RM-1073 | | |

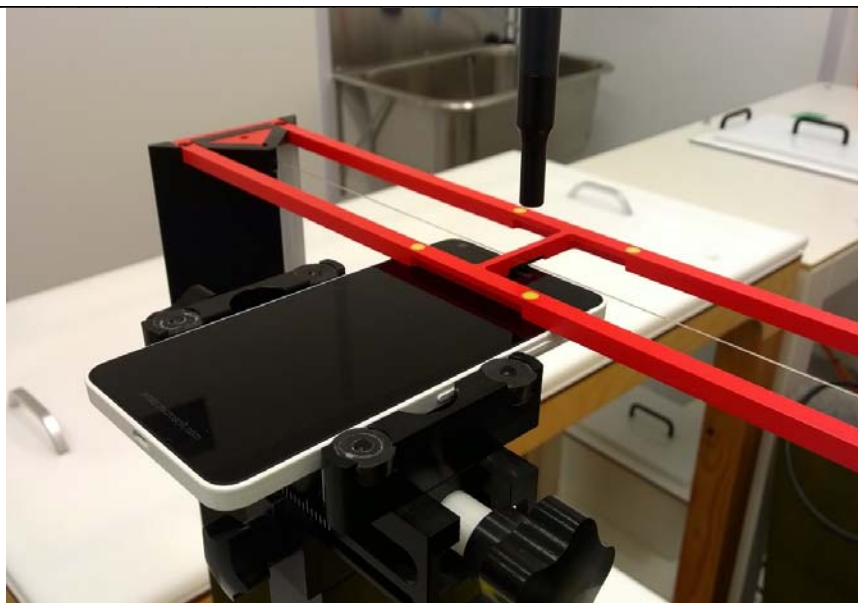
The device was positioned such that Device Reference plane was touching the bottom of the Test Arch. The scan is centered at the acoustic output by aligning the acoustic output with the intersection of the Test Arch's middle bar and dielectric wire.

Photo of the device positioned under Test Arch
