**Setup photos for HAC RF Emissions
and T-Coil Test Report**

Test report no.:	HAC_Photo_RM-1085_03	Date of report:	2015-09-04
Template version:	4.0	Number of pages:	3
Testing laboratory:	TCC Microsoft Salo Laboratory P.O.Box 303 Joensuunkatu 7E FIN-24101 SALO, FINLAND Tel. +358 71 800 8000 Fax. +358 71 80 44122	Client:	Microsoft P.O.Box 303 Joensuunkatu 7 FIN-24101 SALO, FINLAND Tel. +358 71 800 8000 Fax. +358 71 80 44122
Responsible test engineer:	Janne Hirsimäki	Product contact person:	Tia Melava
Measurements made by:	Sami Savela		
Tested devices:	RM-1085		
FCC ID:	PYARM-1085	IC:	661X-RM1085
Supplement reports:	RF_RM-1085_01, T-Coil_RM-1085_02		
Testing has been carried out in accordance with:	<p>ANSI C63.19-2011 American National Standard for Methods of Measurement of Compatibility between Wireless Communications Devices and Hearing Aids</p> <p>CTIA Test Plan for Hearing Aid Compatibility, Revision 3.0, November 2013</p>		
Documentation:	The documentation of the testing performed on the tested devices is archived for 15 years at TCC Microsoft.

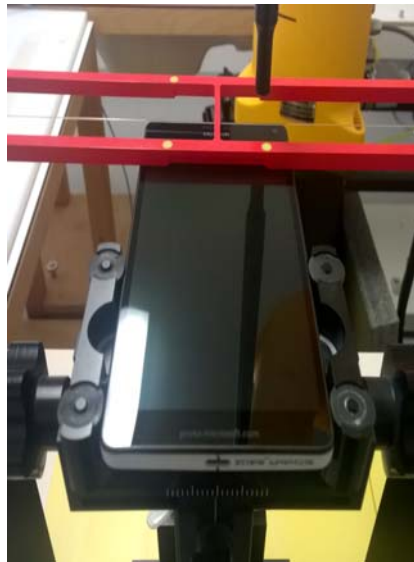
The device was positioned such that Device Reference plane was touching the bottom of the Test Arch. The scan is centered at the acoustic output by aligning the acoustic output with the intersection of the Test Arch's middle bar and dielectric wire.

Photo of the device positioned under Test Arch
