Setup photos for HAC RF Emissions and T-Coil Test Report

Test report no.:	HAC_Photo_RM-824_03		
Template version:	3.0		
Testing laboratory:	TCC Nokia Salo Laboratory P.O.Box 86 Joensuunkatu 7H / Kiila 1B FIN-24101 SALO, FINLAND Tel. +358 (0) 7180 08000 Fax. +358 (0) 7180 45220	Date of report:	2012-08-14
Responsible test engineer:	Juha-Matti Varjonen		
Measurements made by:	Juha-Matti Varjonen, Janne Hirsimäki		
Tested devices:	RM-824		
FCC ID:	PYARM-824		
Product contact person:	Tia Melava		
Supplement reports:	RF_RM-824_01, T-Coil_RM-824_02		
Testing has been carried out in accordance with:	<p>ANSI C63.19-2007 American National Standard for Methods of Measurement of Compatibility between Wireless Communications Devices and Hearing Aids</p>		
Documentation:	The documentation of the testing performed on the tested devices is archived for 15 years at TCC Nokia.		
Test results:	<p>The tested device complies with the requirements in respect of all parameters subject to the test. The test results and statements relate only to the items tested. The test report shall not be reproduced except in full, without written approval of the laboratory.</p>

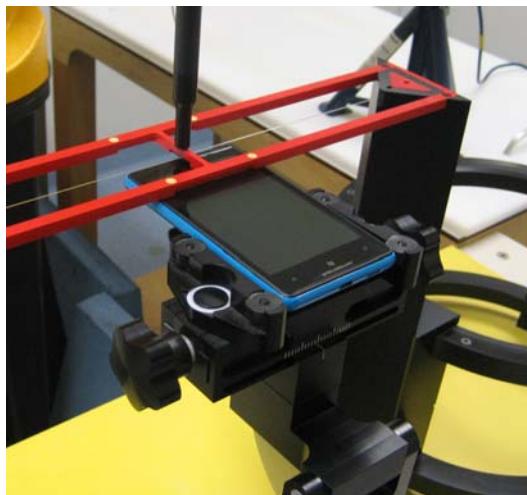
The device was positioned such that Device Reference plane was touching the bottom of the Test Arch. The scan is centered at the acoustic output by aligning the acoustic output with the intersection of the Test Arch's middle bar and dielectric wire.

Photo of the device positioned under Test Arch
