## Setup photos for HAC RF Emissions and T-Coil Test Report

| Test report no.: | HAC_Photo_RM-824_06 | Date of report: | 2012-08-24 |
| Tested devices: | RM-824 (Wireless Charging Cover CC-3401) | | |
| Testing has been carried out in accordance with: | <b>ANSI C63.19-2007</b><br>American National Standard for Methods of Measurement of Compatibility between Wireless Communications Devices and Hearing Aids | | |

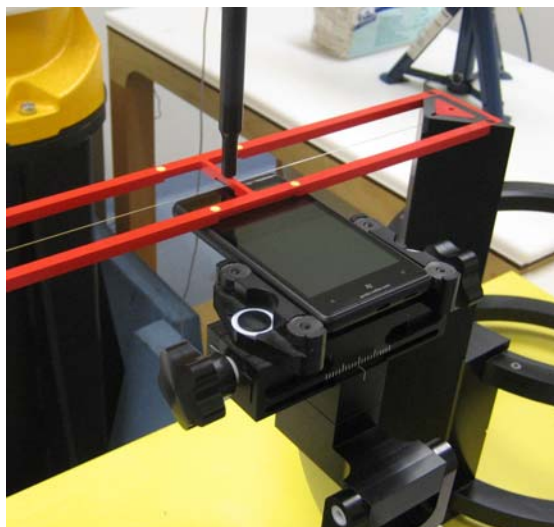
The device was positioned such that Device Reference plane was touching the bottom of the Test Arch. The scan is centered at the acoustic output by aligning the acoustic output with the intersection of the Test Arch's middle bar and dielectric wire.

Photo of the device positioned under Test Arch
