APPENDIX 3: Photographs of test setup

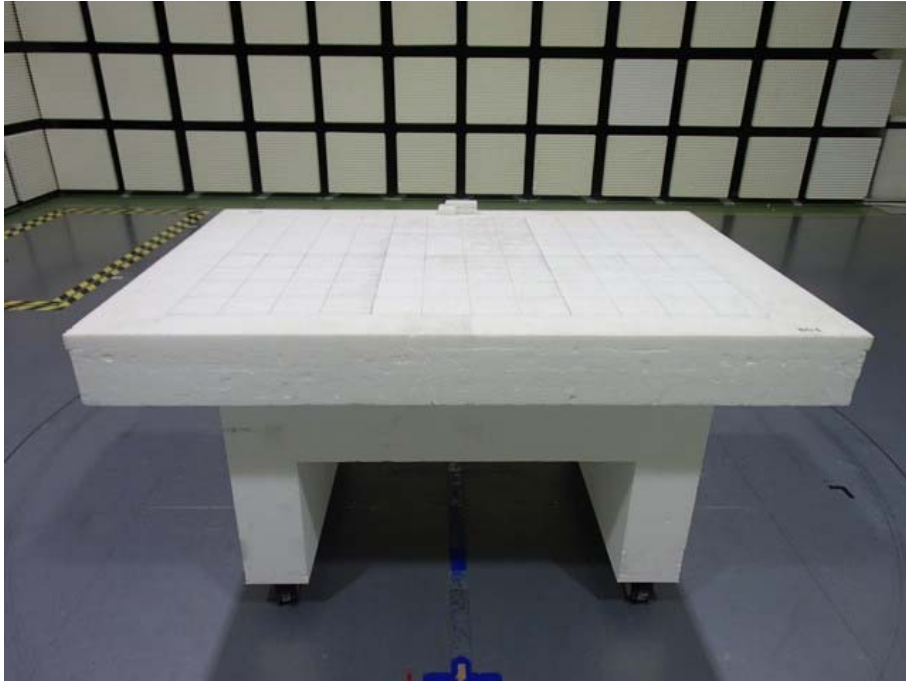
Photo 1

Radiated Spurious Emission
(Below 1 GHz)

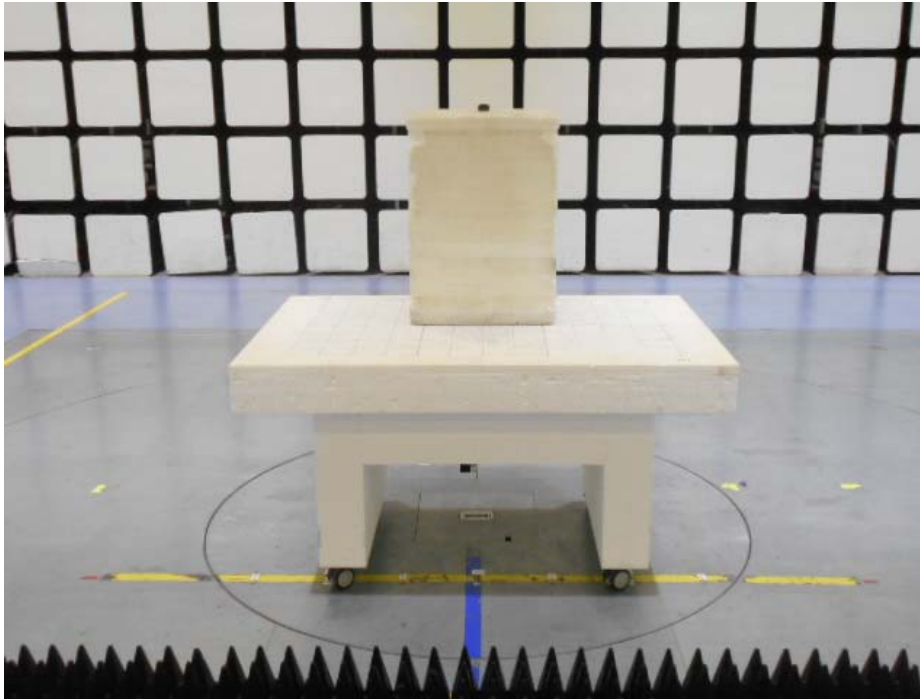
Photo 1

Radiated Spurious Emission
(Above 1 GHz)

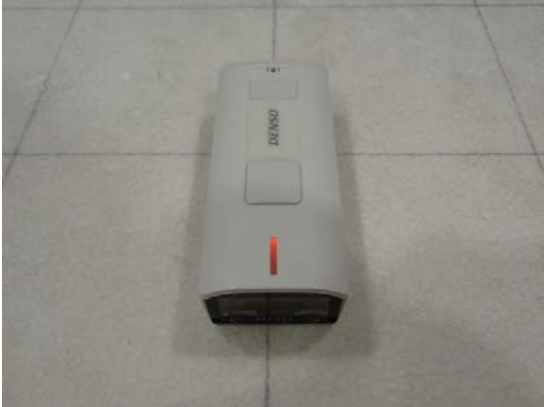
Worst Case Position

Test Range	Horizontal	Vertical
Below 1 GHz	Y-axis	Z-axis
Above 1 GHz	X-axis	Z-axis

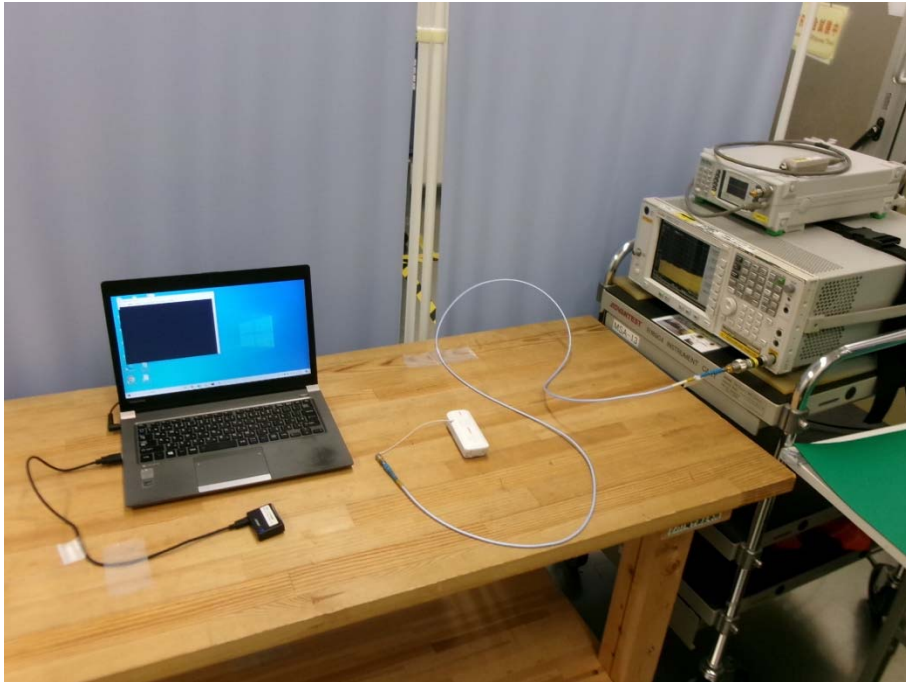
Photo 1

Antenna Terminal Conducted Tests
