APPENDIX 3: Photographs of test setup

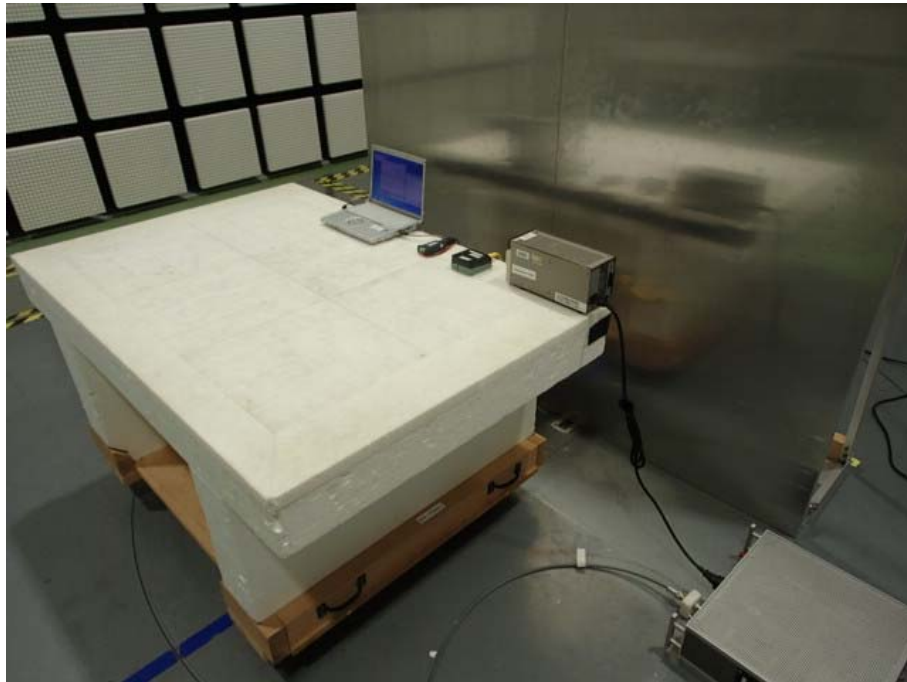
Photo 1

Conducted Emission

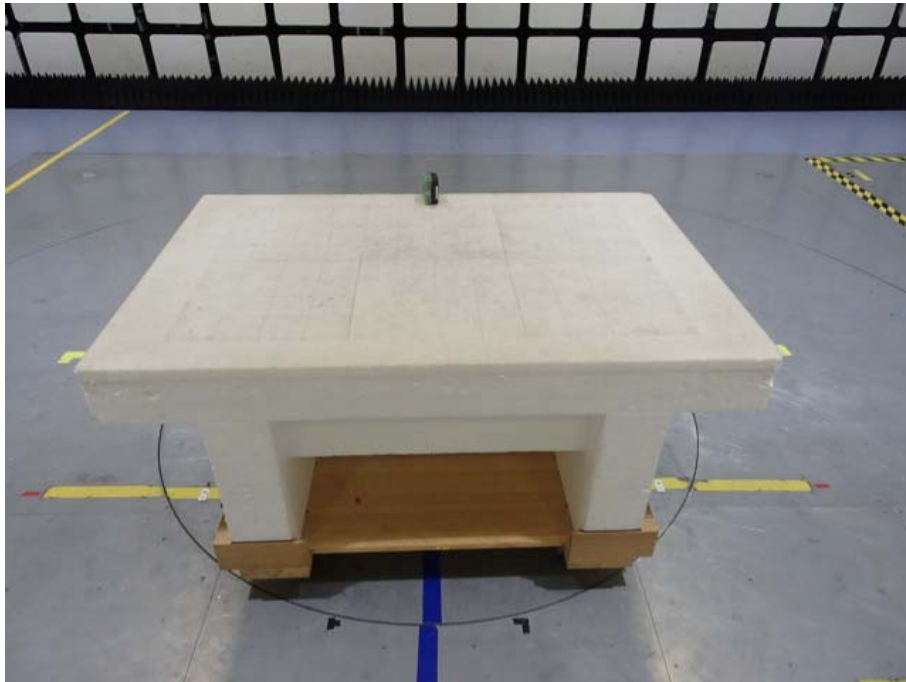
Photo 1

Radiated Emission

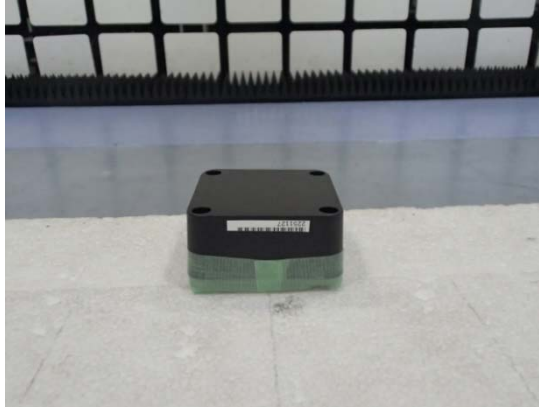
Worst Case Position

Below 30 MHz Z-axis
Above 30 MHz Horizontal: Z-axis / Vertical: X-axis

X-axis

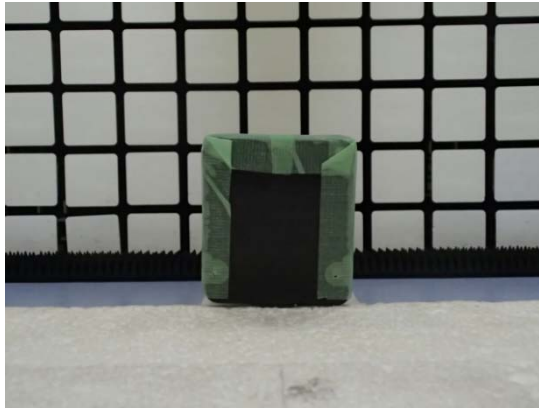
Y-axis

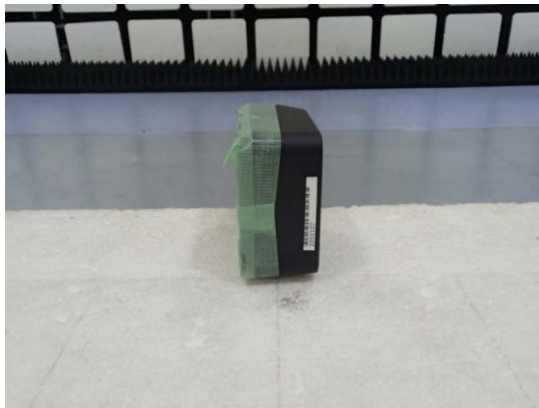
Z-axis

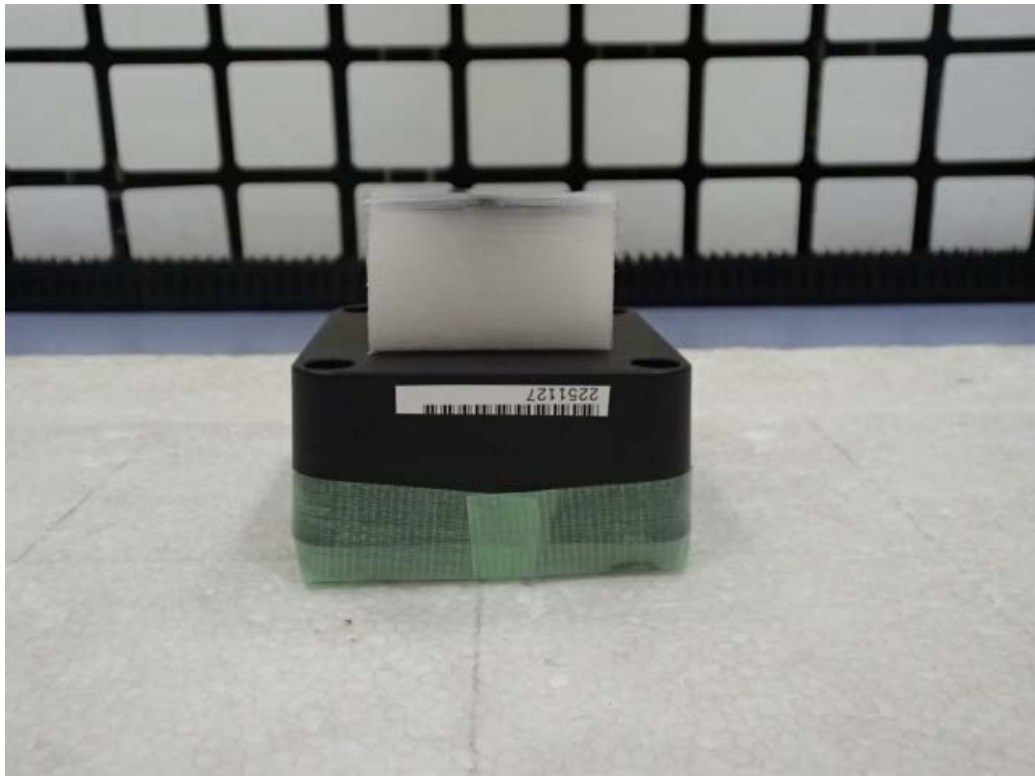
With/Without Tag

With Tag

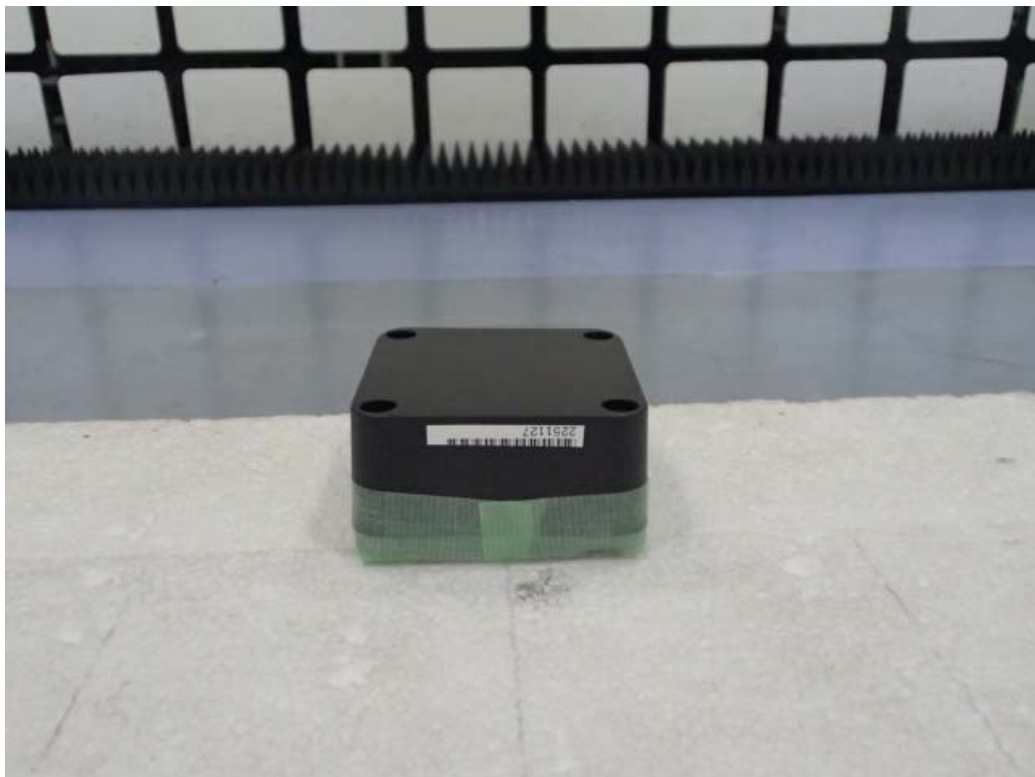
Without Tag (Worst)

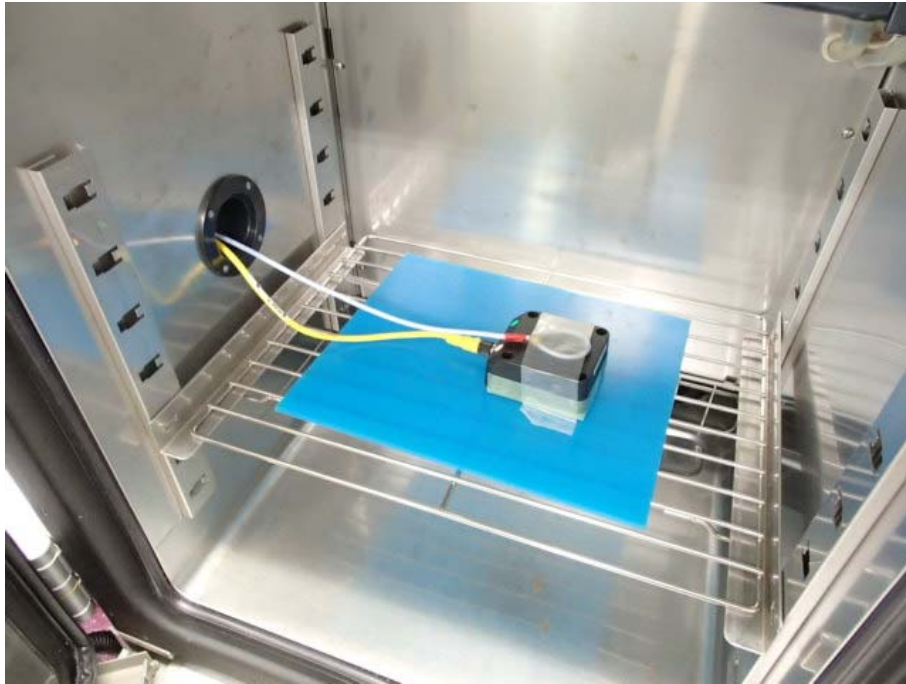
Photo 1

Frequency Tolerance
