APPENDIX 3: Photographs of test setup

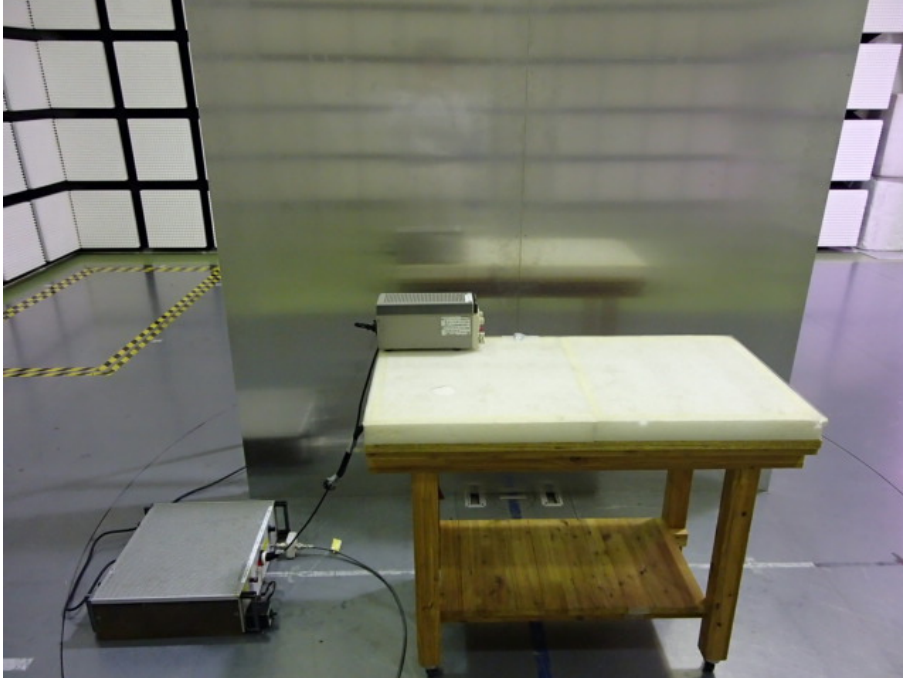
Photo 1

Conducted Emission

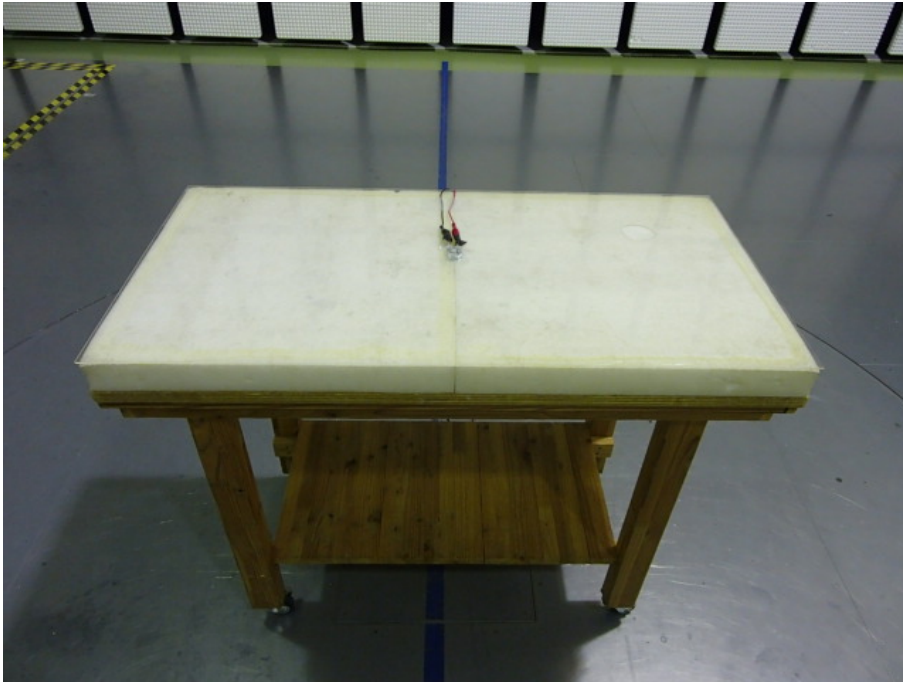
Photo 1

Radiated Spurious Emission

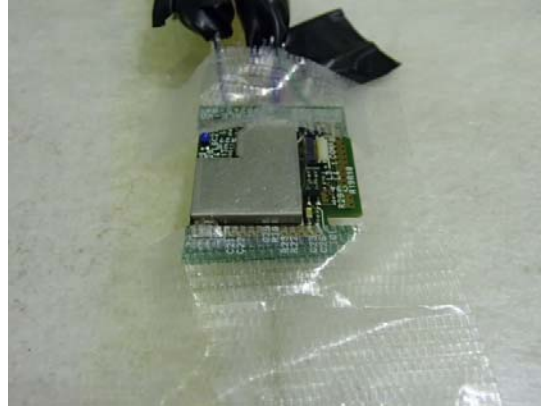
X-axis

Worst Case Position (Horizontal: X-axis/ Vertical:Y-axis)
