## Test setup photos for HAC RF Emissions Test Report

| Test report no.: | Salo_HAC_0840_13 | Date of report: | 2008-10-02 |
| Testing has been carried out in accordance with: | <b>ANSI C63.19-2007</b><br>American National Standard for Methods of Measurement of Compatibility between Wireless Communications Devices and Hearing Aids | | |

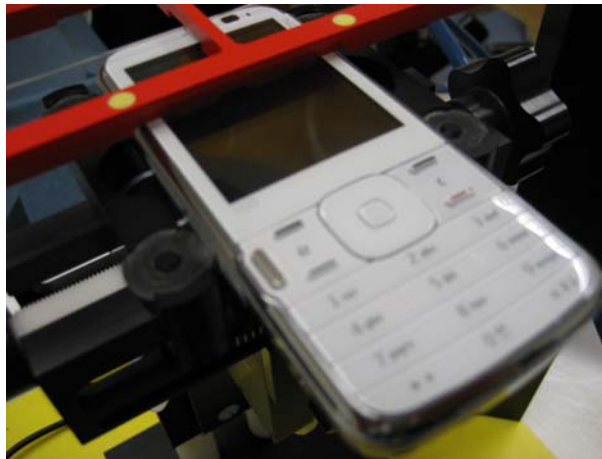
The device was positioned such that Device Reference plane was touching the bottom of the Test Arch. The scan is centered at the acoustic output by aligning the acoustic output with the intersection of the Test Arch's middle bar and dielectric wire.

Photo of the device positioned under Test Arch
