## Test Setup photos for RX-114 SAR Compliance Test Report

| <b>Test report no.:</b> | SAR_Photo_RX-114_02 | <b>Date of report:</b> | 2013-09-25 |
| <b>Tested device:</b> | RX-114 | | |

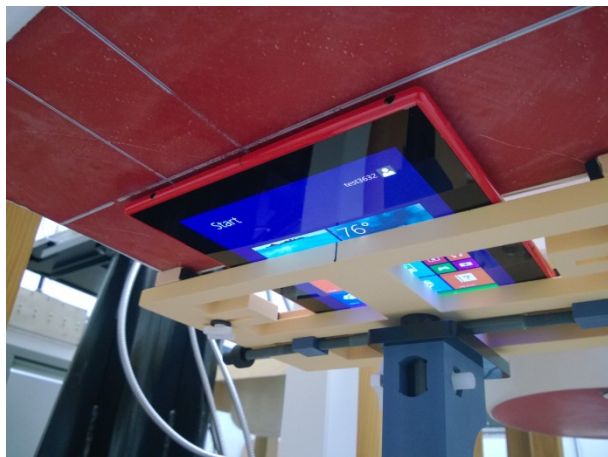
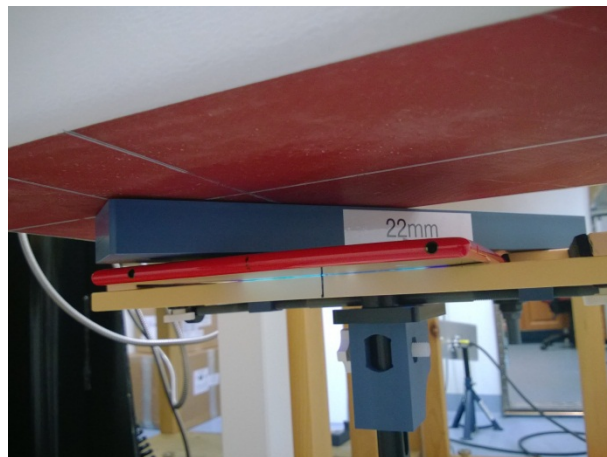
Photo of the device positioned for back facing phantom (for cellular bands measurements).  
The spacer was removed before the start of the measurements.

The device was placed in the Nokia holder using the Nokia spacer and, in sequence, the back, top, bottom and left edges were positioned 0.0mm, 21.0mm or 22.0 mm away from the flat phantom. Separation distance is indicated in the photo. The spacer was removed before the start of the measurements.

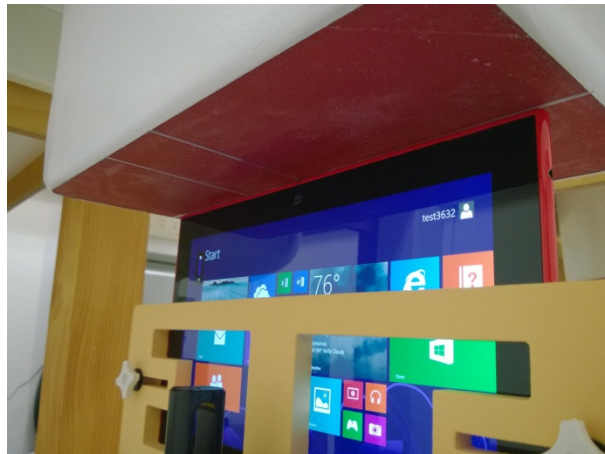
Photo of the device positioned for bottom edge facing phantom.

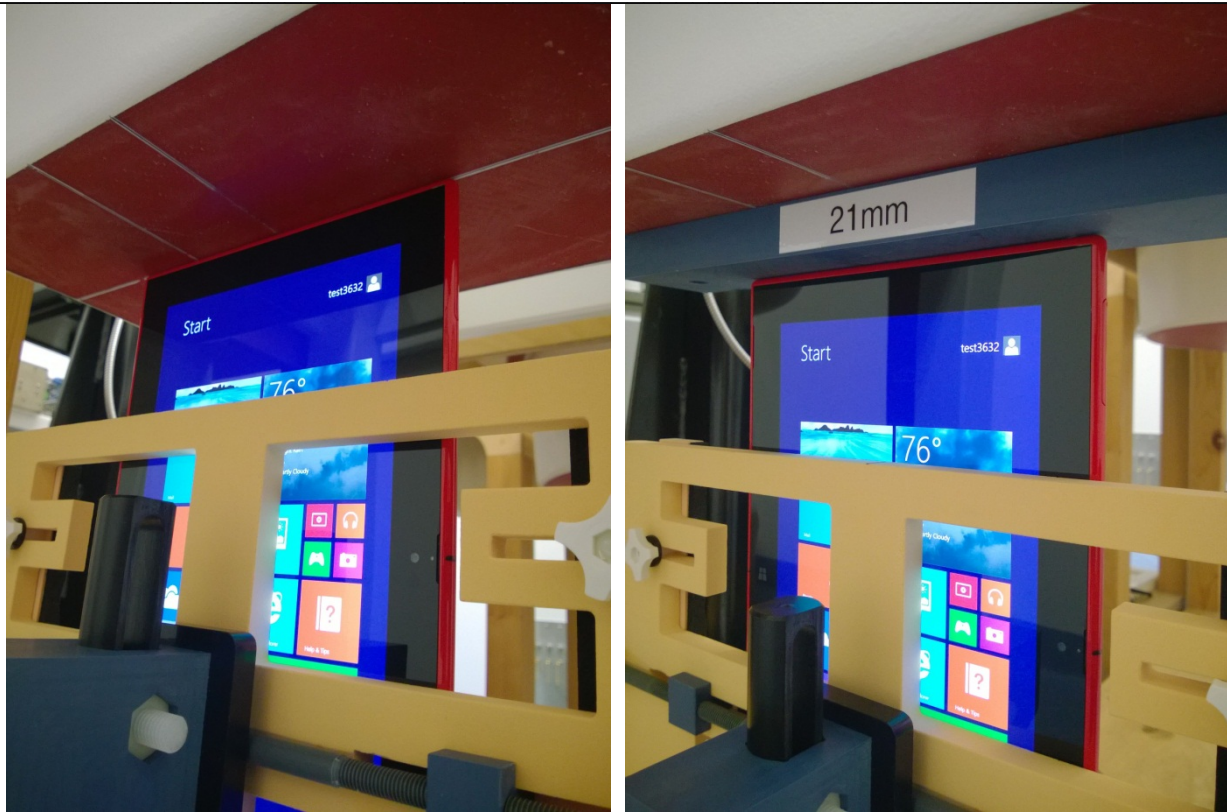
Photo of the device positioned for left edge facing phantom.  
The spacer was removed before the start of the measurements.
