## Setup photos for HAC RF Emissions and T-Coil Test Report

Test report no.:	Salo_HAC_0739_11	Date of report:	2007-10-01
Template version:	1.0	Number of pages:	3
Testing laboratory:	TCC Salo P.O. Box 86 Joensuunkatu 7H / Kiila 1B FIN-24101 SALO, FINLAND Tel. +358 (0) 7180 08000 Fax. +358 (0) 7180 45220	Client:	Nokia Corporation 12278 Scripps Summit Drive SAN DIEGO CA. 92131 USA Tel. +1 858 831 5000 Fax. +1 858 831 6500
Responsible test engineer:	Ari Orte	Product contact person:	Bill Griffin
Measurements made by:	Virpi Tuominen, Ari Orte		
Tested devices:	RM-257 (Hearing aid mode)		
FCC ID:	QMNRM-257		
Supplement reports:	Salo_HAC_0739_01 Salo_HAC_0739_02		
Testing has been carried out in accordance with:	<b>ANSI C63.19-2006</b> American National Standard for Methods of Measurement of Compatibility between Wireless Communications Devices and Hearing Aids		
Documentation:	The documentation of the testing performed on the tested devices is archived for 15 years at TCC Nokia.

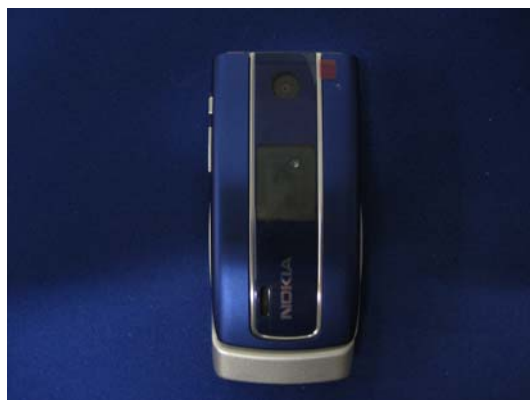
Flip closed

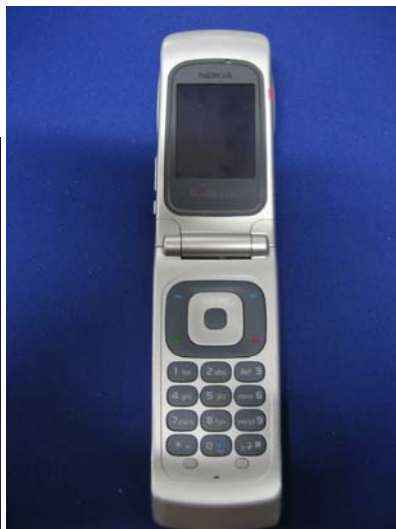
Flip open

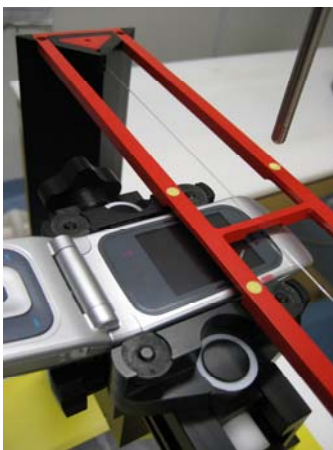
The device was positioned such that Device Reference plane was touching the bottom of the Test Arch. The scan is centered at the acoustic output by aligning the acoustic output with the intersection of the Test Arch's middle bar and dielectric wire.

Photo of the device positioned under Test Arch
