Setup photos for HAC RF Emissions and T-Coil Test Report

Test report no.:	Salo_HAC_0721_04	Date of report:	2007-05-21
Template version:	2.0	Number of pages:	3
Testing laboratory:	TCC Salo P.O. Box 86 Joensuunkatu 7H / Kiila 1B FIN-24101 SALO, FINLAND Tel. +358 (0) 7180 08000 Fax. +358 (0) 7180 45220	Client:	Nokia Corporation 12278 Scripps Summit Drive SAN DIEGO CA. 92131 USA Tel. +1 858 831 5000 Fax. +1 858 831 6500
Responsible test engineer:	Ari Orte	Product contact person:	Bill Griffin
Measurements made by:	Ari Orte		
Tested devices:	RM-289 (Hearing aid mode), HW: 4002		
FCC ID:	QMNRM-289	IC:	661X-RM289
Supplement reports:	Salo_HAC_0719_10 Salo_HAC_0719_11		
Testing has been carried out in accordance with:	ANSI C63.19-2006 American National Standard for Methods of Measurement of Compatibility between Wireless Communications Devices and Hearing Aids		
Documentation:	The documentation of the testing performed on the tested devices is archived for 15 years at TCC Nokia.

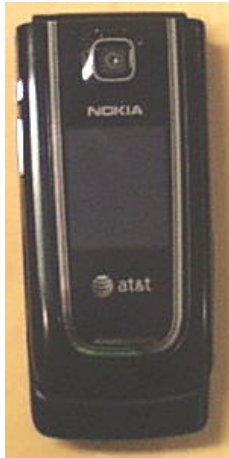
1.1 Picture of Device

Flip closed

Flip open

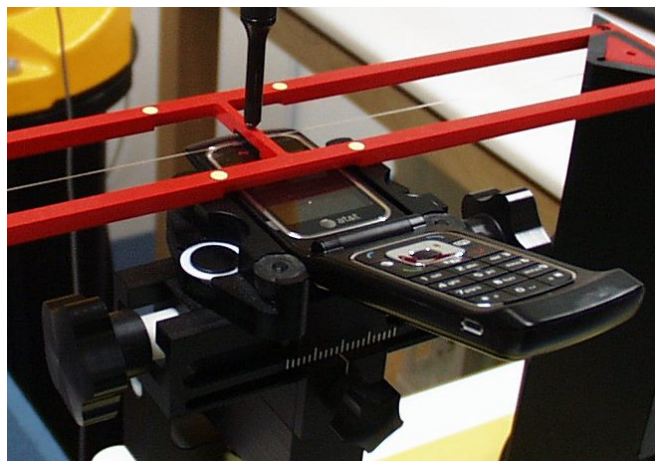
The device was positioned such that Device Reference plane was touching the bottom of the Test Arch. The scan is centered at the acoustic output by aligning the acoustic output with the intersection of the Test Arch's middle bar and dielectric wire.

Photo of the device positioned under Test Arch
