## Test Setup photos for RM-429 HAC RF Emissions Test Report

Test report no.:	Salo_HAC_0825_15		
Template version:	3.0		
Testing laboratory:	TCC Nokia Salo Laboratory P.O.Box 86 Joensuunkatu 7H / Kiila 1B FIN-24101 SALO, FINLAND Tel. +358 (0) 7180 08000 Fax. +358 (0) 7180 45220	Date of report:	2008-06-25
		Number of pages:	4
		Client:	Nokia Corporation 12278 Scripps Summit Drive SAN DIEGO CA. 92131 USA Tel. +1 858 831 5000 Fax. +1 858 831 6500
Responsible test engineer:	Ari Orte	Product contact person:	Bill Griffin
Measurements made by:	Ari Orte		
Tested devices:	RM-429		
FCC ID:	QMNRM-429	IC:	661X-RM429
Supplement reports:	Salo_HAC_0825_14		
Testing has been carried out in accordance with:	<p><b>ANSI C63.19-2007</b> American National Standard for Methods of Measurement of Compatibility between Wireless Communications Devices and Hearing Aids</p>		
Documentation:	The documentation of the testing performed on the tested devices is archived for 15 years at TCC Nokia.

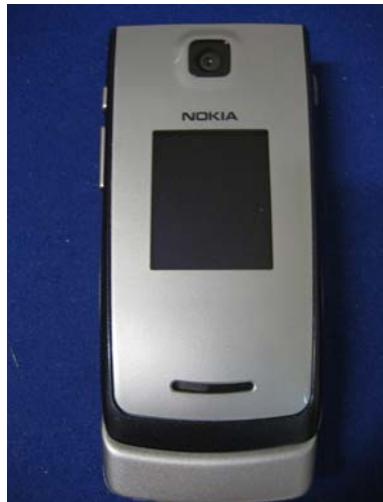
Flip closed

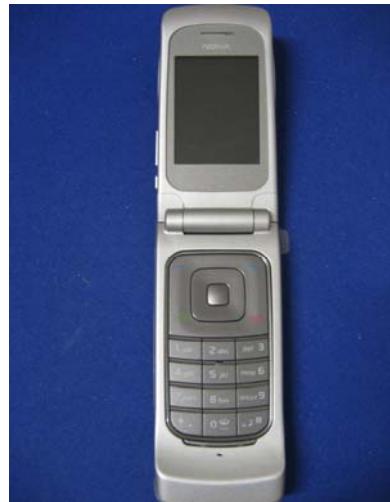
Flip open

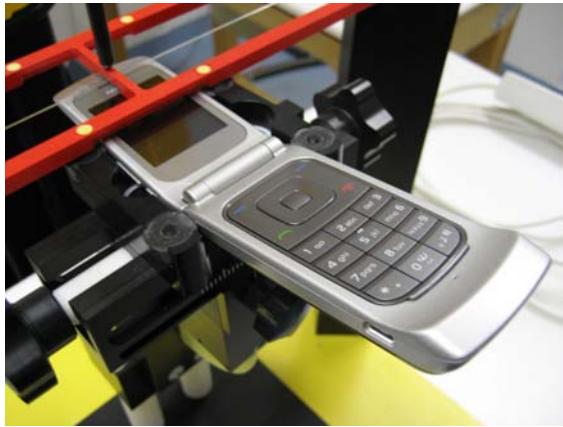
The device was positioned such that Device Reference plane was touching the bottom of the Test Arch. The scan is centered at the acoustic output by aligning the acoustic output with the intersection of the Test Arch's middle bar and dielectric wire.

Photo of the device positioned under Test Arch
