## Setup photos for HAC RF Emissions and T-Coil Test Report

Test report no.:	HAC_Photo_RM-845_03	Date of report:	2012-08-07
Template version:	3.0	Number of pages:	3
Testing laboratory:	TCC Nokia Salo Laboratory P.O.Box 86 Joensuunkatu 7H / Kiila 1B FIN-24101 SALO, FINLAND Tel. +358 (0) 7180 08000 Fax. +358 (0) 7180 45220	Client:	Nokia Corporation 16620 West Bernardo Drive SAN DIEGO CA. 92127 USA Tel. +1 858 831 5000 Fax. +1 858 831 6500
Responsible test engineer:	Janne Hirsimäki	Product contact person:	Victoria Abadilla
Measurements made by:	Janne Hirsimäki		
Tested devices:	RM-845		
FCC ID:	QMNRM-845	IC:	661X-RM845
Supplement reports:	RF_RM-845_01, T-Coil_RM-845_02		
Testing has been carried out in accordance with:	<b>ANSI C63.19-2007</b> American National Standard for Methods of Measurement of Compatibility between Wireless Communications Devices and Hearing Aids		
Documentation:	The documentation of the testing performed on the tested devices is archived for 15 years at TCC Nokia.

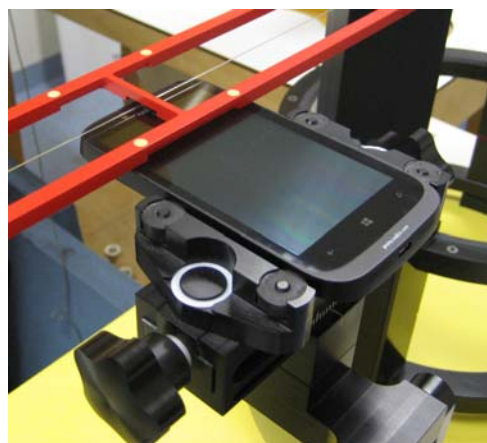
The device was positioned such that Device Reference plane was touching the bottom of the Test Arch. The scan is centered at the acoustic output by aligning the acoustic output with the intersection of the Test Arch's middle bar and dielectric wire.

Photo of the device positioned under Test Arch
