Setup photos for HAC RF Emissions and T-Coil Test Report

Test report no.:	Salo_HAC_0723_12	Date of report:	2007-06-06
Template version:	2.0	Number of pages:	3
Testing laboratory:	TCC Salo P.O. Box 86 Joensuunkatu 7H / Kiila 1B FIN-24101 SALO, FINLAND Tel. +358 (0) 7180 08000 Fax. +358 (0) 7180 45220	Client:	Nokia Corporation Frederikskaej 1790 COPENHAGEN V DENMARK Tel. +45 33 292929 Fax. +45 33 292934
Responsible test engineer:	Ari Orte	Product contact person:	Ole Soerensen
Measurements made by:	Ari Orte		
Tested devices:	RM-207 (Hearing aid mode), HW: 0002		
FCC ID:	QTKRM-207	IC:	
Supplement reports:	'Salo_HAC_0723_01.pdf' 'Salo_HAC_0723_02.pdf'		
Testing has been carried out in accordance with:	<p>ANSI C63.19-2006 American National Standard for Methods of Measurement of Compatibility between Wireless Communications Devices and Hearing Aids</p>		
Documentation:	The documentation of the testing performed on the tested devices is archived for 15 years at TCC Nokia.

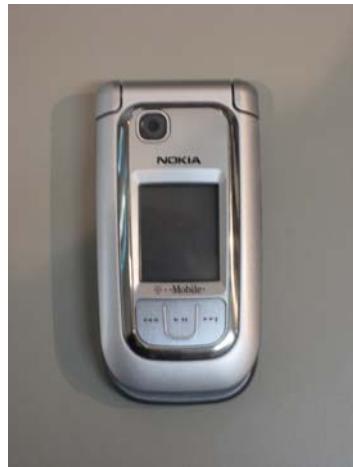
Flip closed

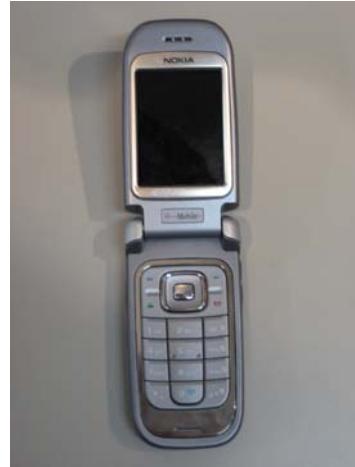
Flip open

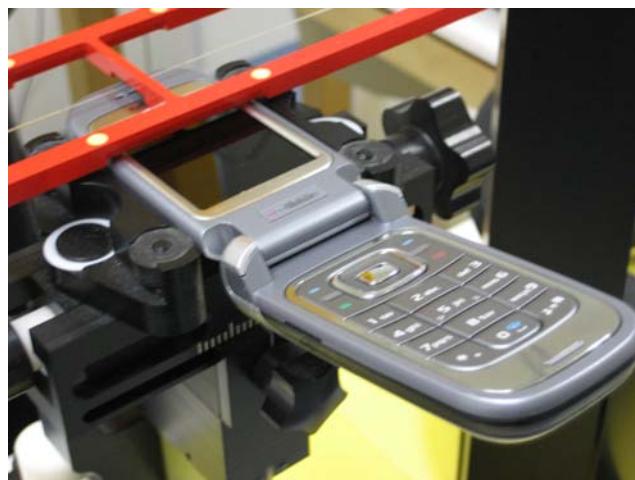
The device was positioned such that Device Reference plane was touching the bottom of the Test Arch. The scan is centered at the acoustic output by aligning the acoustic output with the intersection of the Test Arch's middle bar and dielectric wire.

Photo of the device positioned under Test Arch
