### Setup photos for HAC RF Emissions and T-Coil Test Report

| <b>Test report no.:</b> | HAC_Photo_RM-1041_03 | <b>Date of report:</b> | 2014-10-29 |
| <b>Tested devices:</b> | RM-1041 | | |

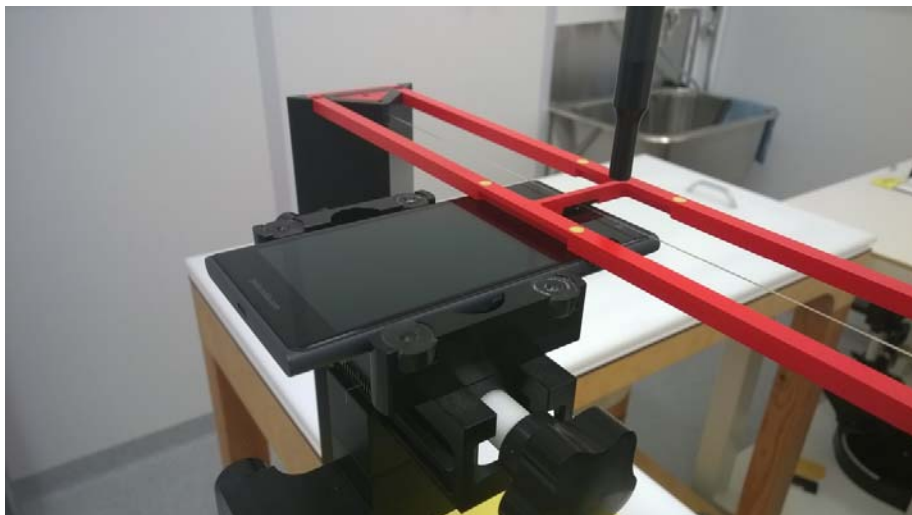
The device was positioned such that Device Reference plane was touching the bottom of the Test Arch. The scan is centered at the acoustic output by aligning the acoustic output with the intersection of the Test Arch's middle bar and dielectric wire.

Photo of the device positioned under Test Arch
