INTERNAL ASSEMBLY VIEW

# PCB COMPONENT SIDE

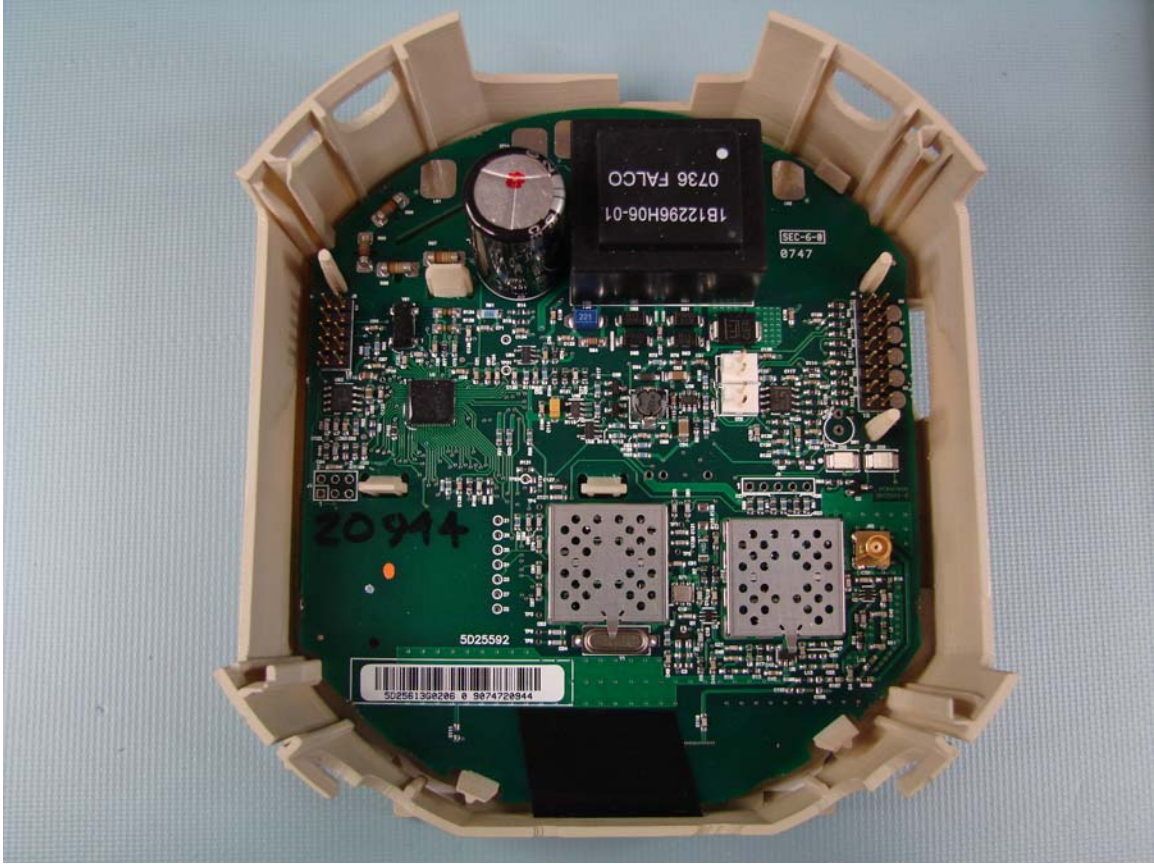
INTERNAL ASSEMBLY SHOWING  
PCB INSTALLED IN FRONT COVER
